Device	XMC1300
Marking/Step	EES-AB, ES-AB, AB
Package	PG-TSSOP-16/28/38, PG-VQFN-24/40

This “Errata Sheet” describes product deviations with respect to the user documentation listed below.

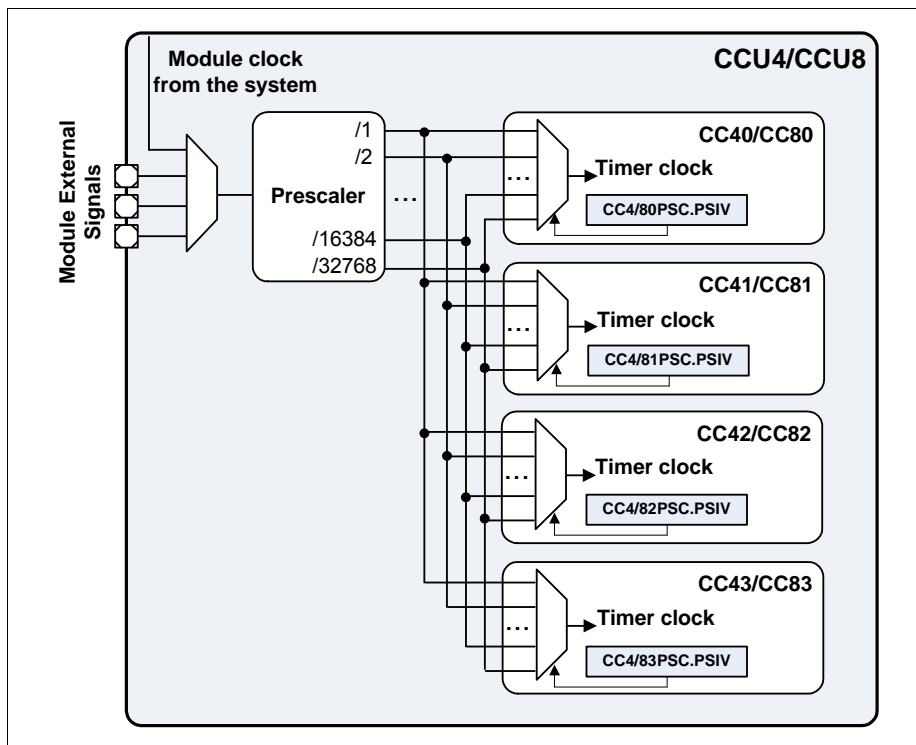
Figure 1 Clock Selection Diagram for CCU4/CCU8

Currently is only possible to use an external signal as Timer Clock when a division ratio of 2 or higher is selected. When no division is selected (divided by 1), the external signal cannot be used.

The user must program the PSIV field of each Timer Slice with a value different from 0000_B - minimum division value is /2.

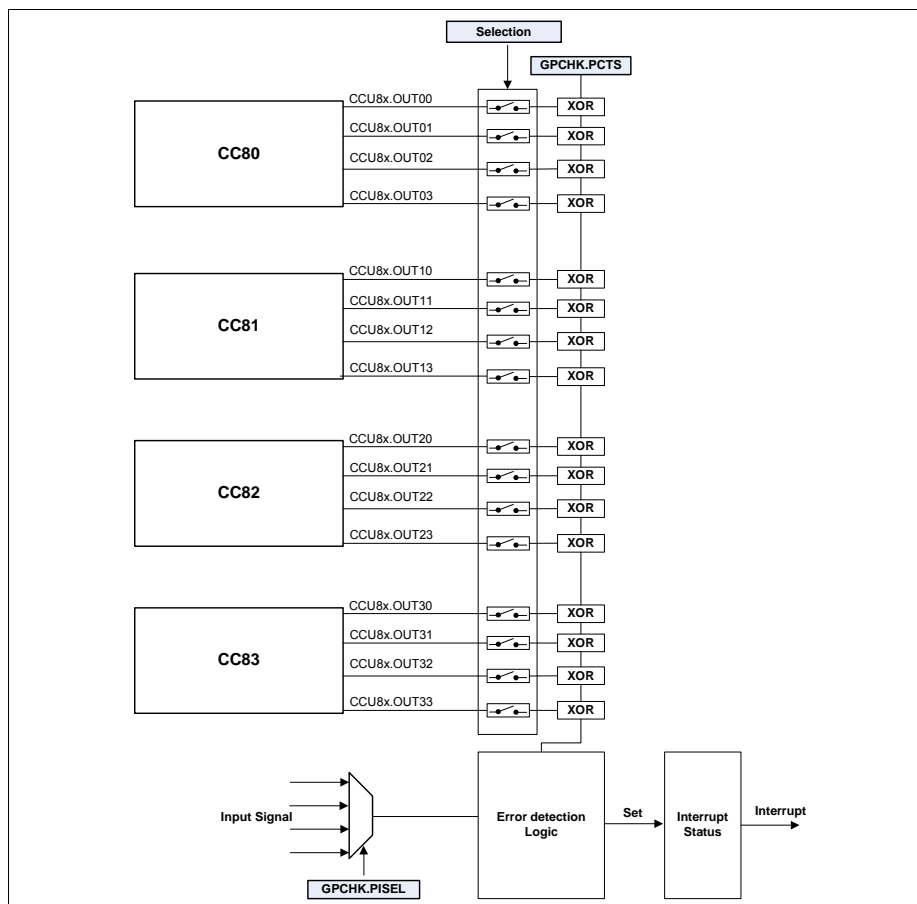
Figure 2 Parity Checker diagram

When using the parity checker function, the associated status bitfield, is cleared automatically by hardware in the next PWM cycle whenever an error is not present.

This means that if in the previous PWM cycle an error was detected and one interrupt was triggered, the software needs to read back the status register before the end of the immediately next PWM cycle.

Not ORing the Parity Checker error interrupt with any other interrupt source. With this approach, the software does not need to read back the status information to understand what was the origin of the interrupt - because there is only one source.

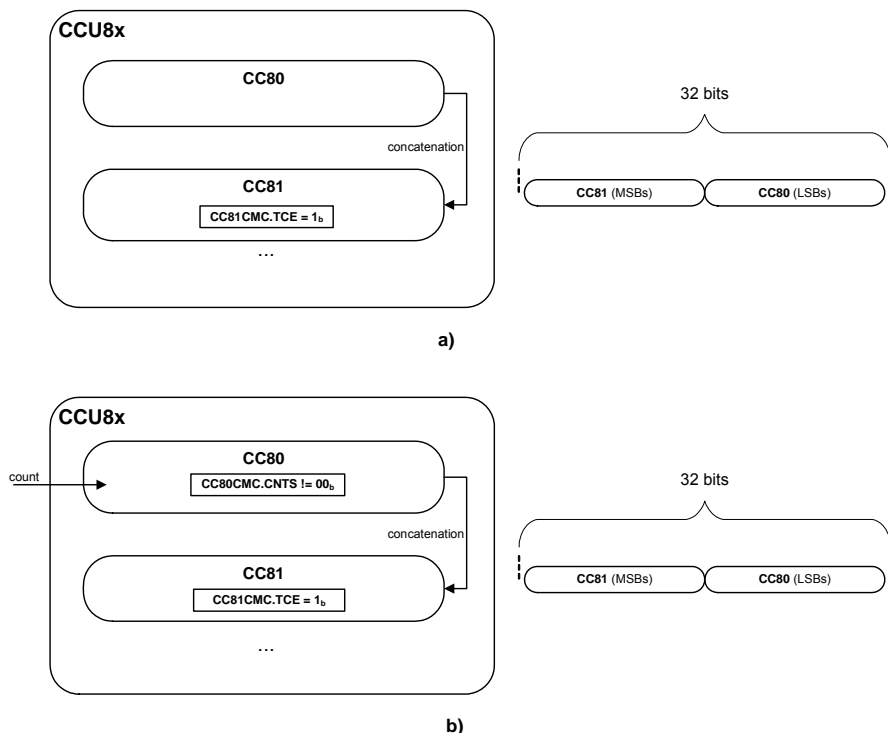
Figure 3 CCU8x concatenation feature resource configuration - a) without external count function; b) with external count function

When an external count signal is enabled - by programming the CC8yCMC.CNTS with 01_B, 10_B or 11_B - the concatenation function does not work. One cannot use in parallel the timer concatenation and external count signal features.

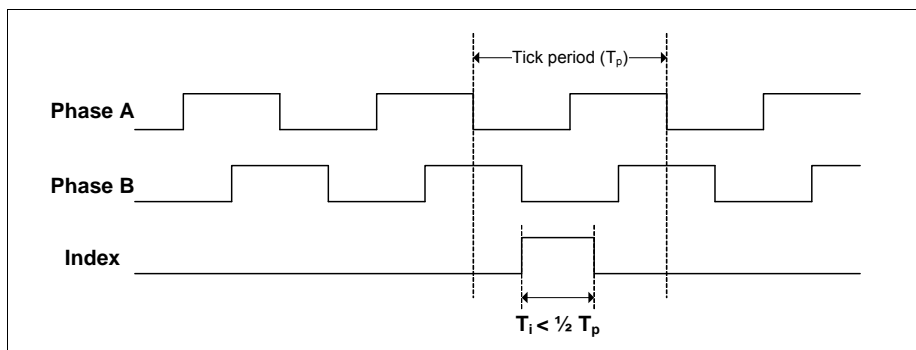
Figure 5 Different index signal types

When the index signal is smaller than 1/2 of the tick period, the POSIF module is not able to decode this signal properly, Figure 2 - notice that the reference edge of the index generation in this figure is the falling of Phase B, nevertheless this is an example and depending on the encoder type, this edge may be one of the other three.

Due to this fact it is not possible to use the POSIF to decode these type of signals (index with duration below 1/2 of the tick period).
