Device	TC1724F/N, TC1728F/N
Marking/Step	ES-AB, AB
Package	see Data Sheet

## 02174AERRA

This Errata Sheet describes the deviations from the current user documentation.

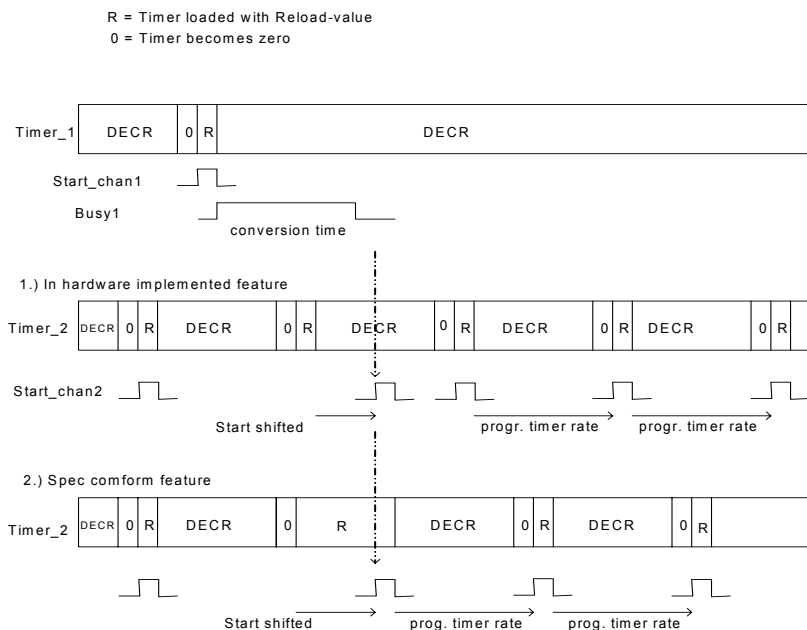
**Figure 1 Timing concerning equidistant multiple timers**

The correct behavior would be a reload when the requested conversion (of `channel_2`) is started.

Therefore the start of conversion for `channel_2` is delayed by maximum one conversion-time. After this delay it will be continued with equidistant conversion-starts. Please refer to the following figure.

Note: the programmed timer rate is much longer than the conversion time, this means that the fault is much smaller than in the picture

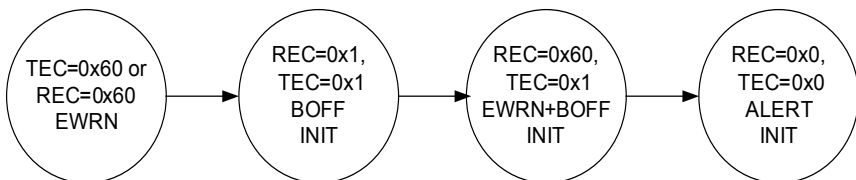
**Figure 2 Alert Interrupt Behavior in case of Bus-Off**

When the threshold for error warning (EWRN) is reached (default value of Error Warning Level EWRN = 0x60), then the EWRN interrupt is issued. The bus-off (BOFF) status is reached if  $TEC > 255$  according to CAN specification, changing the MultiCAN module with REC and TEC to the same value 0x1, setting the INIT bit to 1<sub>B</sub>, and issuing the BOFF interrupt. The bus-off recovery phase starts automatically. Every time an idle time is seen, REC is incremented. If REC = 0x60, a combined status EWRN+BOFF is reached. The corresponding interrupt can also be seen as a pre-warning interrupt, that the bus-off recovery

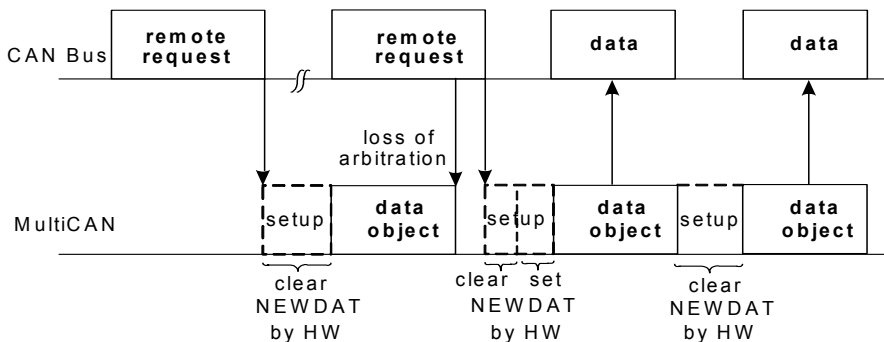
**Figure 3 Loss of Arbitration**

When the appropriate message object (data frame) triggered by the first remote frame wins the arbitration, it will be sent out and NEWDAT is not reset. This leads to an additional data frame, that will be sent by this message object (clearing NEWDAT).

There will, however, not be more data frames than there are corresponding remote requests.

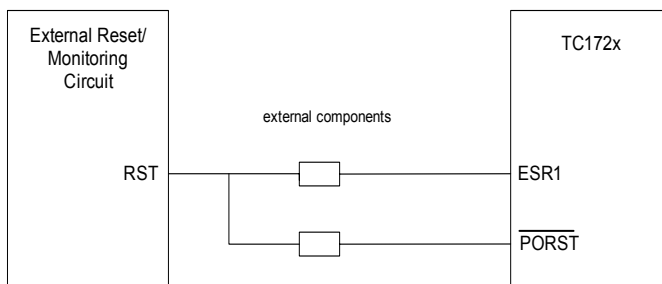
**Figure 4**     **PORST Redundancy Path**

The  $\overline{\text{PORST}}$  pad includes a strong pull-down device controlled by the EVRs. This allows pin  $\overline{\text{PORST}}$  to be actively driven low upon a threshold violation of (at least one of) the monitored supply voltages. For the characteristics of this pull-down see parameter  $\overline{\text{PORST}}$  pad output current  $I_{\text{DDPORST}}$  in the Data Sheet.

FMEA considerations of such a failure mode recommend that the device is set into a safe reset state when  $\overline{\text{PORST}}$  cannot be activated from external devices (voltage regulators, safety monitors) in case critical failures are observed in the system and the microcontroller needs to be set into reset as a result.

a) Connect the reset line additionally to the ESR1 pin (or other appropriate pins) to provide a redundant path to detect such a failure mode.

b) Activate internal voltage monitoring for external supply which acts as a redundant supply watchdog in addition to the supply monitoring carried out by the external regulator.
