Device TC1724F/N, TC1728F/N
Marking/Step ES-AC, AC
Package see Data Sheet

02807AERRA

This Errata Sheet describes the deviations from the current user documentation.

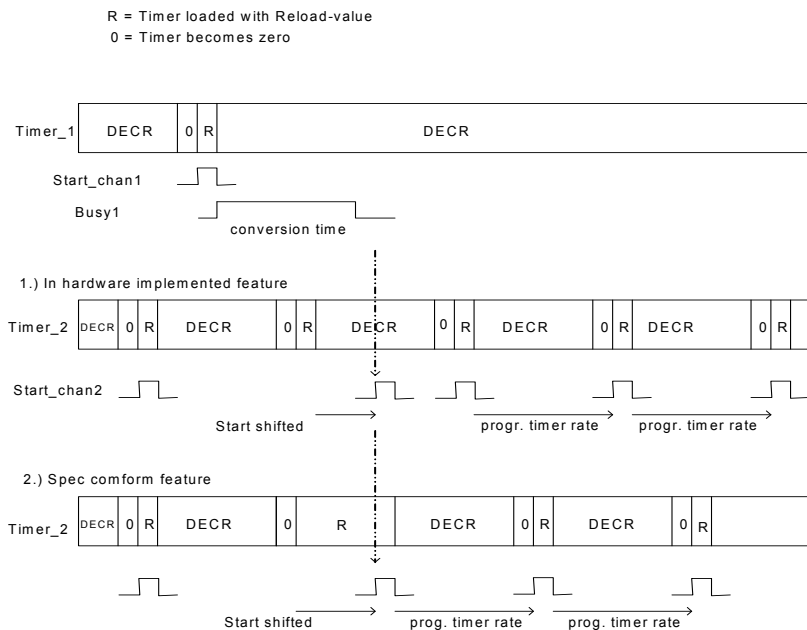
Figure 1 Timing concerning equidistant multiple timers

The correct behavior would be a reload when the requested conversion (of `channel_2`) is started.

Therefore the start of conversion for `channel_2` is delayed by maximum one conversion-time. After this delay it will be continued with equidistant conversion-starts. Please refer to the following figure.

Note: the programmed timer rate is much longer than the conversion time, this means that the fault is much smaller than in the picture

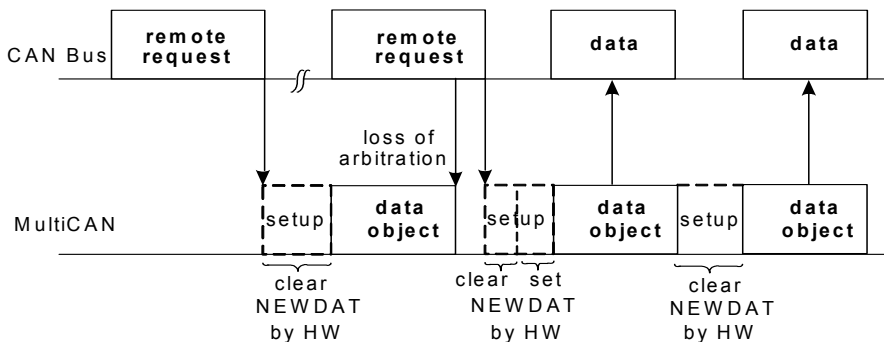
Figure 3 Loss of Arbitration

When the appropriate message object (data frame) triggered by the first remote frame wins the arbitration, it will be sent out and NEWDAT is not reset. This leads to an additional data frame, that will be sent by this message object (clearing NEWDAT).

There will, however, not be more data frames than there are corresponding remote requests.

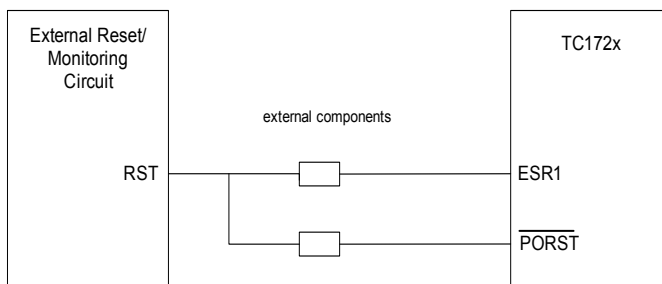
Figure 4 **PORST Redundancy Path**

FMEA considerations of such a failure mode recommend that the device is set into a safe reset state when $\overline{\text{PORST}}$ cannot be activated from external devices (voltage regulators, safety monitors) in case critical failures are observed in the system and the microcontroller needs to be set into reset as a result.

a) Connect the reset line additionally to the ESR1 pin (or other appropriate pins) to provide a redundant path to detect such a failure mode.

b) Activate internal voltage monitoring for external supply which acts as a redundant supply watchdog in addition to the supply monitoring carried out by the external regulator.
