Device TC1736
Marking/Step EES-AA, ES-AA, AA
Package PG-LQFP-144-10

01708AERRA

This Errata Sheet describes the deviations from the current user documentation.

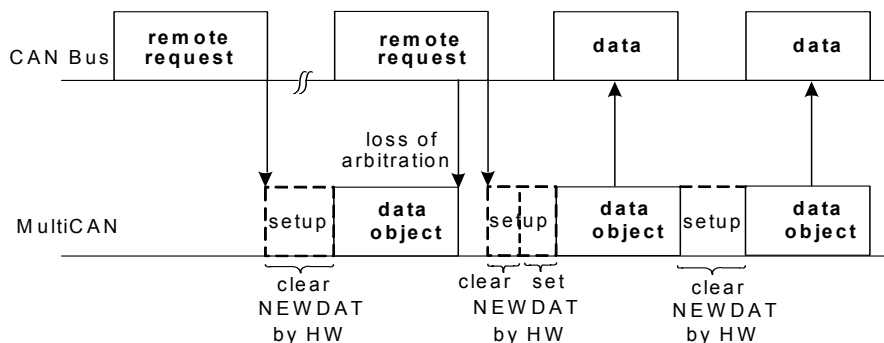
Figure 2 Loss of Arbitration

When the appropriate message object (data frame) triggered by the first remote frame wins the arbitration, it will be sent out and `NEWDAT` is not reset. This leads to an additional data frame, that will be sent by this message object (clearing `NEWDAT`).

There will, however, not be more data frames than there are corresponding remote requests.
