Device	TC1762
Marking/Step	EES-AA, ES-AA, AA
Package	PG-LQFP-176-2

01742AERRA

This Errata Sheet describes the deviations from the current user documentation.

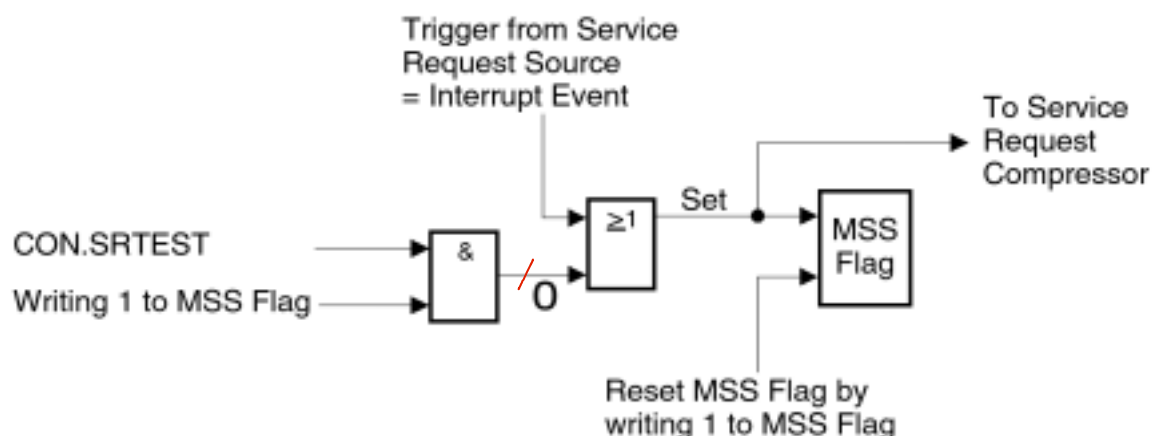
Figure 1

ADC_TC.023 Setting the MSS-flag doesn't generate an interrupt in TEST-MODE

It is possible to generate a software triggered interrupt event in TESTMODE (ADCx_CON.SRTEST=1) by setting one of the bitflags in register ADCx_MSS0/1. Due to the fact, that this mechanism is not working, it is not possible to generate a corresponding interrupt by software.
