Device TC1762
Marking/Step EES-AC, ES-AC, AC
Package PG-LQFP-176-2

02971AERRA

This Errata Sheet describes the deviations from the current user documentation.

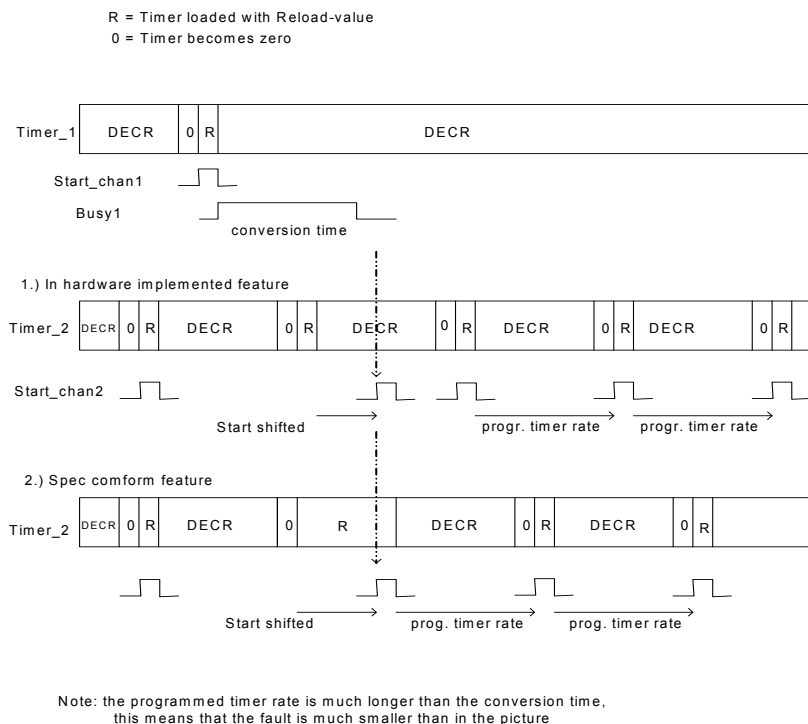
Figure 2 Timing concerning equidistant multiple timers

The correct behavior would be a reload when the requested conversion (of `channel_2`) is started.

Therefore the start of conversion for `channel_2` is delayed by maximum one conversion-time. After this delay it will be continued with equidistant conversion-starts. Please refer to the following figure.

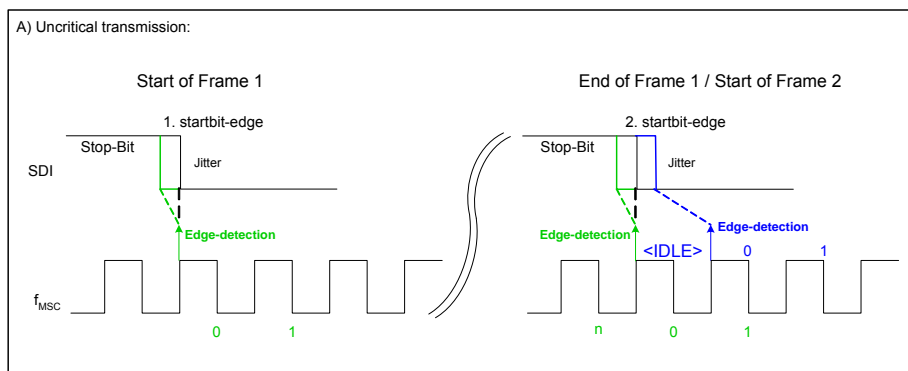
Figure 3 **Uncritical transmission**

As the falling startbit edge is shifted to the left of the rising clock edge (**Figure 3** left), there occurs a secure detection of the next start-bit edge in the last cycle of the previous frame (here cycle n, **Figure 3** right) independent from the applied jitter to this edge.

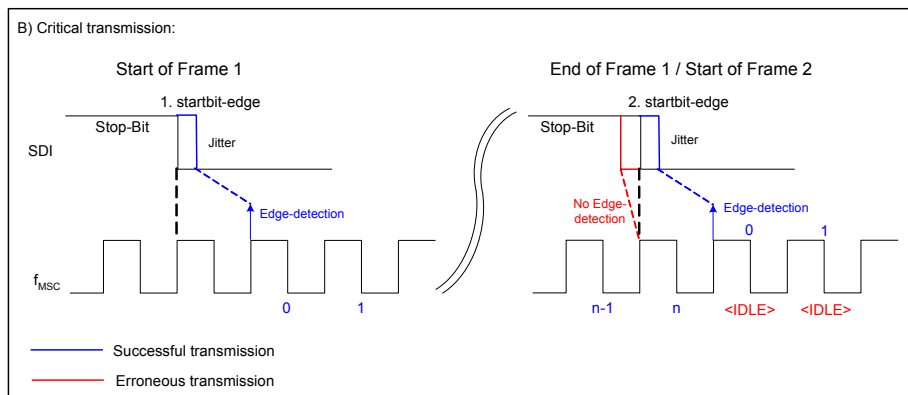
Figure 4 Critical transmission

If the high-low edge of the start-bit in the first frame is just not detected by the near clock-edge (**Figure 4** - left) and the start-bit edge of the second frame is jittering to cycle n-1 (**Figure 4** - right, red coloured), then an erroneous transmission will take place. In this case the state-machine switches to IDLE after the last state n and wakes up on the next falling edge that may be a data-bit recognized as a start-bit. If the start-bit of the second frame is jittering to cycle n (**Figure 4** - right, blue colored), then the state-machine will not switch to IDLE but will start receiving the next frame correctly.

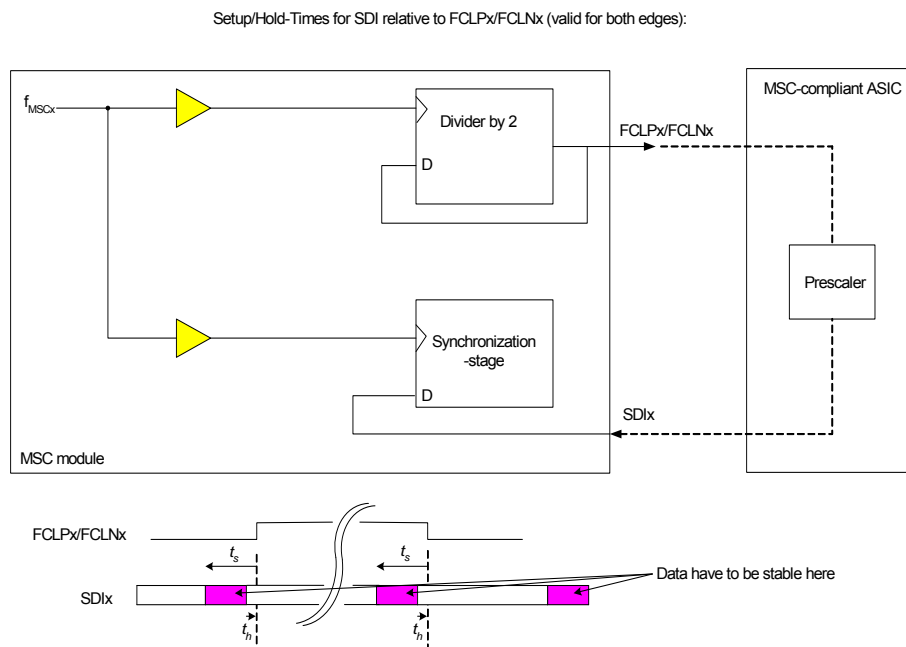
Figure 5 Delay adjustment relative to the module clock

Figure 5 shows the principle blockdiagram of the input synchronization stage of the MSC module.

The delay depends on the maximal skew in the data-stream. For this workaround the downstream clock FCLPx/FCLNx can be measured as reference and the data stream at the input of the upstream channel SDIx has to be adjusted according to the setup- and hold-times of the input-pins SDIx.

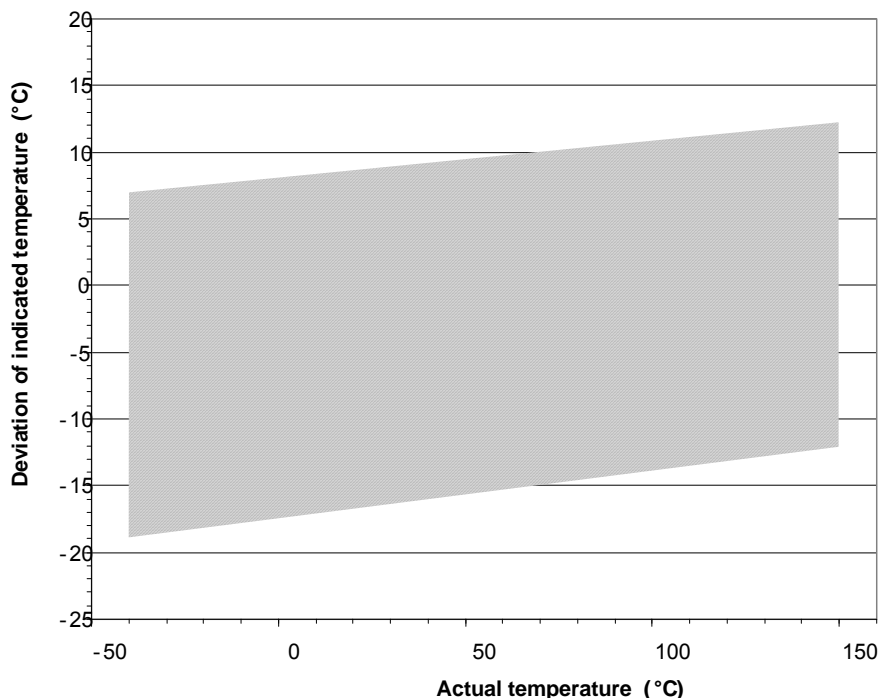
Figure 9 Current accuracy range

- $\pm 12^{\circ}\text{C}$ at $T_J = 150^{\circ}\text{C}$
- $\pm 9/-17^{\circ}\text{C}$ at $T_J = 25^{\circ}\text{C}$
- $\pm 7/-19^{\circ}\text{C}$ at $T_J = -40^{\circ}\text{C}$

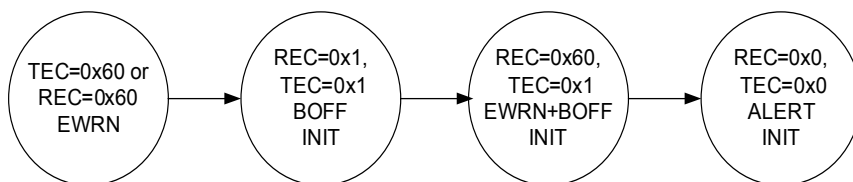
Figure 11 Alert Interrupt Behavior in case of Bus-Off

When the threshold for error warning (EWRN) is reached (default value of Error Warning Level EWRN = 0x60), then the EWRN interrupt is issued. The bus-off (BOFF) status is reached if $TEC > 255$ according to CAN specification, changing the MultiCAN module with REC and TEC to the same value 0x1, setting the INIT bit to 1_B, and issuing the BOFF interrupt. The bus-off recovery phase starts automatically. Every time an idle time is seen, REC is incremented. If REC = 0x60, a combined status EWRN+BOFF is reached. The corresponding interrupt can also be seen as a pre-warning interrupt, that the bus-off recovery phase will be finished soon. When the bus-off recovery phase has finished (128 times idle time have been seen on the bus), EWRN and BOFF are cleared, the ALERT interrupt bit is set and the INIT bit is still set.

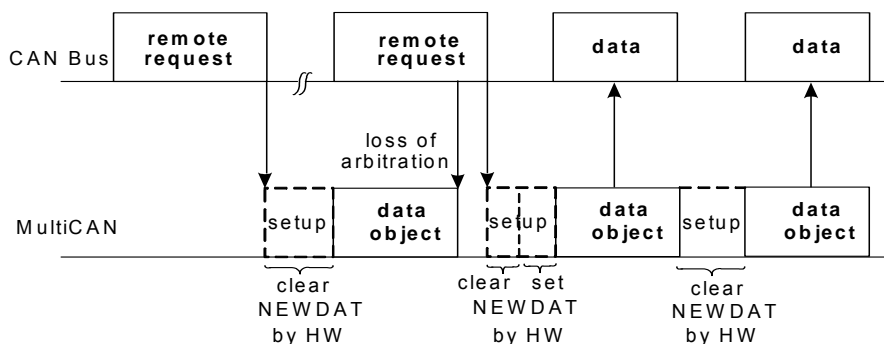
Figure 12 Loss of Arbitration

When the appropriate message object (data frame) triggered by the first remote frame wins the arbitration, it will be sent out and `NEWDAT` is not reset. This leads to an additional data frame, that will be sent by this message object (clearing `NEWDAT`).

There will, however, not be more data frames than there are corresponding remote requests.
