Device	TC1766
Marking/Step	EES-BB, ES-BB, BB
Package	PG-LQFP-176-2

01740AERRA

This Errata Sheet describes the deviations from the current user documentation.

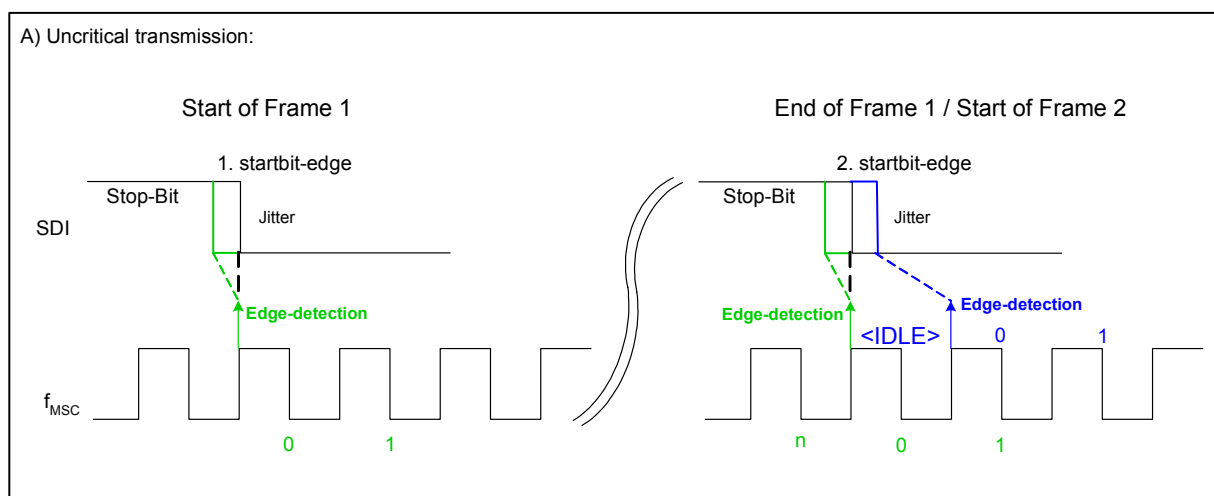
Figure 4 **Uncritical transmission**

As the falling startbit edge is shifted to the left of the rising clock edge (**Figure 4** left), there occurs a secure detection of the next start-bit edge in the last cycle of the previous frame (here cycle n, **Figure 4** right) independent from the applied jitter to this edge.

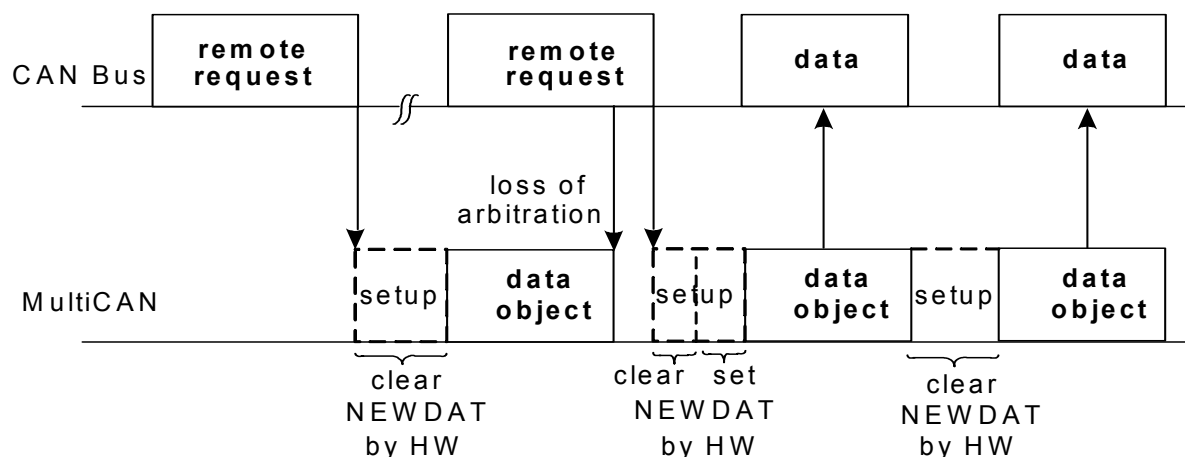
Figure 12 Loss of Arbitration

When the appropriate message object (data frame) triggered by the first remote frame wins the arbitration, it will be sent out and `NEWDAT` is not reset. This leads to an additional data frame, that will be sent by this message object (clearing `NEWDAT`).

There will, however, not be more data frames than there are corresponding remote requests.
