Device TC1766
Marking/Step ES-BD, BD
Package PG-LQFP-176-2

02967AERRA

This Errata Sheet describes the deviations from the current user documentation.

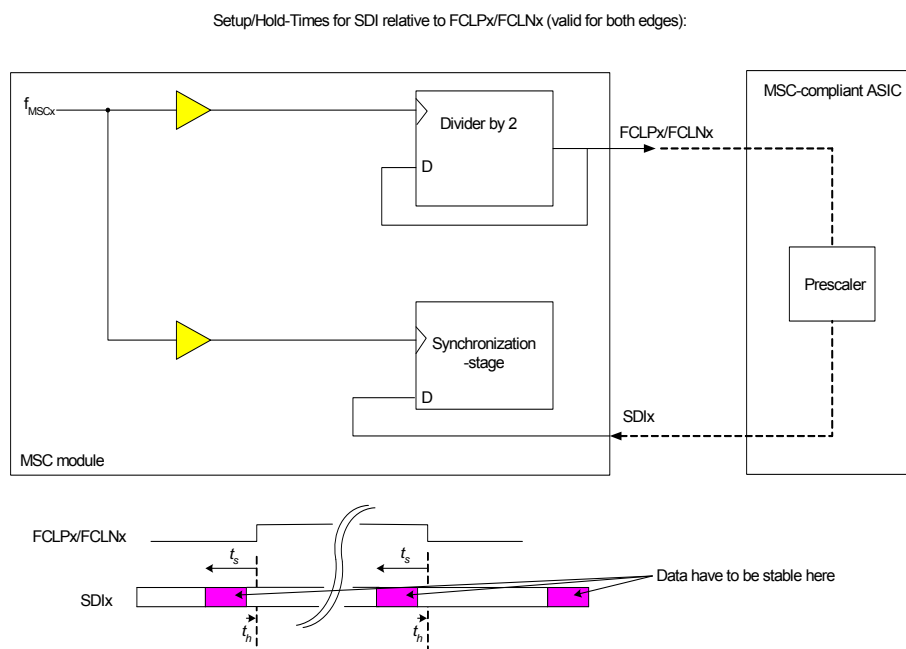
The delay depends on the maximal skew in the data-stream. For this workaround the downstream clock FCLPx/FCLNx can be measured as reference and the data stream at the input of the upstream channel SDIx has to be adjusted according to the setup- and hold-times of the input-pins SDIx.

Figure 5 shows the principle blockdiagram of the input synchronization stage of the MSC module.

Figure 5 Delay adjustment relative to the module clock

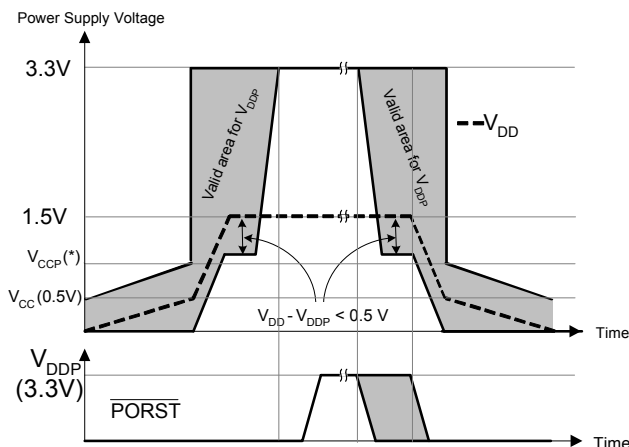
- All analog voltages (V_{DDOSC3} , V_{DDM} , V_{DDMF} , V_{DDFL3}) must also follow V_{DDP} power-up/down sequence.
- V_{DDAF} , V_{DDOSC} must follow V_{DD} power-up/down sequence.
- The absolute value of the maximum allowed deviation between any two supplies is 0.5 V while the 1.5V supplies are below their specified operating conditions.

Figure 10 Exemplary power-up/down sequence

Note: V_{CC} and V_{CCP} in [Figure 10](#) refer to devices with PWR_TC.P009 erratum.

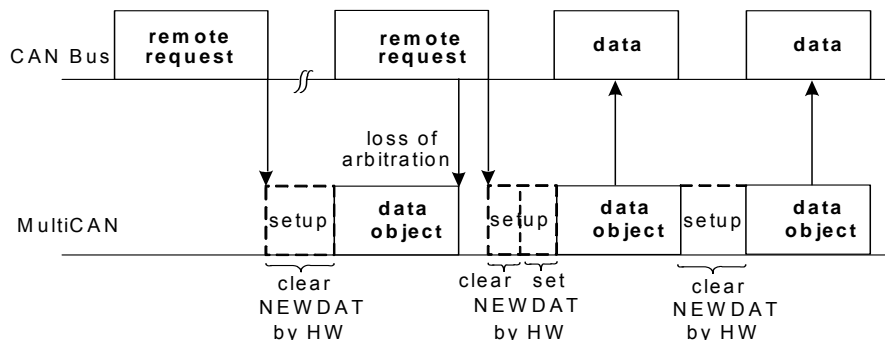
When the appropriate message object (data frame) triggered by the first remote frame wins the arbitration, it will be sent out and `NEWDAT` is not reset. This leads to an additional data frame, that will be sent by this message object (clearing `NEWDAT`).

There will, however, not be more data frames than there are corresponding remote requests.

Figure 12 Loss of Arbitration
