**Device** TC1767  
**Marking/Step** EES-AD, ES-AD, AD  
**Package** PG-LQFP-176-5

## 01704AERRA

This Errata Sheet describes the deviations from the current user documentation.

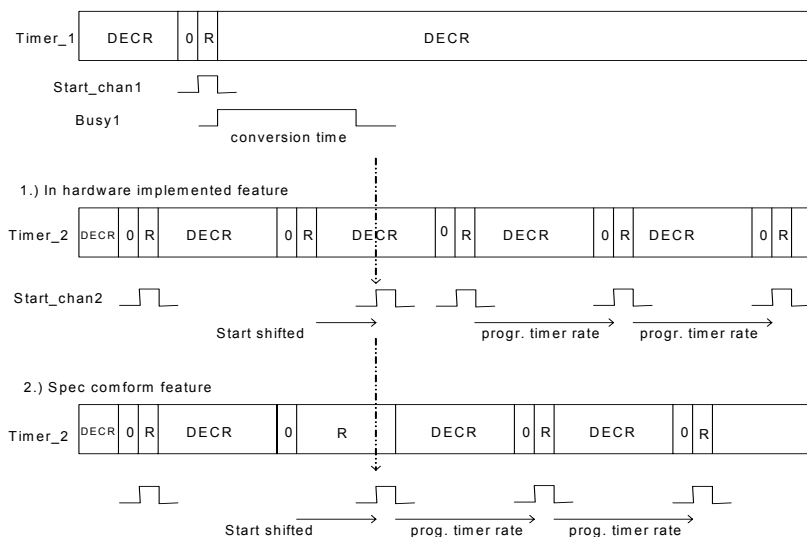
**Figure 1 Timing concerning equidistant multiple timers**

Therefore the start of conversion for channel\_2 is delayed by maximum one conversion-time. After this delay it will be continued with equidistant conversion-starts. Please refer to the following figure.

Note: the programmed timer rate is much longer than the conversion time,  
this means that the fault is much smaller than in the picture

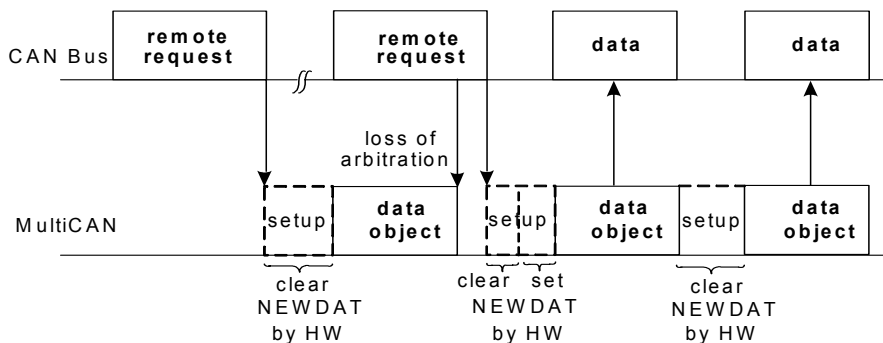
**Figure 2 Loss of Arbitration**

When the appropriate message object (data frame) triggered by the first remote frame wins the arbitration, it will be sent out and NEWDAT is not reset. This leads to an additional data frame, that will be sent by this message object (clearing NEWDAT).

There will, however, not be more data frames than there are corresponding remote requests.
