Device	TC1796
Marking/Step	EES-BD, ES-BD, BD
Package	P-BGA-416, PG-BGA-416

02129AERRA

This Errata Sheet describes the deviations from the current user documentation.

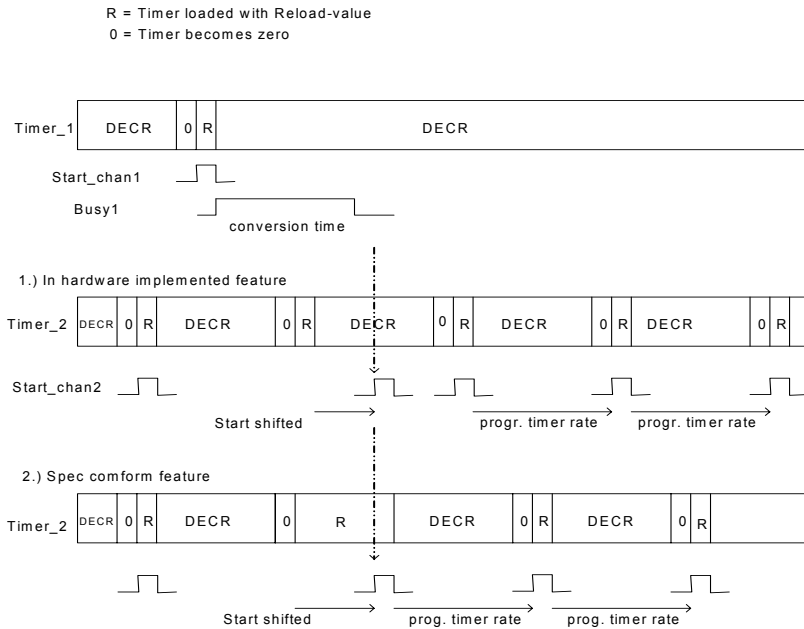
The correct behavior would be a reload when the requested conversion (of channel_2) is started.

Therefore the start of conversion for channel_2 is delayed by maximum one conversion-time. After this delay it will be continued with equidistant conversion-starts. Please refer to the following figure.

Note: the programmed timer rate is much longer than the conversion time, this means that the fault is much smaller than in the picture

Figure 3 Timing concerning equidistant multiple timers

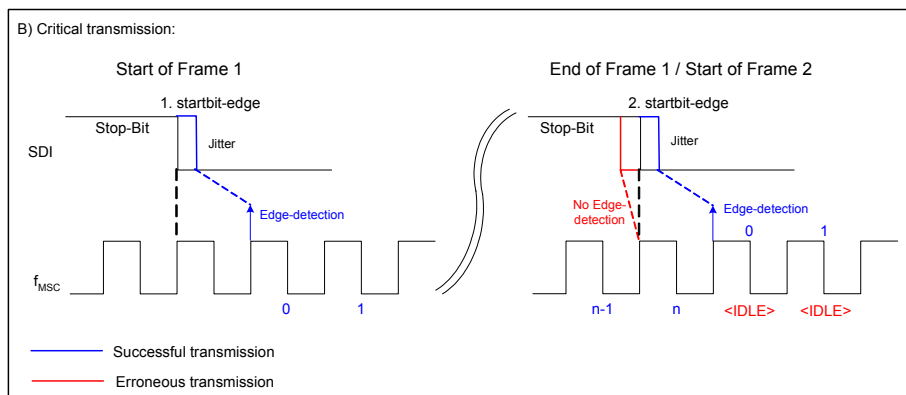
Figure 5 Critical transmission

As the falling startbit edge is shifted to the left of the rising clock edge (**Figure 4** left), there occurs a secure detection of the next startbit edge in the last cycle of the previous frame (here cycle n, **Figure 4** right) independent from the applied jitter to this edge.

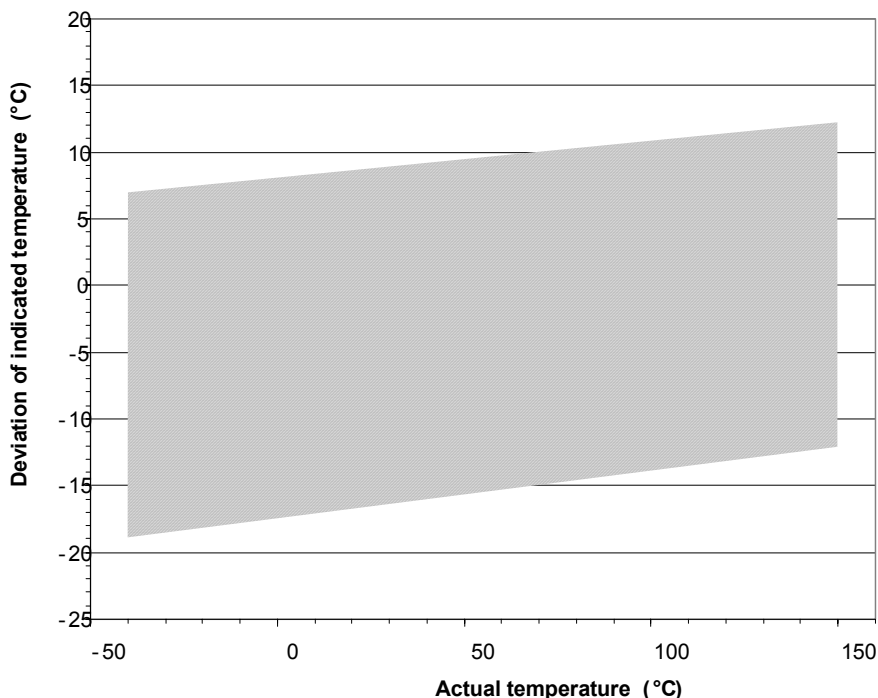
- $\pm 12^{\circ}\text{C}$ at $T_J = 150^{\circ}\text{C}$
- $\pm 9/-17^{\circ}\text{C}$ at $T_J = 25^{\circ}\text{C}$
- $\pm 7/-19^{\circ}\text{C}$ at $T_J = -40^{\circ}\text{C}$

Figure 11 Current accuracy range

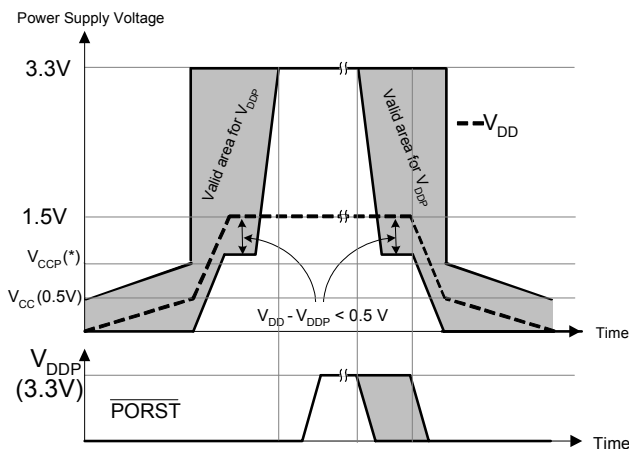
As per Data Sheet, $V_{DD} - V_{DDP} < 0.5 \text{ V}$ has to be valid at any time in order to avoid increased latch-up risk. The figure below shows the possible V_{DDP} values as shaded region for an exemplary V_{DD} ramp. Moreover, the following rules apply:

- V_{DDEBU} and all analog voltages (V_{DDOSC3} , V_{DDM} , V_{DDMF} , V_{DDFL3}) must also follow V_{DDP} power-up/down sequence.
- V_{DDAF} , V_{DDOSC} must follow V_{DD} power-up/down sequence.
- The absolute value of the maximum allowed deviation between any two supplies is 0.5 V while the 1.5V supplies are below their specified operating conditions.

Figure 14 Exemplary power-up/down sequence

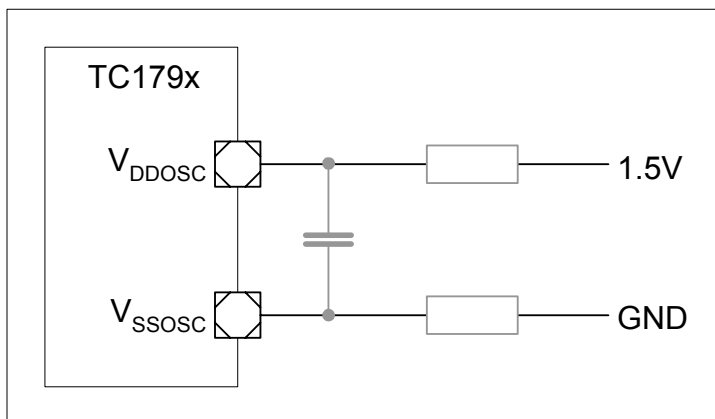
Figure 17

V_{DDOSC} and V_{SSOSC} silicon pads are not connected to their package balls, but V_{DDOSC} is connected to V_{DD} (core supply) and V_{SSOSC} is connected to V_{SS} , in order to reduce short-term jitter. Thus V_{DDOSC} and V_{SSOSC} package balls are unconnected. For future design improvements it is recommended to prepare the PCB like it is shown in the figure below. The capacitance and both resistors need not to be assembled on the PCB but they should be planned for values of about 10?F...100?F for the blocking capacitance and 0?...10? for the resistors.

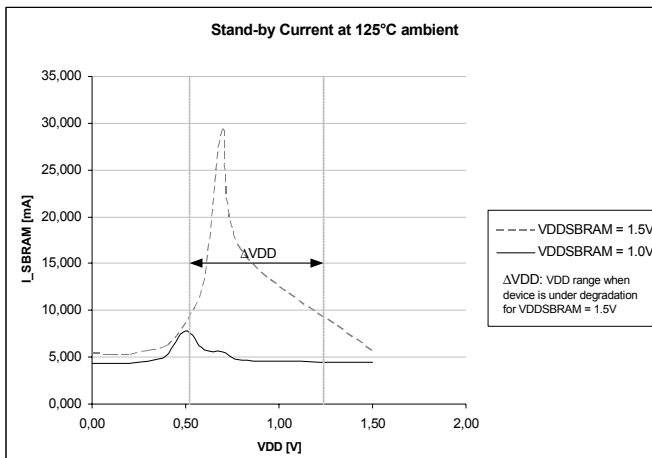
During transition from/to stand-by mode, while increasing or decreasing core power supply (V_{DD}), it may happen, due to cross-current, that I_{SBRAM} reaches high current values.

The worst case takes place when $V_{DD} = V_{DDSBRAM}/2$, specially if $V_{DDSBRAM} = 1.5$ V (SBRAM power supply for normal operation). In this situation, I_{SBRAM} may reach 29.5 mA (hot at 125°C ambient).

Figure 18 Stand-by current at 125°C ambient
