Device	TC1796
Marking/Step	EES-BE, ES-BE, BE
Package	P-BGA-416, PG-BGA-416

## 02104AERRA

This Errata Sheet describes the deviations from the current user documentation.

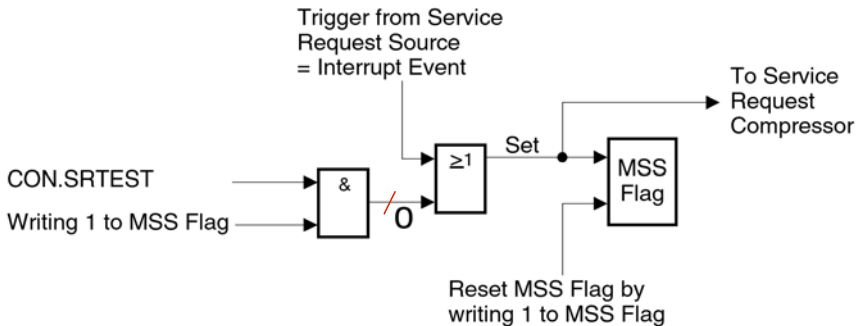
**Figure 1**

**ADC\_TC.023 Setting the MSS-flag doesn't generate an interrupt in TEST-MODE**

It is possible to generate a software triggered interrupt event in TESTMODE (ADCx\_CON.SRTEST=1) by setting one of the bitflags in register ADCx\_MSS0/1. Due to the fact, that this mechanism is not working, it is not possible to generate a corresponding interrupt by software.

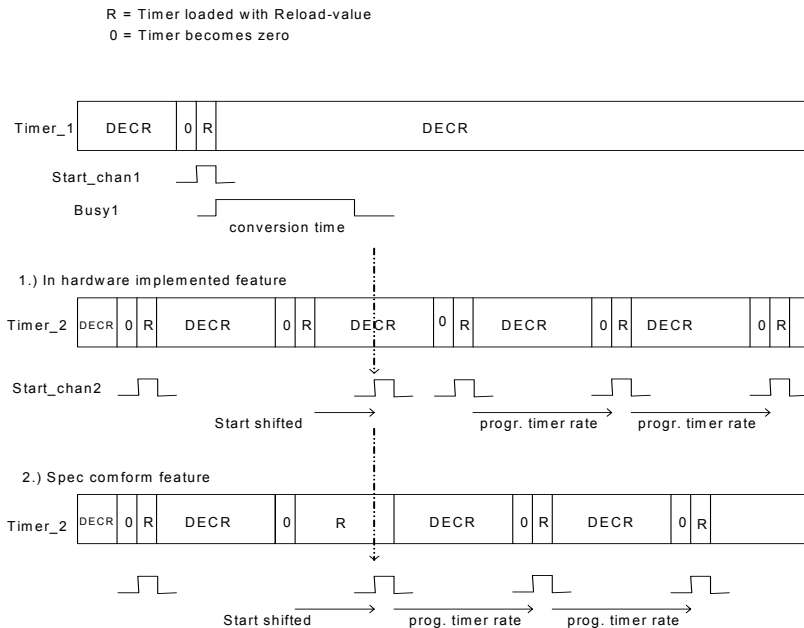
The correct behavior would be a reload when the requested conversion (of channel\_2) is started.

Therefore the start of conversion for channel\_2 is delayed by maximum one conversion-time. After this delay it will be continued with equidistant conversion-starts. Please refer to the following figure.

Note: the programmed timer rate is much longer than the conversion time, this means that the fault is much smaller than in the picture

**Figure 2 Timing concerning equidistant multiple timers**

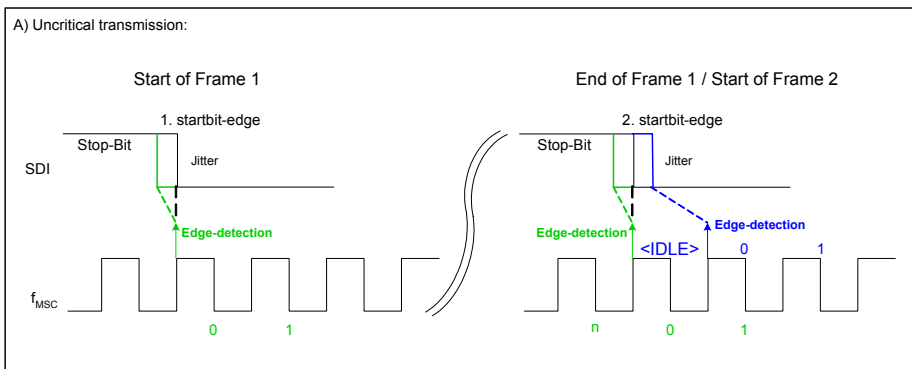
**Figure 3**      **Uncritical transmission**

As the falling startbit edge is shifted to the left of the rising clock edge (**Figure 3** left), there occurs a secure detection of the next start-bit edge in the last cycle of the previous frame (here cycle n, **Figure 3** right) independent from the applied jitter to this edge.

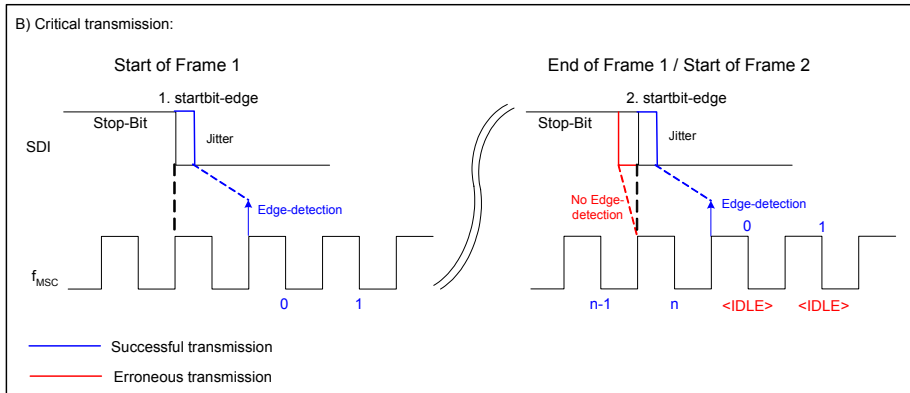
**Figure 4 Critical transmission**

If the high-low edge of the start-bit in the first frame is just not detected by the near clock-edge (**Figure 4** - left) and the start-bit edge of the second frame is jittering to cycle  $n-1$  (**Figure 4** - right, red coloured), then an erroneous transmission will take place. In this case the state-machine switches to IDLE after the last state  $n$  and wakes up on the next falling edge that may be a data-bit recognized as a start-bit. If the start-bit of the second frame is jittering to cycle  $n$  (**Figure 4** - right, blue colored), then the state-machine will not switch to IDLE but will start receiving the next frame correctly.

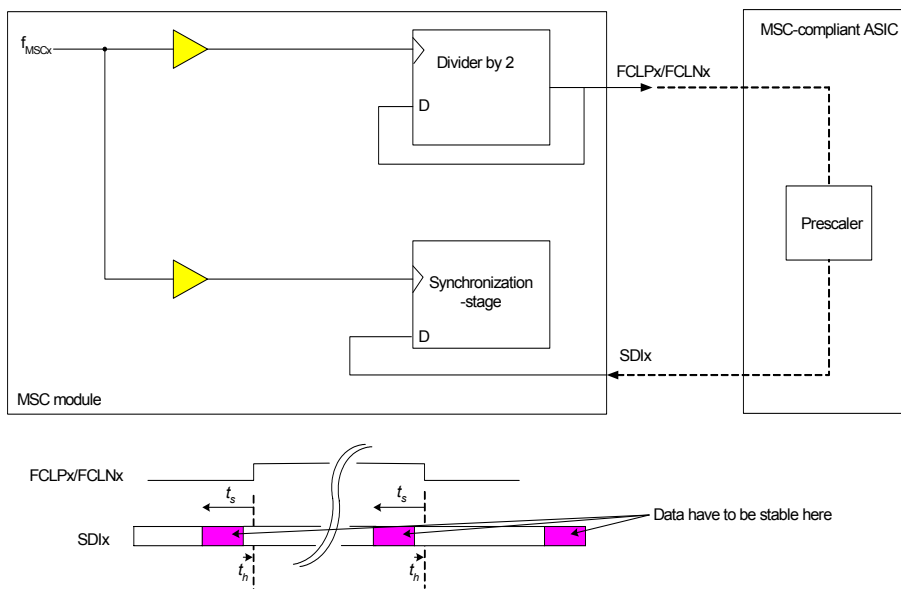
**Figure 5** shows the principle blockdiagram of the input synchronization stage of the MSC module.

**Figure 5 Delay adjustment relative to the module clock**

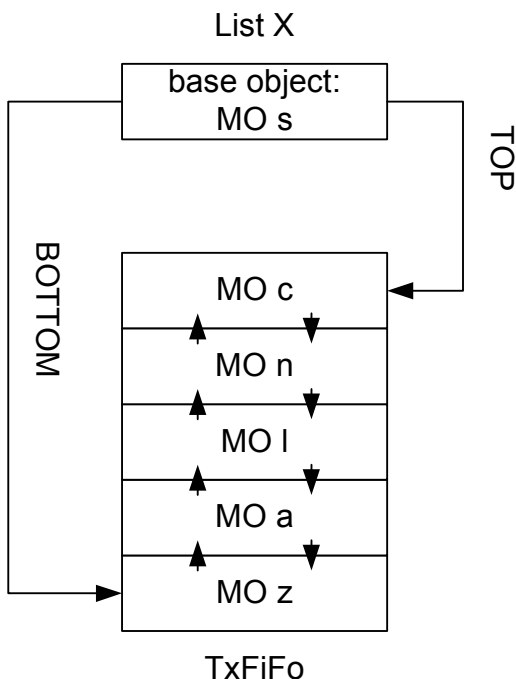
**Figure 6** FIFO structure

If Tx FIFO overflow interrupt needed, take the FIFO base object out of the circular list of the Tx message objects. That is to say, just use the FIFO base object for FIFO control, but not to store a Tx message.

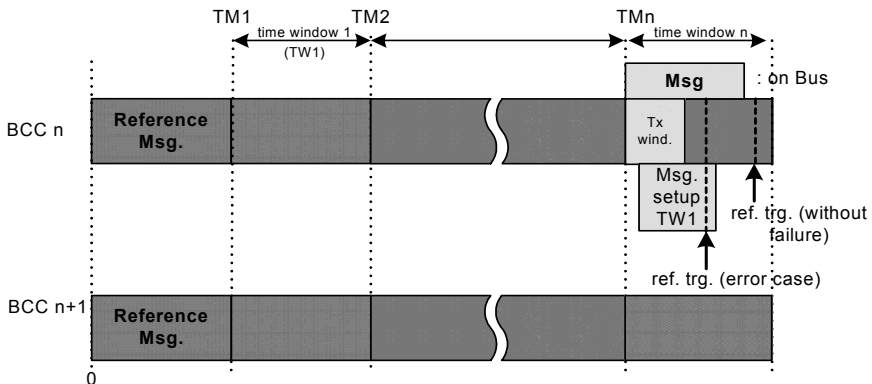
**Figure 8**

### **MultiCAN\_TC.036 Wrong message may be sent during reference message trigger in a gap**

The TTCAN controller is configured as timer master, gap mode has been selected and no message is transferred (reception or transmission) after the transmit enable window in the last time window. With the end of the transmit enable window, the TTCAN logic starts waiting for a reference message trigger to send a reference message. At the beginning of each time window, the TTCAN logic evaluates the scheduler entries for the following time window and prepares the setup of the corresponding message for the next transfer window. If the reference trigger becomes active after the end of the transmit enable window, but still during the setup phase, the prepared message will be sent out instead of the reference message. After this erroneously sent message, the reference message will be sent out correctly. The error does not occur if the reference trigger becomes active after the end of the setup time.

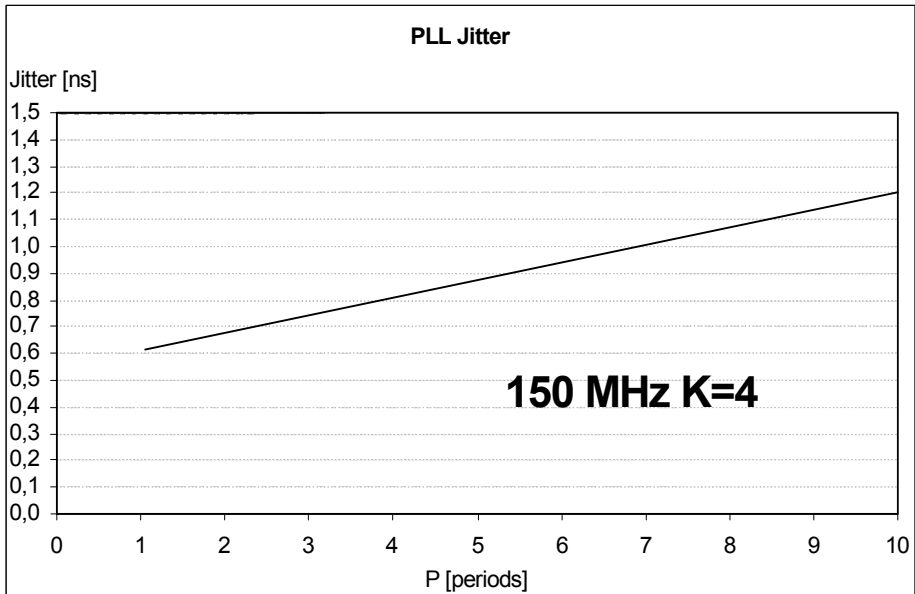
When all listed system preconditions are fulfilled the PLL jitter at 150MHz and  $K = 4$  with  $K = KDIV + 1$  is below the marked range as shown in the figures.

**Figure 11 Short term PLL Jitter in  $f_{CPU}$  clock periods at  $f_{CPU} = 150$  MHz and  $K = 4$**

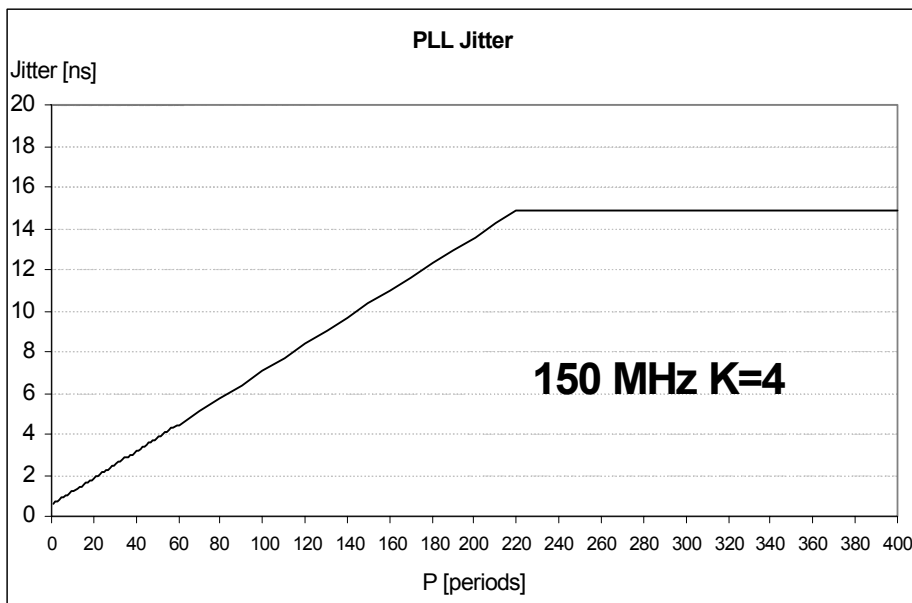
**Figure 12 Long term PLL Jitter in  $f_{\text{CPU}}$  clock periods at  $f_{\text{CPU}} = 150 \text{ MHz}$  and  $K = 4$**

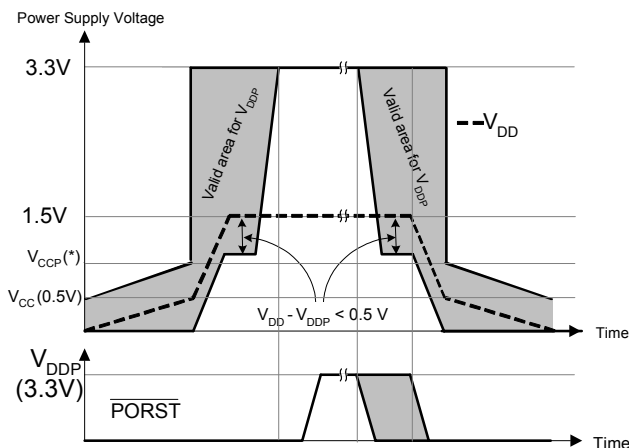
- $V_{DDAF}$ ,  $V_{DDOSC}$  must follow  $V_{DD}$  power-up/down sequence.
- The absolute value of the maximum allowed deviation between any two supplies is 0.5 V while the 1.5V supplies are below their specified operating conditions.

**Figure 13 Exemplary power-up/down sequence**

*Note:  $V_{CC}$  and  $V_{CCP}$  in [Figure 13](#) refer to devices with PWR\_TC.P009 erratum.*

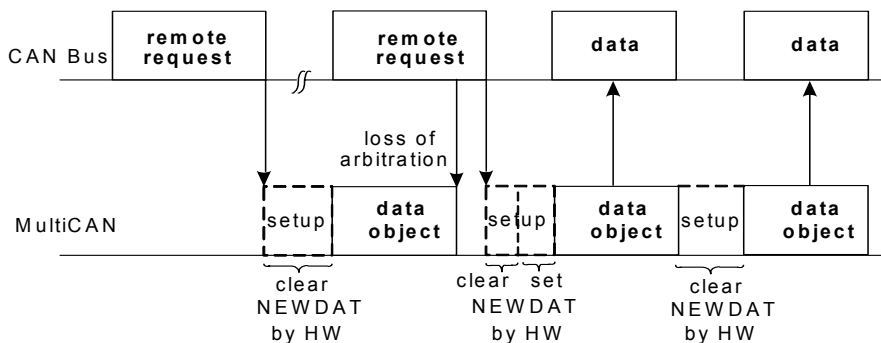
When the appropriate message object (data frame) triggered by the first remote frame wins the arbitration, it will be sent out and NEWDAT is not reset. This leads to an additional data frame, that will be sent by this message object (clearing NEWDAT).

**Figure 15 Loss of Arbitration**

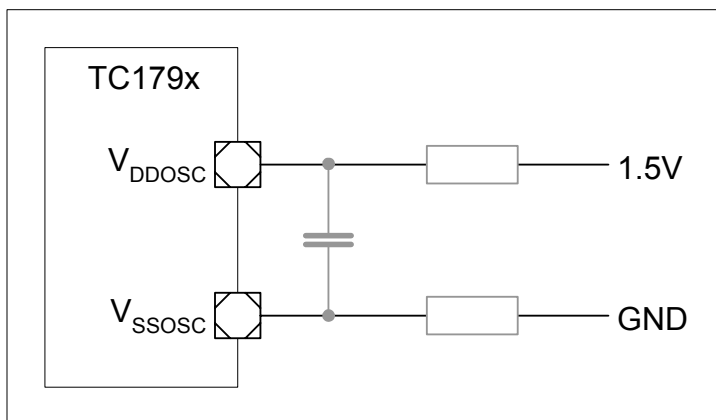
**Figure 16**

### **PLL\_TC.H004 $V_{DDOSC}$ and $V_{SSOSC}$ bonding change**

$V_{DDOSC}$  and  $V_{SSOSC}$  silicon pads are not connected to their package balls, but  $V_{DDOSC}$  is connected to  $V_{DD}$  (core supply) and  $V_{SSOSC}$  is connected to  $V_{SS}$ , in order to reduce short-term jitter. Thus  $V_{DDOSC}$  and  $V_{SSOSC}$  package balls are unconnected. For future design improvements it is recommended to prepare the PCB like it is shown in the figure below. The capacitance and both resistors need not to be assembled on the PCB but they should be planned for values of about 10?F...100?F for the blocking capacitance and 0?...10? for the resistors.

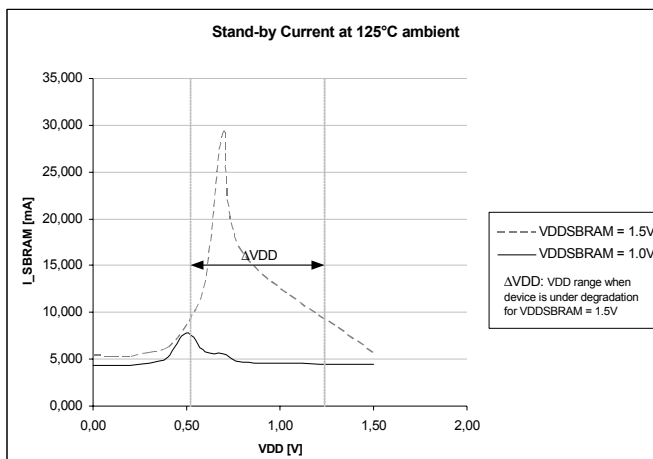
During transition from/to stand-by mode, while increasing or decreasing core power supply ( $V_{DD}$ ), it may happen, due to cross-current, that  $I_{SBRAM}$  reaches high current values.

The worst case takes place when  $V_{DD} = V_{DDSB\text{RAM}}/2$ , specially if  $V_{DDSB\text{RAM}} = 1.5$  V (SBRAM power supply for normal operation). In this situation,  $I_{SB\text{RAM}}$  may reach 29.5 mA (hot at 125°C ambient).

**Figure 17 Stand-by current at 125°C ambient**
