**Device**                **TC1797**  
**Marking/Step**      **QS-AC**  
**Package**             **P/PG-BGA-416-10**

## 01961AERRA

This Errata Sheet describes the deviations from the current user documentation.

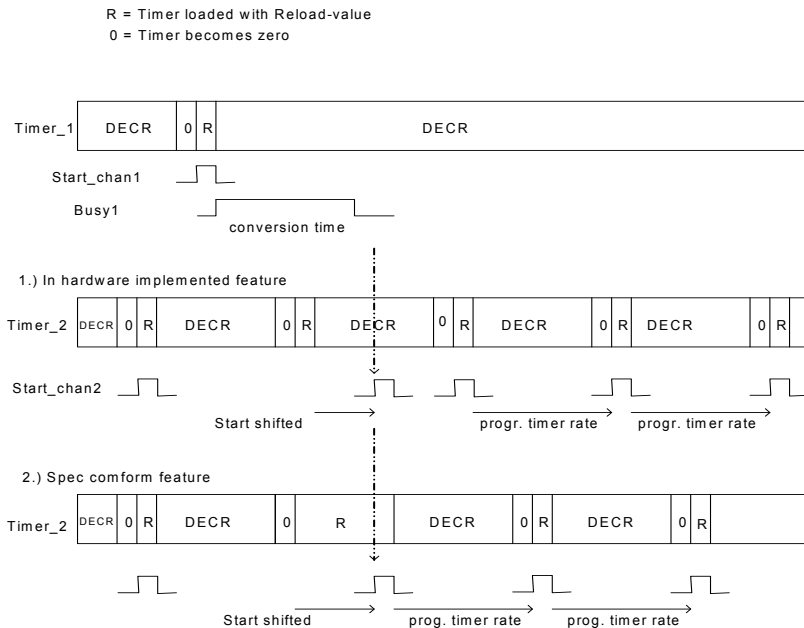
**Figure 1 Timing concerning equidistant multiple timers**

The correct behavior would be a reload when the requested conversion (of channel\_2) is started.

Therefore the start of conversion for channel\_2 is delayed by maximum one conversion-time. After this delay it will be continued with equidistant conversion-starts. Please refer to the following figure.

Note: the programmed timer rate is much longer than the conversion time, this means that the fault is much smaller than in the picture

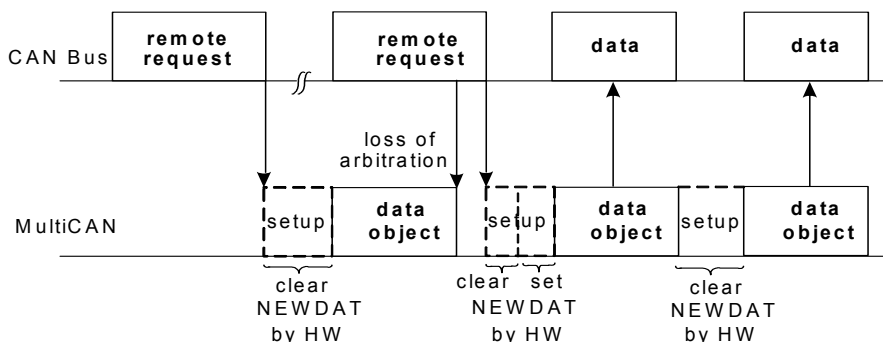
**Figure 3 Loss of Arbitration**

When the appropriate message object (data frame) triggered by the first remote frame wins the arbitration, it will be sent out and `NEWDAT` is not reset. This leads to an additional data frame, that will be sent by this message object (clearing `NEWDAT`).

There will, however, not be more data frames than there are corresponding remote requests.
