Device **XC161CS-32F**
Marking/Step **(E)ES-BB, BB**
Package **PG-TQFP-144-7, P-TQFP-144-19**

This Errata Sheet describes the deviations from the current user documentation.

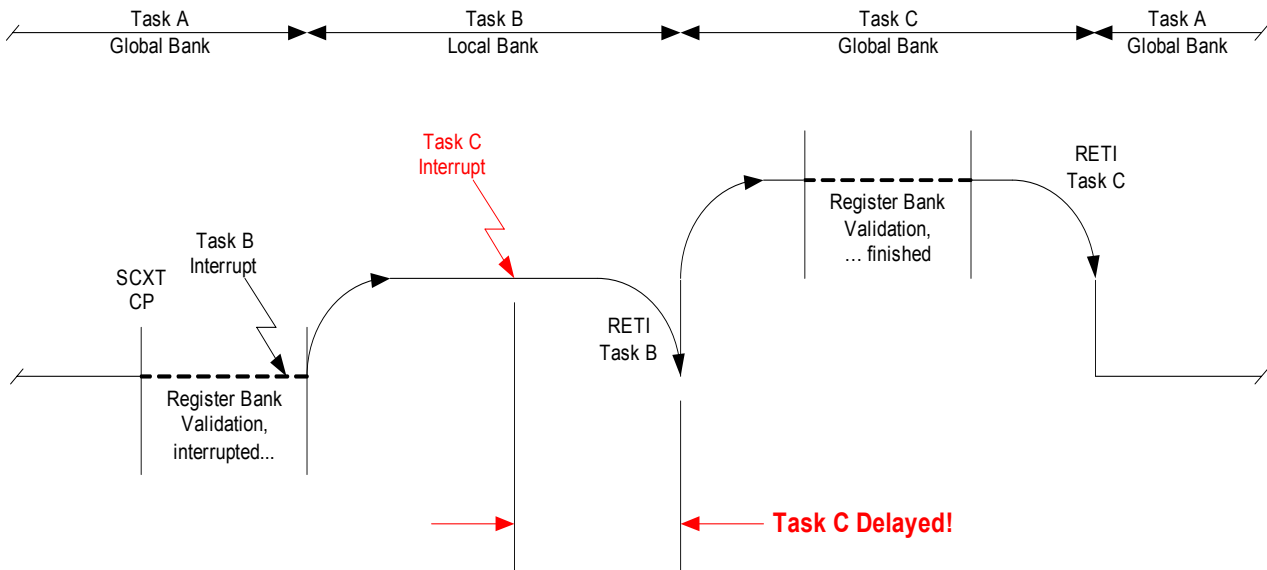
Figure 1 Example for Case 2: Interrupt Service for Task C delayed

In this case service of this interrupt request (for Task C) is delayed until bit field PSW.BANK becomes 00_B after executing the RETI instruction at the end of the routine (Task B) using the local bank.

Workaround for Case 1
