Errata Sheet

V0.3, 2004-08-19

Device XC164CS-16FF, -16F20F, -16F40F
Stepping Code/Marking ES-AD, AD
Package P-TQFP-100-16

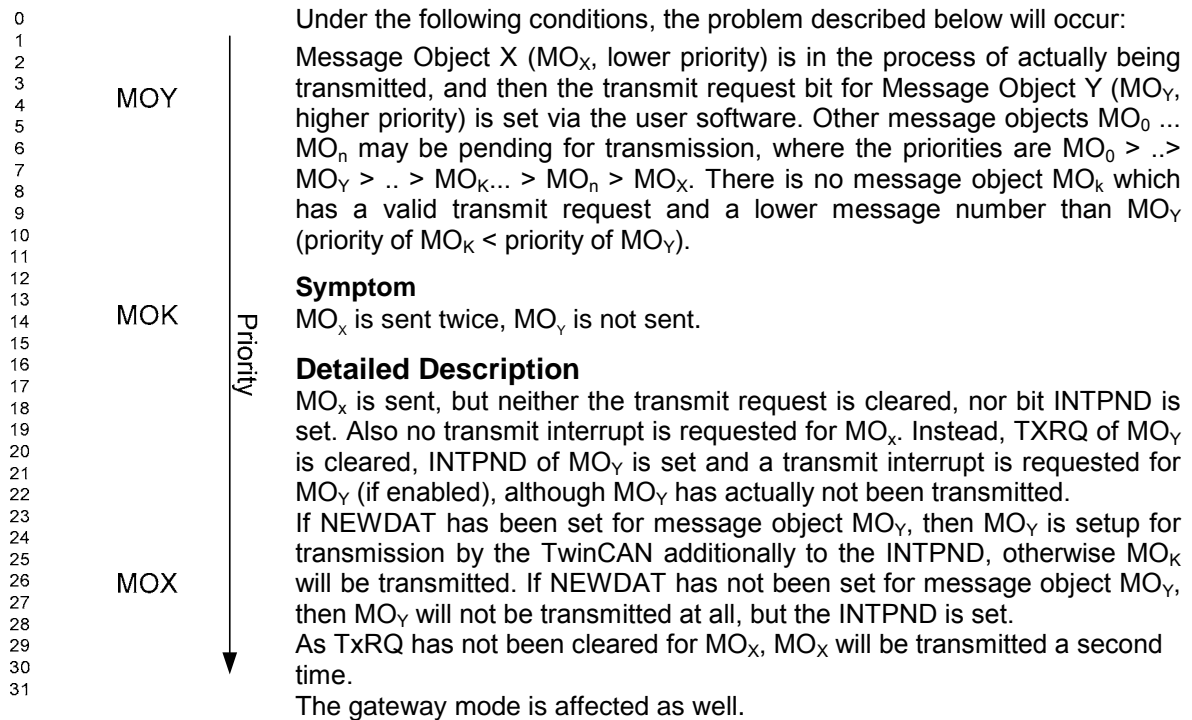
TwinCAN2.005: Double Send

In case the STT bit is used, the error will occur in any case.

- a) Remote frames have to be forbidden; otherwise an "uncontrolled" TxRQ will be set. Set Message Object Transmit Requests (TxRQs) in order from 0 to 31, rather than at random. This could be done by implementing a software array for transmit requests TxRQs[32]. When a TxRQ bit for a Message Object has to be set, the software should write to the corresponding location within the software array. On a regular basis, all transmit requests then have to be reset and set according to the settings within the software array, to enable all message objects with TxRQs to be updated in the correct order. Between reset and set the application has to wait for the length of two CAN frames.
In order to use the gateway mode, do not set the GDFS bit in MSGFGCR.

- b) Under the same software control as in workaround a) TxRQs can be set, as long as CPUUPD is set and only reset in the natural order. In this case Remote Frames are allowed.
