<b>Device</b>	<b>XC164CS-32F</b>
<b>Marking/Step</b>	<b>(E)ES-BB, BB</b>
<b>Package</b>	<b>PG-TQFP-100-5, P-TQFP-100-16</b>

This Errata Sheet describes the deviations from the current user documentation.

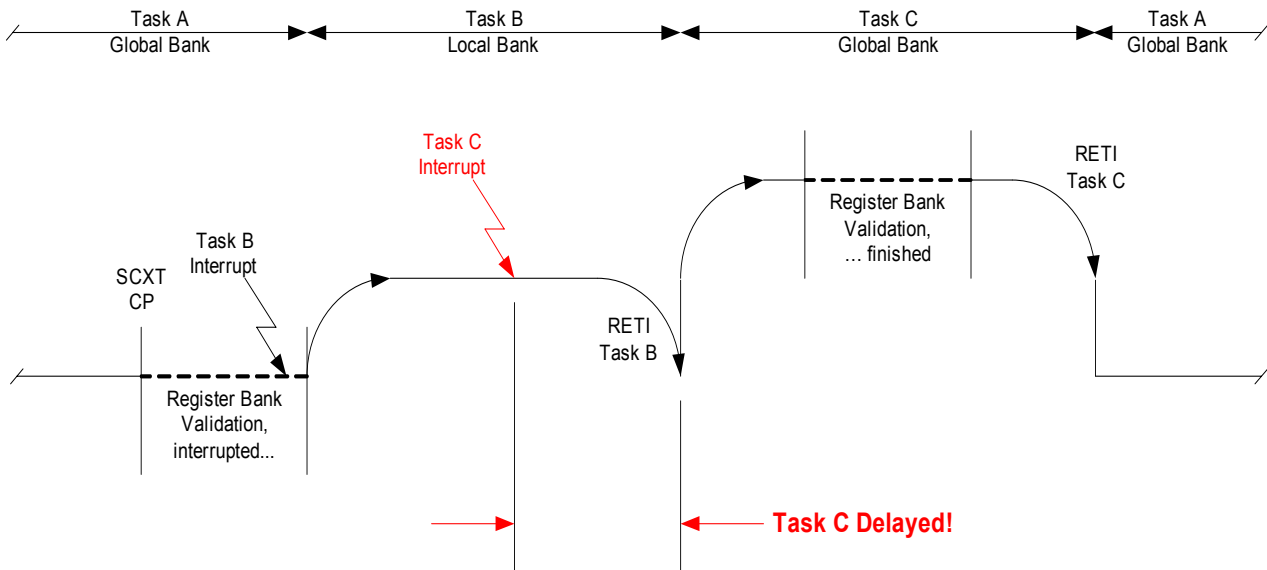
In this case service of this interrupt request (for Task C) is delayed until bit field PSW.BANK becomes 00<sub>B</sub> after executing the RETI instruction at the end of the routine (Task B) using the local bank.

Figure 1 Example for Case 2: Interrupt Service for Task C delayed

### Workaround for Case 1
