Device **XC164CS-8F**
Marking/Step **(E)ES-BB, BB**
Package **PG-TQFP-100-5, P-TQFP-100-16**

This Errata Sheet describes the deviations from the current user documentation.

1 History List/Change Summary

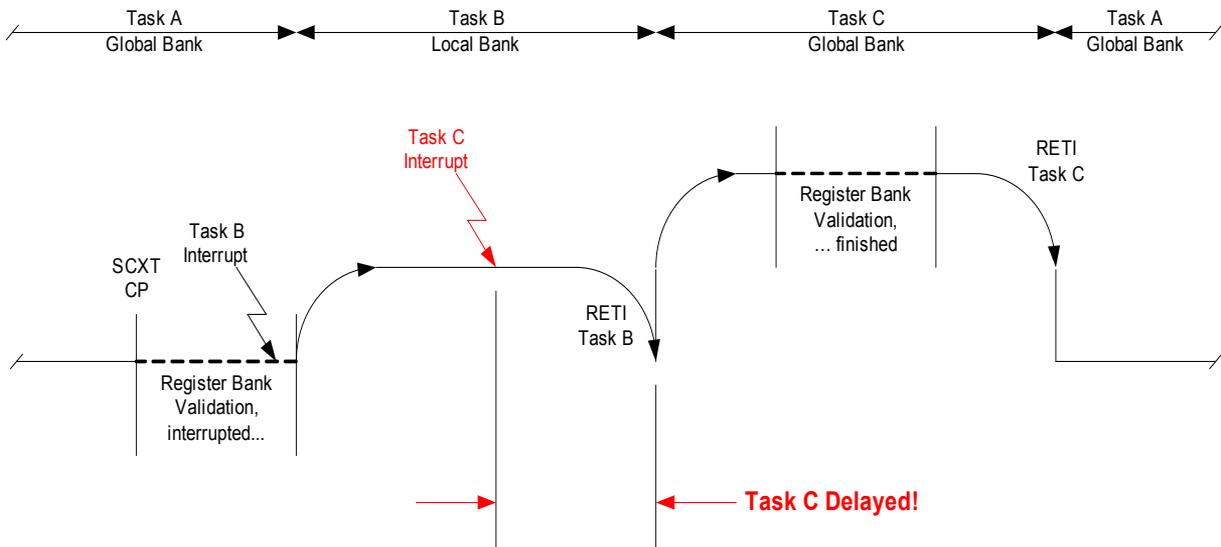
Figure 1 Example for Case 2: Interrupt Service for Task C delayed

In this case service of this interrupt request (for Task C) is delayed until bit field PSW.BANK becomes 00_B after executing the RETI instruction at the end of the routine (Task B) using the local bank.
