Device	XC164CS-8F
Marking/Step	(E)ES-BB, BB
Package	PG-TQFP-100-5, P-TQFP-100-16

This Errata Sheet describes the deviations from the current user documentation.

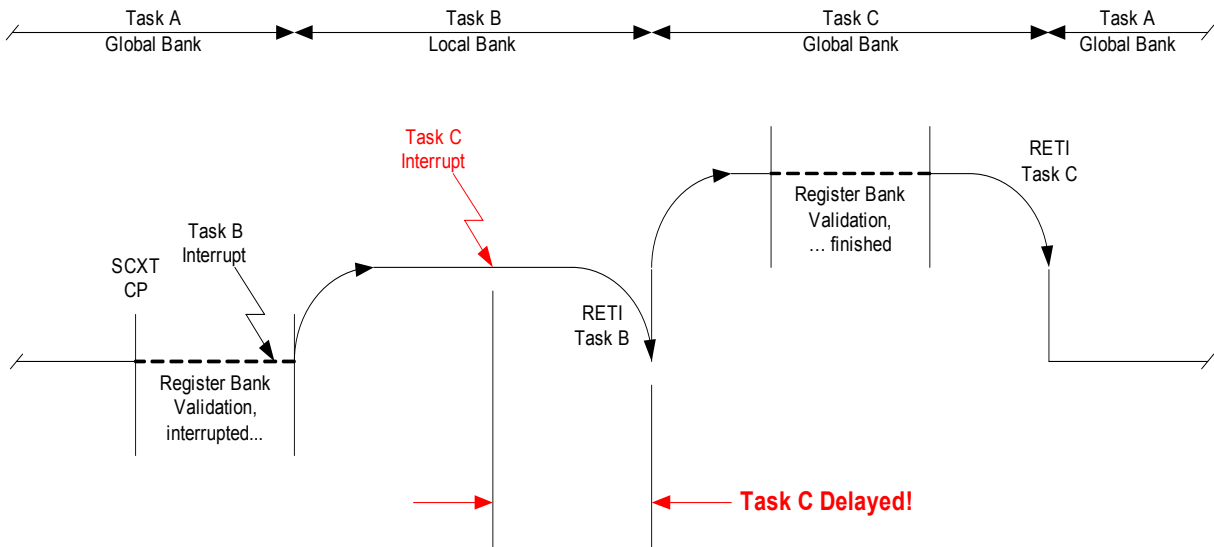
Figure 1 Example for Case 2: Interrupt Service for Task C delayed

In this case service of this interrupt request (for Task C) is delayed until bit field PSW.BANK becomes 00_B after executing the RETI instruction at the end of the routine (Task B) using the local bank.

Workaround for Case 1
