Errata Sheet

V0.1, 2005-03-30

Device	XC164D-16F20F, -16F40F, -8F20F, -8F40F XC164N-16F20F, -16F40F, -8F20F, -8F40F XC164S-16F20F, -16F40F, -8F20F, -8F40F
Stepping Code/Marking	AC
Package	P-TQFP-100-16

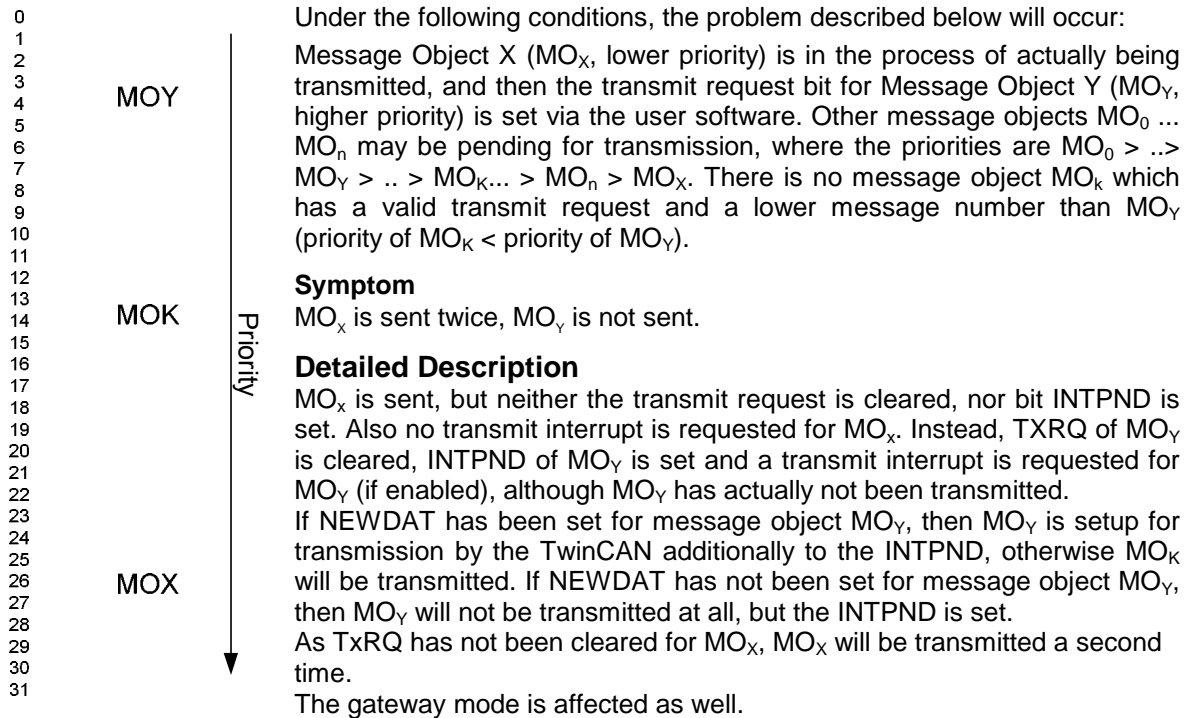
TwinCAN2.005: Double Send

In case the STT bit is used, the error will occur in any case.

- Remote frames have to be forbidden; otherwise an "uncontrolled" TxRQ will be set. Set Message Object Transmit Requests (TxRQs) in order from 0 to 31, rather than at random. This could be done by implementing a software array for transmit requests TxRQs[32]. When a TxRQ bit for a Message Object has to be set, the software should write to the corresponding location within the software array. On a regular basis, all transmit requests then have to be reset and set according to the settings within the software array, to enable all message objects with TxRQs to be updated in the correct order. Between reset and set the application has to wait for the length of two CAN frames.
In order to use the gateway mode, do not set the GDFS bit in MSGFGCR.

- Under the same software control as in workaround a) TxRQs can be set, as long as CPUUPD is set and only reset in the natural order. In this case Remote Frames are allowed.
