Errata Sheet

V0.5, 2004-09-27

Device XC167CI-16FF, -16F20F, -16F40F
Stepping Code/Marking ES-AC, AC
Package P-TQFP-144-19

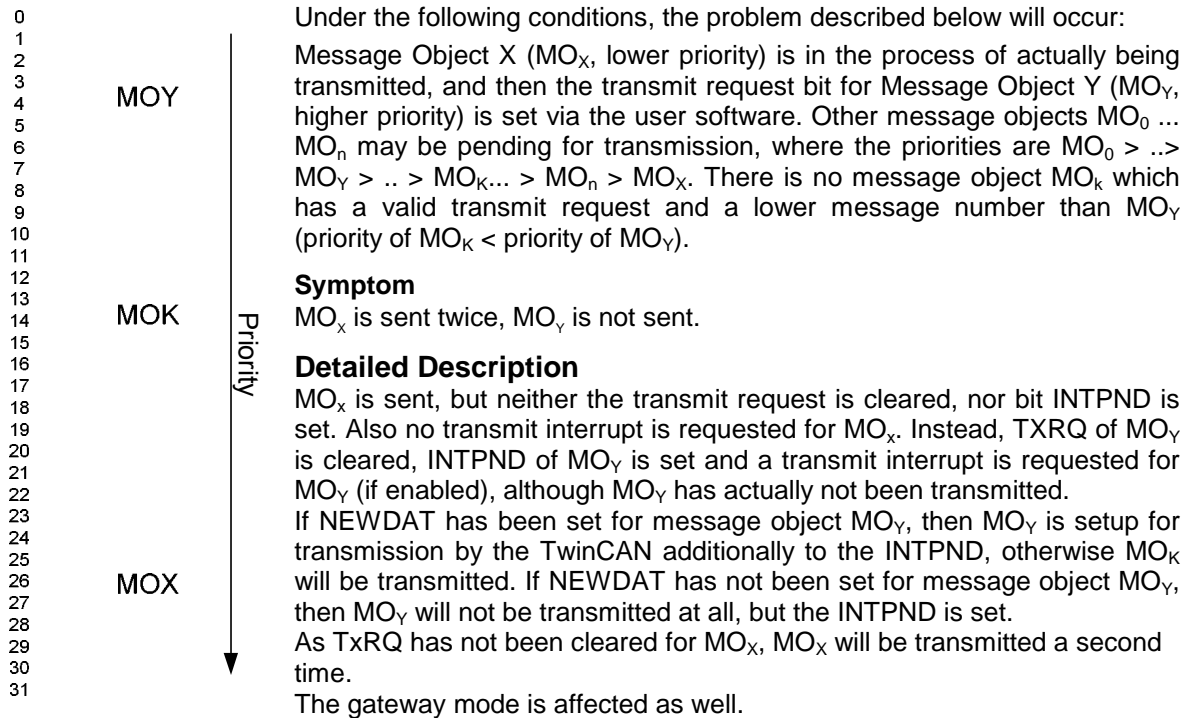
TwinCAN2.005: Double Send

In case the STT bit is used, the error will occur in any case.

Workarounds

- Remote frames have to be forbidden; otherwise an "uncontrolled" TxRQ will be set. Set Message Object Transmit Requests (TxRQs) in order from 0 to 31, rather than at random. This could be done by implementing a software array for transmit requests TxRQs[32]. When a TxRQ bit for a Message Object has to be set, the software should write to the corresponding location within the software array. On a regular basis, all transmit requests then have to be reset and set according to the settings within the software array, to enable all message objects with TxRQs to be updated in the correct order. Between reset and set the application has to wait for the length of two CAN frames.
In order to use the gateway mode, do not set the GDFS bit in MSGFGCR.

- Under the same software control as in workaround a) TxRQs can be set, as long as CPUUPD is set and only reset in the natural order. In this case Remote Frames are allowed.
