Device **XC167CI-16F**
Marking/Step **(E)ES-BB, BB**
Package **PG-TQFP-144-7, P-TQFP-144-19**

This Errata Sheet describes the deviations from the current user documentation.

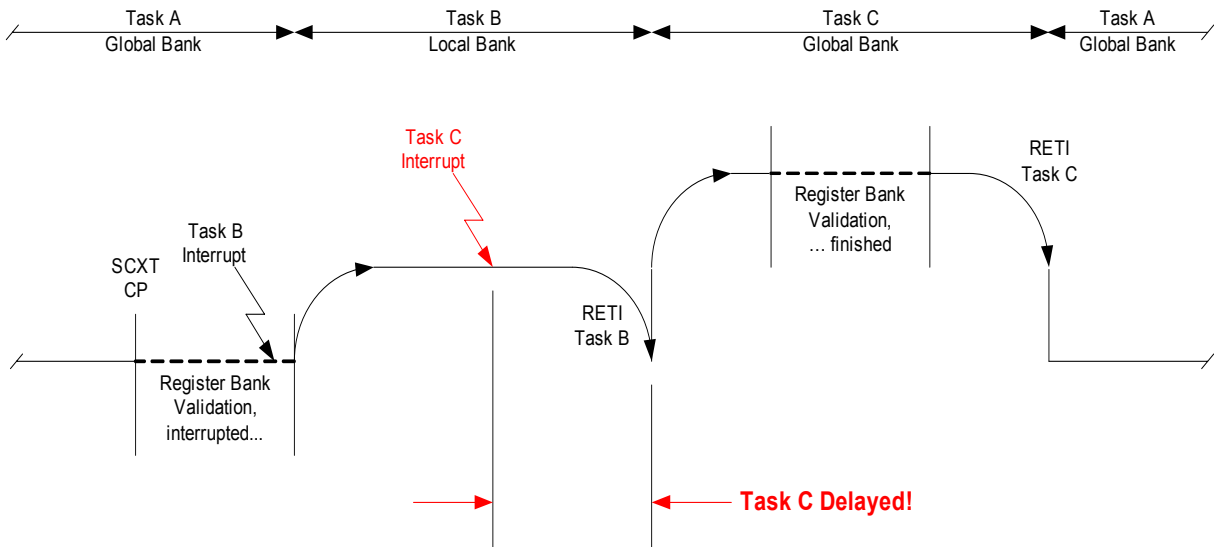
Figure 1 Example for Case 2: Interrupt Service for Task C delayed

In this case service of this interrupt request (for Task C) is delayed until bit field PSW.BANK becomes 00_B after executing the RETI instruction at the end of the routine (Task B) using the local bank.

Workaround for Case 1
