Device	XC167CI-16F
Marking/Step	(E)ES-BB, BB
Package	PG-TQFP-144-7, P-TQFP-144-19

This Errata Sheet describes the deviations from the current user documentation.

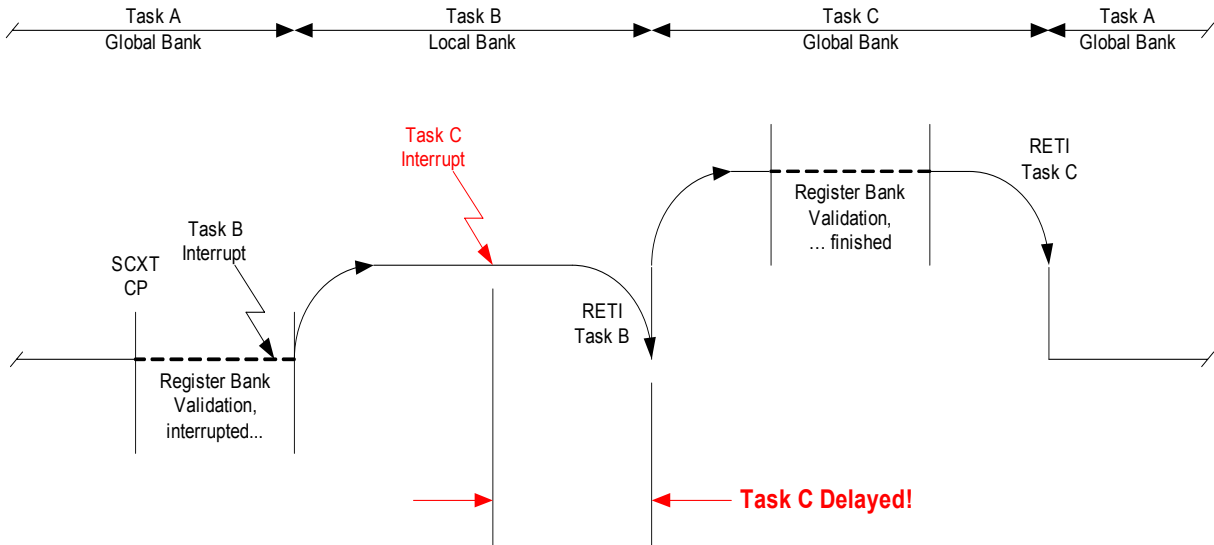
Figure 1 Example for Case 2: Interrupt Service for Task C delayed

In this case service of this interrupt request (for Task C) is delayed until bit field PSW.BANK becomes 00_B after executing the RETI instruction at the end of the routine (Task B) using the local bank.

Workaround for Case 1
