Device **XC167CI-32F**
Marking/Step **(E)ES-BB, BB**
Package **PG-TQFP-144-7, P-TQFP-144-19**

This Errata Sheet describes the deviations from the current user documentation.

1 History List/Change Summary

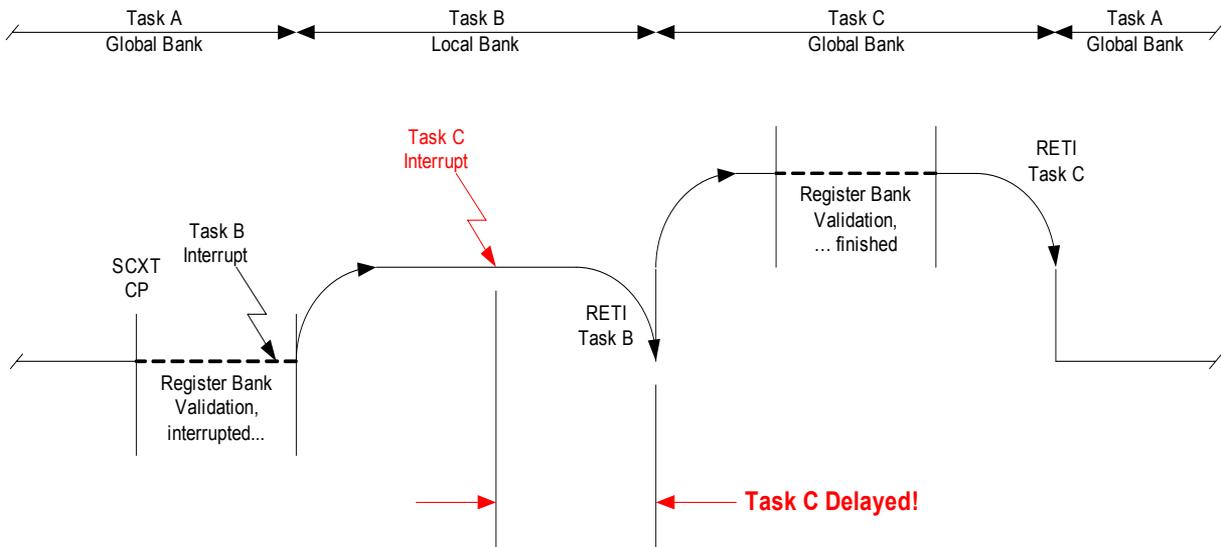
Figure 1 Example for Case 2: Interrupt Service for Task C delayed

In this case service of this interrupt request (for Task C) is delayed until bit field PSW.BANK becomes 00_B after executing the RETI instruction at the end of the routine (Task B) using the local bank.

Workaround for Case 1
