## XC27x4X Derivatives

16/32-Bit Single-Chip Microcontroller  
with 32-Bit Performance  
XC2000 Family / Value Line

Errata Sheet

V1.4 2009-10

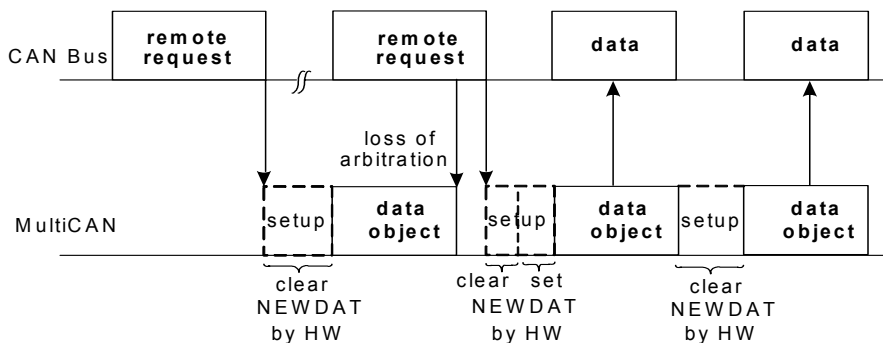
**Figure 1 Loss of Arbitration**

When the appropriate message object (data frame) triggered by the first remote frame wins the arbitration, it will be sent out and NEWDAT is not reset. This leads to an additional data frame, that will be sent by this message object (clearing NEWDAT).

There will, however, not be more data frames than there are corresponding remote requests.

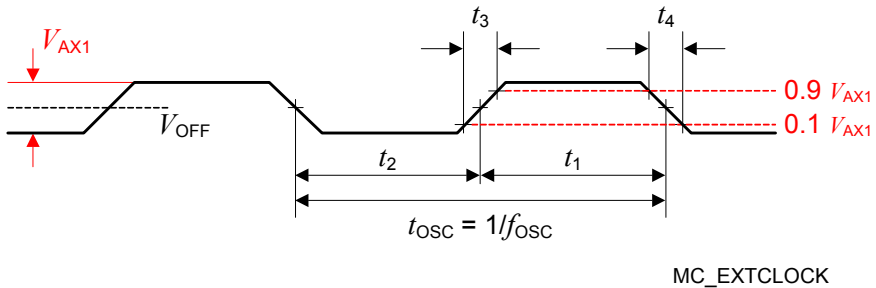
**Figure 2 External Clock Drive XTAL1**

Parameter	Symbol	Values			Unit	Note / Test Condition
		Min.	Typ.	Max.		
Oscillator frequency	$f_{osc}$ SR	4	-	40	MHz	Input=Clock Signal
		4	-	16	MHz	Input=crystal or ceramic resonator
Input voltage amplitude on XTAL1 <sup>1)</sup>	$V_{AX1}$ SR	$0.3 \times V_{DDIM}$	-	-	V	4 to 16 MHz
		<b><math>0.4 \times V_{DDIM}</math></b>	-	-	V	16 to 25 MHz
		<b><math>0.5 \times V_{DDIM}</math></b>	-	-	V	25 to 40MHz

*Note: For crystal or ceramic resonator operation, it is strongly recommended to measure the oscillation allowance (negative resistance) in the final target*

system (layout) to determine the optimum parameters for oscillator operation.
