**Device**            **XC835/836MT Series**  
**Marking/Step**   **AB**  
**Package**         **PG-TSSOP-28/DSO-24**

This Errata Sheet describes the deviations from the current user documentation. The module oriented classification and numbering system uses an ascending sequence over several derivatives, including already solved deviations. So gaps inside this enumeration can occur.

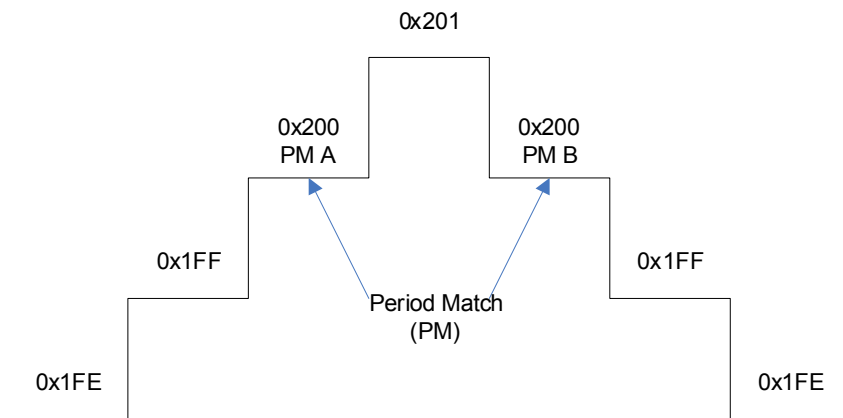
**Figure 1 Counting sequence of T12 in center-aligned mode**

After detecting a period match (PM A) in centre-aligned mode, T12 counts down from PM + 1 as shown below:

This means a second PM event (PM B) will occur during the counting down. If ADC is triggered externally via REQTRxC (T12PM), it will be triggered twice in succession. Depending on how real-time the application code is running as well as the T12 count rate and ADC conversion rate, the application could observe two ADC interrupts - once at PM A and once at PM B.

To avoid triggering twice the ADC interrupts, it is suggested to use REQTRxF from multi-channel mode instead of REQTRxC as the trigger source for ADC. Additional initialization are as follows:

- Configure MCMCTR.SWSEL = 101<sub>B</sub> (Transfer on T12 period match)
- Configure MCMCTR.SWSYN = 00<sub>B</sub> (Direct transfer)
- Write to MCMOUTSTL = CF<sub>H</sub> (To enable multi-Channel PWM pattern on CC6x and COUT6x)
