| Device | XC864L-1FR |
| Marking/Step | AA |
| Package | PG-TSSOP-20 |

This Errata Sheet describes the deviations from the current user documentation. The module oriented classification and numbering system uses an ascending sequence over several derivatives, including already solved deviations. So gaps inside this enumeration can occur.

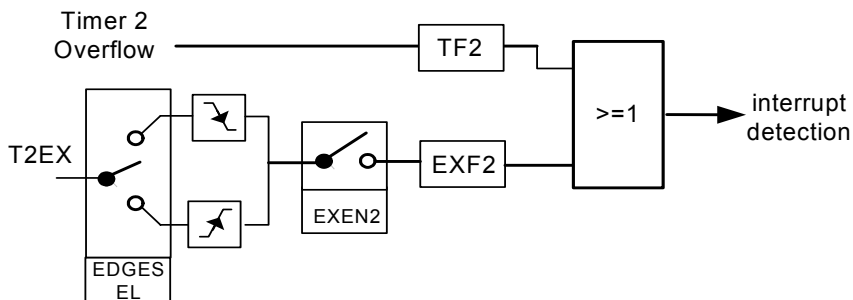
Figure 1

As illustrated in the simplified figure, the Timer 2 interrupt flags `TF2` and `EXF2` are combined as one interrupt request output. These flags are located within the Timer 2 kernel, with a single interrupt request line as output from the kernel.

Being of interrupt structure 2, the interrupt request of Timer 2 is detected on the rising edge of a positive pulse.

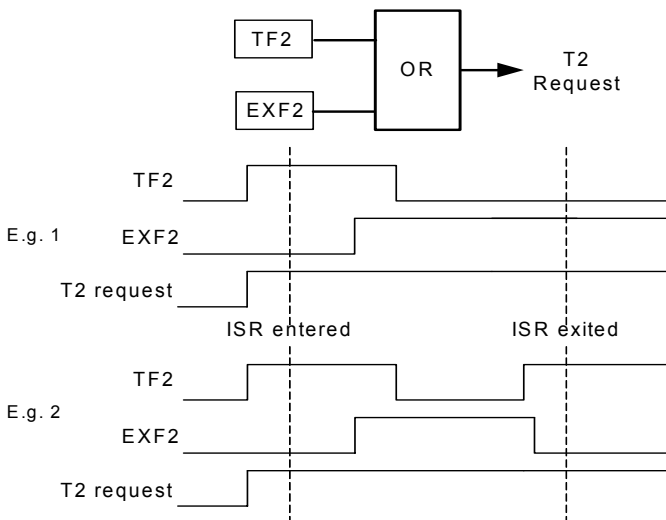
Figure 2

Two example scenarios are illustrated in the following figure:

This means, any future Timer 2 TF2 or EXF2 event is not able to cause a rising edge and therefore not able to trigger an interrupt request to the core – as if the Timer 2 interrupts had been disabled, until both EXF2 and TF2 flags are cleared at some time. The clearing of flags would have to be done by user's code additionally outside of the Timer 2 interrupt routine, which is however normally not feasible with an interrupt service scheme.

Otherwise if EXF2 is enabled, while TF2 is always enabled when Timer 2 is running, there are two suggested workaround:

1. If other events of Timer 2 interrupt node (ET2) need not be enabled for interrupt, disable this interrupt node and use software polling of the flags instead.
2. Before return from interrupt, check again if TF2 or EXF2 is (still) set (due to new request since the last check). If so, jump and execute the ISR routine from start. Exit only when all flags are checked to be cleared. However, dummy interrupt of the node may occur after return from interrupt, and should be ignored. Another drawback is if Timer 2 events are occurring at high rate, the CPU may be 'stuck' in the service routine of the Timer 2 interrupt for a long time.

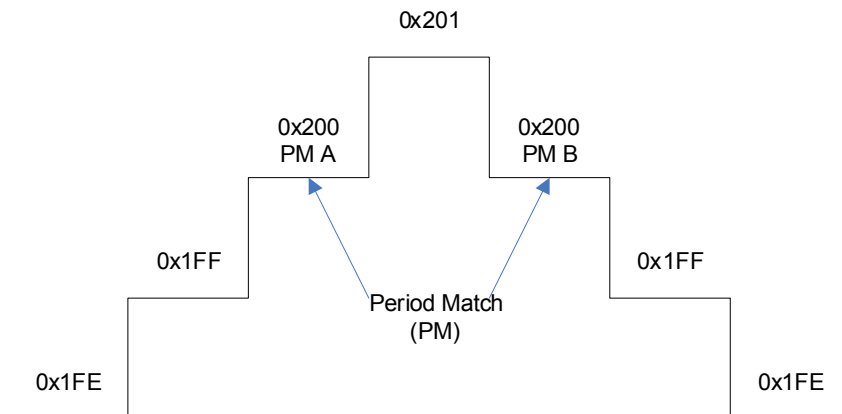
Figure 4 Counting sequence of T12 in center-aligned mode

This means a second PM event (PM B) will occur during the counting down. If ADC is triggered externally via ETRx2 (T12PM), it will be triggered twice in succession. Depending on how real-time the application code is running as well as the T12 count rate and ADC conversion rate, the application could observe two ADC interrupts - once at PM A and once at PM B.

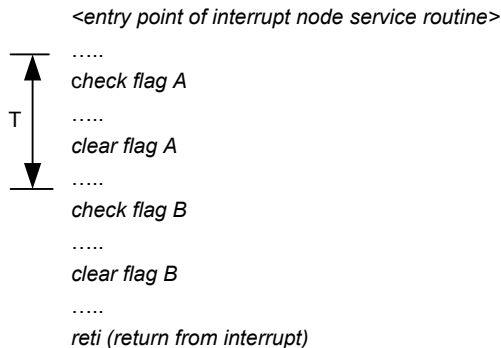
Figure 5

Consider the following interrupt service routine pseudo-code, and scenario where a interrupt source A event leads to interrupt request of the node and CPU vectors to the interrupt routine. Meanwhile, interrupt source B and its flag becomes active any time in the duration indicated by T:

In this case, flag B will be cleared as a standard procedure by the interrupt routine in the current service of the interrupt node. However, the pending interrupt request for the node remains activated after RETI, as it is only cleared by hardware when CPU acknowledge the interrupt and vectors to the interrupt routine.

This leads to following servicing of the interrupt node again, but potentially no active flag is found, i.e. dummy interrupt service. The point to note is that the interrupt source B is not lost, as it was actually serviced in the current service of the interrupt node.

The recommendation is to ignore these dummy interrupt vectoring.
