**Device**            **XC866-2FR**  
**Marking/Step**   **BC**  
**Package**           **PG-TSSOP-38**

This Errata Sheet describes the deviations from the current user documentation. The module oriented classification and numbering system uses an ascending sequence over several derivatives, including already solved deviations. So gaps inside this enumeration can occur.

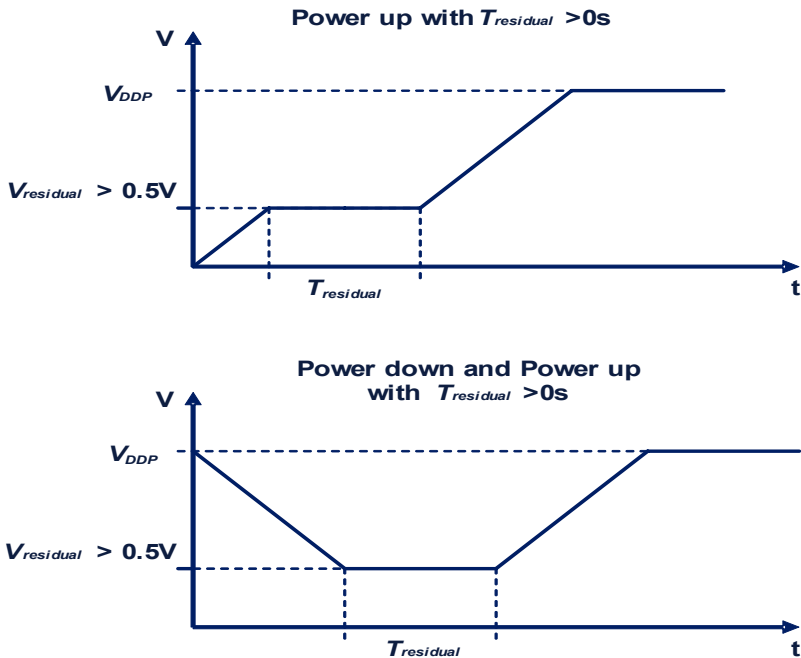
Figure 1 Critical Cases for Power up/ Power down when  $V_{residual} > 500mV$

Due to the limitation of the EVR, the reset toggling may occur during the power up. To prevent the reset toggling issue for power up, the following conditions must be met :

1. For power up, the rising time must be less than  $2\text{ms}/V$ .
2. The power down time must be more than  $0.2\text{ms}/V$ .
3. A permanent  $V_{DDP}$  residual voltage is less than 500mV.

In case of  $V_{DDP}$  residual voltage is more than 500mV, the holding time of residual voltage affects the reset toggling issue. **Figure 1** shows the critical cases for power up/power down when the residual voltages is held for some time. **Figure 2** shows the uncritical case for power up and power down when the power up is triggered immediately after power down. In case of a residual voltage due to immediate power up after power down, the users have to contact IFX to ensure no power up failure.

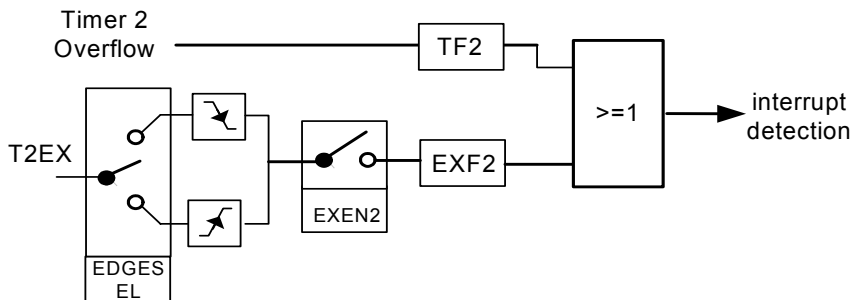
**Figure 3**

As illustrated in the simplified figure, the Timer 2 interrupt flags TF2 and EXF2 are combined as one interrupt request output. These flags are located within the Timer 2 kernel, with a single interrupt request line as output from the kernel.

The problem is that it may occur at some point in the application, that any new Timer 2 interrupt request can no longer be detected after a return-from-interrupt (reti) due to service of earlier event(s). This happens when the following conditions are true:

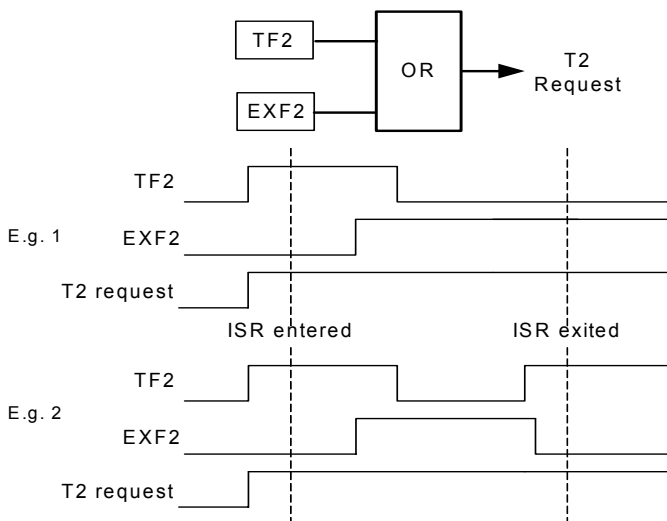
**Figure 4**

Two example scenarios are illustrated in the following figure:

This means, any future Timer 2 TF2 or EXF2 event is not able to cause a rising edge and therefore not able to trigger an interrupt request to the core – as if the Timer 2 interrupts had been disabled, until both EXF2 and TF2 flags are cleared at some time. The clearing of flags would have to be done by user's code additionally outside of the Timer 2 interrupt routine, which is however normally not feasible with an interrupt service scheme.

There is no problem if EXF2 is not enabled by setting bit EXEN2 = 0 i.e. external events are disabled, or if bit DCEN = 1 in auto-reload mode.

Otherwise if EXF2 is enabled, while TF2 is always enabled when Timer 2 is running, there are two suggested workaround:

1. If other events of Timer 2 interrupt node (ET2) need not be enabled for interrupt, disable this interrupt node and use software polling of the flags instead.
2. Before return from interrupt, check again if TF2 or EXF2 is (still) set (due to new request since the last check). If so, jump and execute the ISR routine from start. Exit only when all flags are checked to be cleared. However, dummy interrupt of the node may occur after return from interrupt, and should be ignored. Another drawback is if Timer 2 events are occurring at high rate, the CPU may be 'stuck' in the service routine of the Timer 2 interrupt for a long time.

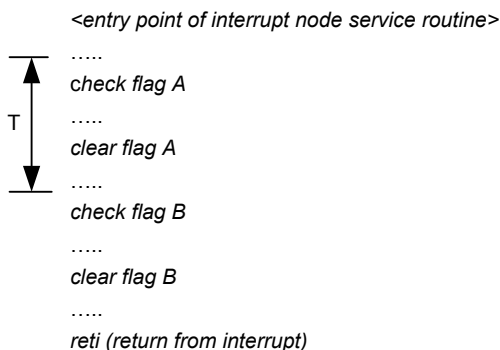
**Figure 6**

Consider the following interrupt service routine pseudo-code, and scenario where a interrupt source A event leads to interrupt request of the node and CPU vectors to the interrupt routine. Meanwhile, interrupt source B and its flag becomes active any time in the duration indicated by T:

In this case, flag B will be cleared as a standard procedure by the interrupt routine in the current service of the interrupt node. However, the pending

interrupt request for the node remains activated after RETI, as it is only cleared by hardware when CPU acknowledge the interrupt and vectors to the interrupt routine.

This leads to following servicing of the interrupt node again, but potentially no active flag is found, i.e. dummy interrupt service. The point to note is that the interrupt source B is not lost, as it was actually serviced in the current service of the interrupt node.

The recommendation is to ignore these dummy interrupt vectoring.

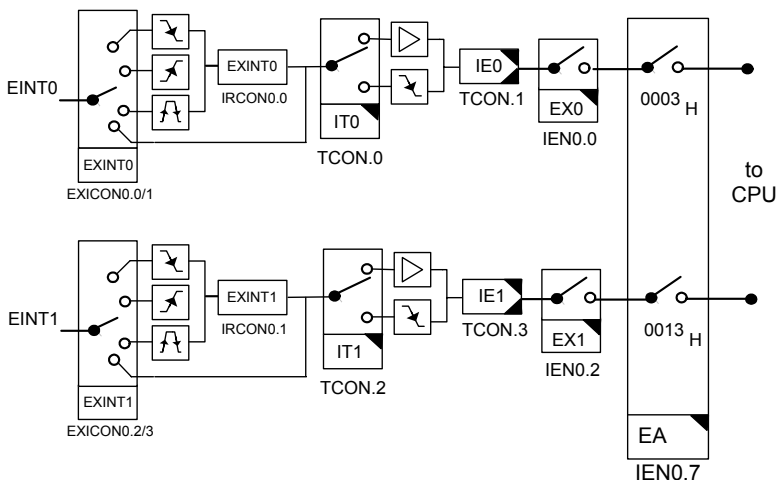
**Figure 7**

External interrupt 0 and 1 may individually be selected via respective bits ( $EXINTx$ ) in  $EXICON0$  register, to request interrupt on falling edge, rising edge, both edges or to bypass the edge detection.

Edge detection is done in the system unit. If enabled, an active event will set the  $EXINTx$  flag and correspondingly set the  $IEx$  flag in  $TCON$ . It should be noted that after any external interrupt  $x$  event, flag  $EXINTx$  must be cleared. In case of falling edge as active event, this allows any future active event to be able to set the flag  $IEx$  as interrupt request. In case of low level as active event, this prevents unintended recurring triggering of interrupt request.

In case of bypass edge detection, the input is connected directly to the core (bypass the system unit). The flag  $IEx$  in  $TCON$  will be set on the selected falling edge or low level (at least 2 clock cycles) event. In case of falling edge selected as active event by  $TCON.ITx$ , the flag  $EXINTx$  is set in addition to the flag  $IEx$ . However to use this mode properly, user must not clear the flag  $EXINTx$  and if necessary, to only access the flag  $TCON.IEx$  (refer to INT\_XC8.003).
