**Device**            **XC866-2FR**  
**Marking/Step**   **BE**  
**Package**           **PG-TSSOP-38**

This Errata Sheet describes the deviations from the current user documentation. The module oriented classification and numbering system uses an ascending sequence over several derivatives, including already solved deviations. So gaps inside this enumeration can occur.

# 1 History List / Change Summary

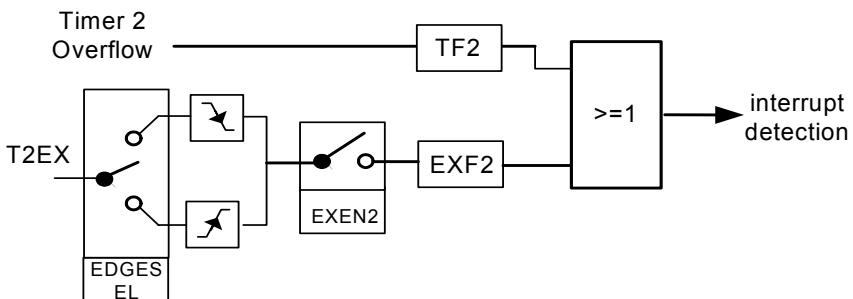
**Figure 1**

### **INT\_XC8.004 Unable to Detect New Interrupt Request if Any One of Timer 2 Interrupt Flags Is Not Cleared (Unexpectedly)**

As illustrated in the simplified figure, the Timer 2 interrupt flags TF2 and EXF2 are combined as one interrupt request output. These flags are located within the Timer 2 kernel, with a single interrupt request line as output from the kernel.

Being of interrupt structure 2, the interrupt request of Timer 2 is detected on the rising edge of a positive pulse.

The problem is that it may occur at some point in the application, that any new Timer 2 interrupt request can no longer be detected after a return-from-interrupt (reti) due to service of earlier event(s). This happens when the following conditions are true:

There is no problem if EXF2 is not enabled by setting bit EXEN2 = 0 i.e. external events are disabled, or if bit DCEN = 1 in auto-reload mode.

Otherwise if EXF2 is enabled, while TF2 is always enabled when Timer 2 is running, there are two suggested workaround:

1. If other events of Timer 2 interrupt node (ET2) need not be enabled for interrupt, disable this interrupt node and use software polling of the flags instead.
2. Before return from interrupt, check again if TF2 or EXF2 is (still) set (due to new request since the last check). If so, jump and execute the ISR routine from start. Exit only when all flags are checked to be cleared. However, dummy interrupt of the node may occur after return from interrupt, and should be ignored. Another drawback is if Timer 2 events are occurring at high rate, the CPU may be 'stuck' in the service routine of the Timer 2 interrupt for a long time.

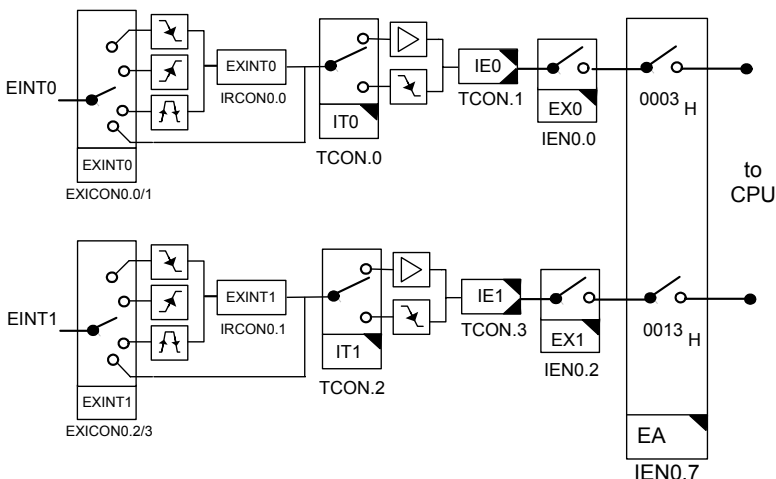
**Figure 5**

Edge detection is done in the system unit. If enabled, an active event will set the  $EXINTx$  flag and correspondingly set the  $IEx$  flag in  $TCON$ . It should be noted that after any external interrupt  $x$  event, flag  $EXINTx$  must be cleared. In case of falling edge as active event, this allows any future active event to be able to set the flag  $IEx$  as interrupt request. In case of low level as active event, this prevents unintended recurring triggering of interrupt request.

In case of bypass edge detection, the input is connected directly to the core (bypass the system unit). The flag  $IEx$  in  $TCON$  will be set on the selected falling edge or low level (at least 2 clock cycles) event. In case of falling edge selected as active event by  $TCON.ITx$ , the flag  $EXINTx$  is set in addition to the flag  $IEx$ . However to use this mode properly, user must not clear the flag  $EXINTx$  and if necessary, to only access the flag  $TCON.IEx$  (refer to INT\_XC8.003).
