Device **XC866-4FR**
Marking/Step **BC**
Package **PG-TSSOP-38**

This Errata Sheet describes the deviations from the current user documentation. The module oriented classification and numbering system uses an ascending sequence over several derivatives, including already solved deviations. So gaps inside this enumeration can occur.

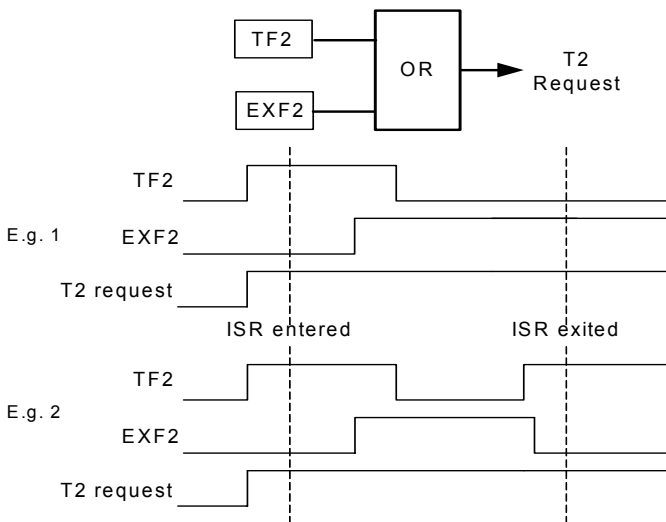
Figure 4

Two example scenarios are illustrated in the following figure:

This means, any future Timer 2 TF2 or EXF2 event is not able to cause a rising edge and therefore not able to trigger an interrupt request to the core – as if the Timer 2 interrupts had been disabled, until both EXF2 and TF2 flags are cleared at some time. The clearing of flags would have to be done by user's code additionally outside of the Timer 2 interrupt routine, which is however normally not feasible with an interrupt service scheme.

Otherwise if EXF2 is enabled, while TF2 is always enabled when Timer 2 is running, there are two suggested workaround:

1. If other events of Timer 2 interrupt node (ET2) need not be enabled for interrupt, disable this interrupt node and use software polling of the flags instead.
2. Before return from interrupt, check again if TF2 or EXF2 is (still) set (due to new request since the last check). If so, jump and execute the ISR routine from start. Exit only when all flags are checked to be cleared. However, dummy interrupt of the node may occur after return from interrupt, and should be ignored. Another drawback is if Timer 2 events are occurring at high rate, the CPU may be 'stuck' in the service routine of the Timer 2 interrupt for a long time.

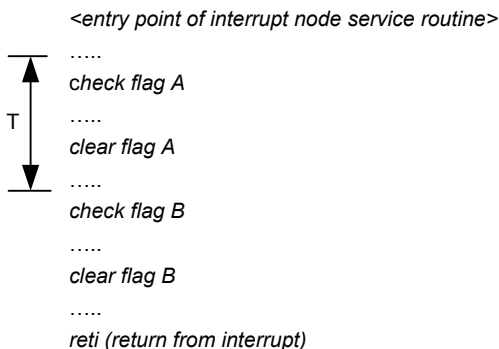
Figure 6

Consider the following interrupt service routine pseudo-code, and scenario where a interrupt source A event leads to interrupt request of the node and CPU vectors to the interrupt routine. Meanwhile, interrupt source B and its flag becomes active any time in the duration indicated by T:

In this case, flag B will be cleared as a standard procedure by the interrupt routine in the current service of the interrupt node. However, the pending

This leads to following servicing of the interrupt node again, but potentially no active flag is found, i.e. dummy interrupt service. The point to note is that the interrupt source B is not lost, as it was actually serviced in the current service of the interrupt node.

The recommendation is to ignore these dummy interrupt vectoring.
