**Device**            **XC866-4FR**  
**Marking/Step**   **BE**  
**Package**           **PG-TSSOP-38**

This Errata Sheet describes the deviations from the current user documentation. The module oriented classification and numbering system uses an ascending sequence over several derivatives, including already solved deviations. So gaps inside this enumeration can occur.

# 1 History List / Change Summary

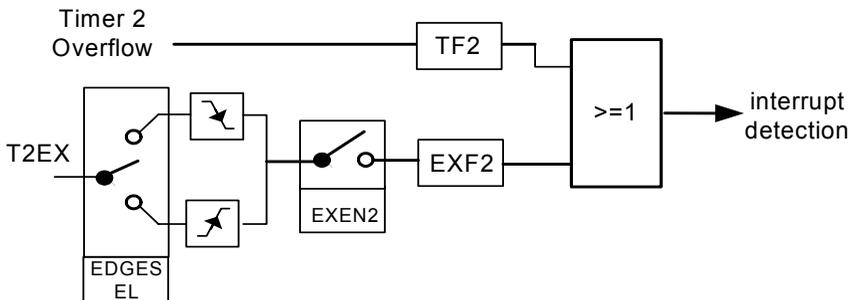
**Figure 1**

As illustrated in the simplified figure, the Timer 2 interrupt flags TF2 and EXF2 are combined as one interrupt request output. These flags are located within the Timer 2 kernel, with a single interrupt request line as output from the kernel.

Being of interrupt structure 2, the interrupt request of Timer 2 is detected on the rising edge of a positive pulse.

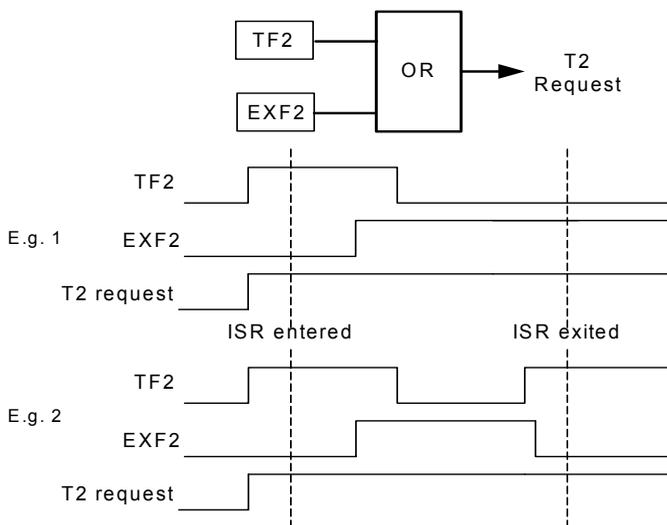
**Figure 2**

The problem is that it may occur at some point in the application, that any new Timer 2 interrupt request can no longer be detected after a return-from-interrupt (reti) due to service of earlier event(s). This happens when the following conditions are true:

1. Timer 2 events are serviced by interrupt (i.e. flags are checked and cleared only in the interrupt routine ISR),
2. Either TF2 or EXF2 is set at any one time throughout the ISR (even while the other is cleared) such that at least one of the flags is still set after reti, causing the Timer 2 request line, which is an OR-function of the two flags TF2 and EXF2, to remain set throughout the ISR and after reti.

Two example scenarios are illustrated in the following figure:

This means, any future Timer 2 TF2 or EXF2 event is not able to cause a rising edge and therefore not able to trigger an interrupt request to the core – as if the Timer 2 interrupts had been disabled, until both EXF2 and TF2 flags are cleared at some time. The clearing of flags would have to be done by user's code additionally outside of the Timer 2 interrupt routine, which is however normally not feasible with an interrupt service scheme.

There is no problem if EXF2 is not enabled by setting bit EXEN2 = 0 i.e. external events are disabled, or if bit DCEN = 1 in auto-reload mode.

Otherwise if EXF2 is enabled, while TF2 is always enabled when Timer 2 is running, there are two suggested workaround:

1. If other events of Timer 2 interrupt node (ET2) need not be enabled for interrupt, disable this interrupt node and use software polling of the flags instead.
2. Before return from interrupt, check again if TF2 or EXF2 is (still) set (due to new request since the last check). If so, jump and execute the ISR routine from start. Exit only when all flags are checked to be cleared. However, dummy interrupt of the node may occur after return from interrupt, and should be ignored. Another drawback is if Timer 2 events are occurring at high rate, the CPU may be 'stuck' in the service routine of the Timer 2 interrupt for a long time.

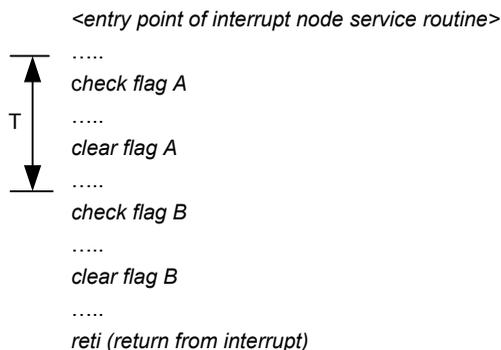
**Figure 4**

It might occur in the application, that sometimes interrupt requests are serviced, but no active interrupt flags are found. This would happen for those interrupt nodes which is shared by several interrupt sources.

Consider the following interrupt service routine pseudo-code, and scenerio where a interrupt source A event leads to interrupt request of the node and CPU vectors to the interrupt routine. Meanwhile, interrupt source B and its flag becomes active any time in the duration indicated by T:

In this case, flag B will be cleared as a standard procedure by the interrupt routine in the current service of the interrupt node. However, the pending interrupt request for the node remains activated after RETI, as it is only cleared

This leads to following servicing of the interrupt node again, but potentially no active flag is found, i.e. dummy interrupt service. The point to note is that the interrupt source B is not lost, as it was actually serviced in the current service of the interrupt node.

The recommendation is to ignore these dummy interrupt vectoring.

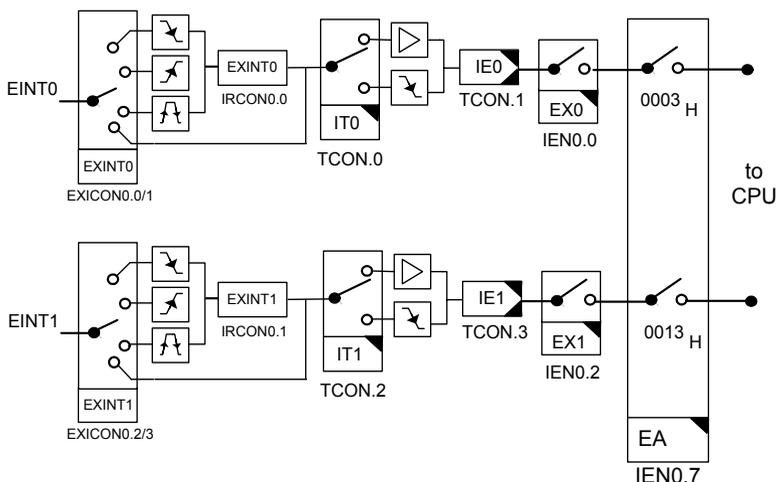
**Figure 5**

External interrupt 0 and 1 may individually be selected via respective bits ( $EXINTx$ ) in  $EXICON0$  register, to request interrupt on falling edge, rising edge, both edges or to bypass the edge detection.

Edge detection is done in the system unit. If enabled, an active event will set the  $EXINTx$  flag and correspondingly set the  $IEx$  flag in  $TCON$ . It should be noted that after any external interrupt  $x$  event, flag  $EXINTx$  must be cleared. In case of falling edge as active event, this allows any future active event to be able to set the flag  $IEx$  as interrupt request. In case of low level as active event, this prevents unintended recurring triggering of interrupt request.

In case of bypass edge detection, the input is connected directly to the core (bypass the system unit). The flag  $IEx$  in  $TCON$  will be set on the selected falling edge or low level (at least 2 clock cycles) event. In case of falling edge selected as active event by  $TCON.ITx$ , the flag  $EXINTx$  is set in addition to the flag  $IEx$ . However to use this mode properly, user must not clear the flag  $EXINTx$  and if necessary, to only access the flag  $TCON.IEx$  (refer to INT\_XC8.003).
