Device **XC866L-2FR**
Marking/Step **BC**
Package **PG-TSSOP-38**

This Errata Sheet describes the deviations from the current user documentation. The module oriented classification and numbering system uses an ascending sequence over several derivatives, including already solved deviations. So gaps inside this enumeration can occur.

XC866 User's Manual	V1.2	June 2006
XC866 Data Sheet	V1.0	Feb 2006

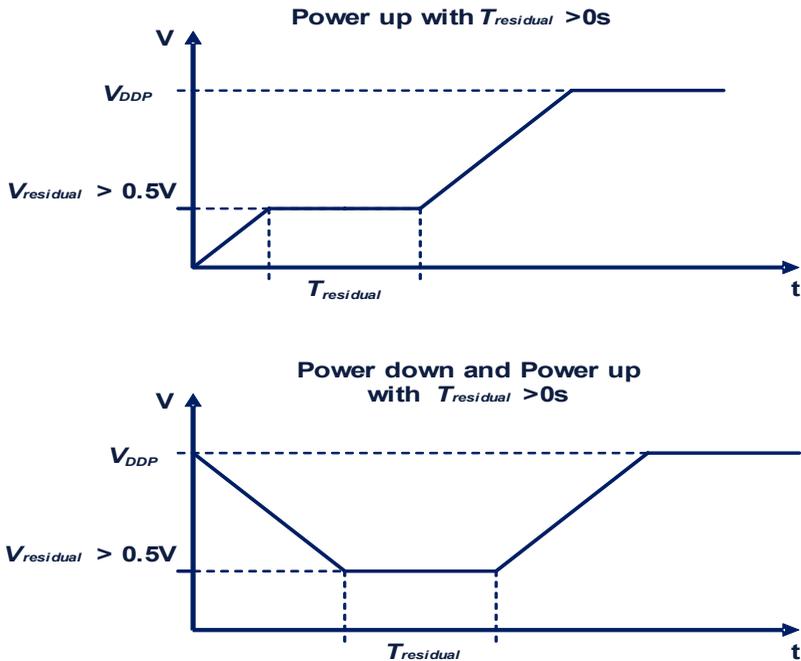
Figure 1 Critical Cases for Power up/ Power down when $V_{residual} > 500mV$

Due to the limitation of the EVR, the reset toggling may occur during the power up. To prevent the reset toggling issue for power up, the following conditions must be met :

1. For power up, the rising time must be less than $2\text{ms}/V$.
2. The power down time must be more than $0.2\text{ms}/V$.
3. A permanent V_{DDP} residual voltage is less than 500mV .

In case of V_{DDP} residual voltage is more than 500mV , the holding time of residual voltage affects the reset toggling issue. **Figure 1** shows the critical cases for power up/power down when the residual voltages is held for some time. **Figure 2** shows the uncritical case for power up and power down when the power up is triggered immediately after power down. In case of a residual voltage due to immediate power up after power down, the users have to contact IFX to ensure no power up failure.

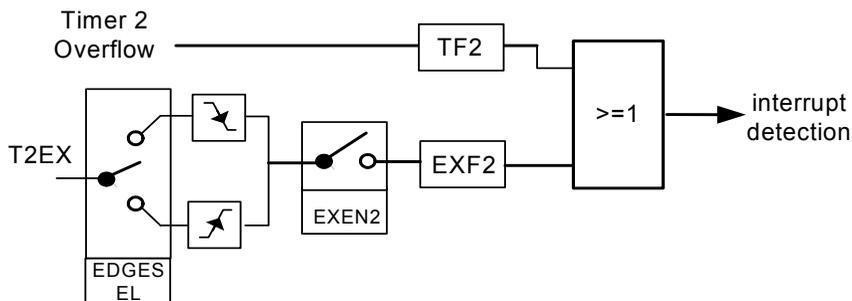
Figure 3

As illustrated in the simplified figure, the Timer 2 interrupt flags TF2 and EXF2 are combined as one interrupt request output. These flags are located within the Timer 2 kernel, with a single interrupt request line as output from the kernel.

Being of interrupt structure 2, the interrupt request of Timer 2 is detected on the rising edge of a positive pulse.

The problem is that it may occur at some point in the application, that any new Timer 2 interrupt request can no longer be detected after a return-from-interrupt (reti) due to service of earlier event(s). This happens when the following conditions are true:

There is no problem if EXF2 is not enabled by setting bit EXEN2 = 0 i.e. external events are disabled, or if bit DCEN = 1 in auto-reload mode.

Otherwise if EXF2 is enabled, while TF2 is always enabled when Timer 2 is running, there are two suggested workaround:

1. If other events of Timer 2 interrupt node (ET2) need not be enabled for interrupt, disable this interrupt node and use software polling of the flags instead.
2. Before return from interrupt, check again if TF2 or EXF2 is (still) set (due to new request since the last check). If so, jump and execute the ISR routine from start. Exit only when all flags are checked to be cleared. However, dummy interrupt of the node may occur after return from interrupt, and should be ignored. Another drawback is if Timer 2 events are occurring at high rate, the CPU may be 'stuck' in the service routine of the Timer 2 interrupt for a long time.

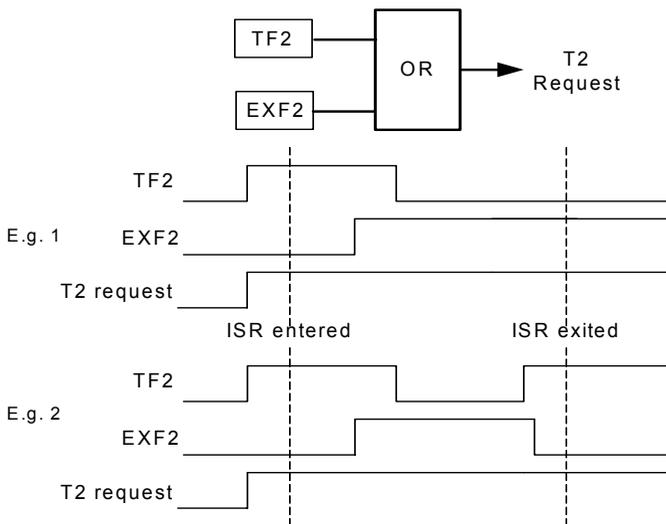
Figure 4

1. Timer 2 events are serviced by interrupt (i.e. flags are checked and cleared only in the interrupt routine ISR),
2. Either TF2 or EXF2 is set at any one time throughout the ISR (even while the other is cleared) such that at least one of the flags is still set after reti, causing the Timer 2 request line, which is an OR-function of the two flags TF2 and EXF2, to remain set throughout the ISR and after reti.

Two example scenarios are illustrated in the following figure:

This means, any future Timer 2 TF2 or EXF2 event is not able to cause a rising edge and therefore not able to trigger an interrupt request to the core – as if the Timer 2 interrupts had been disabled, until both EXF2 and TF2 flags are cleared at some time. The clearing of flags would have to be done by user's code additionally outside of the Timer 2 interrupt routine, which is however normally not feasible with an interrupt service scheme.

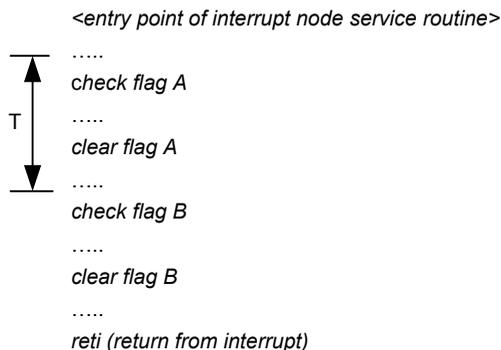
Figure 6

It might occur in the application, that sometimes interrupt requests are serviced, but no active interrupt flags are found. This would happen for those interrupt nodes which is shared by several interrupt sources.

Consider the following interrupt service routine pseudo-code, and scenario where a interrupt source A event leads to interrupt request of the node and CPU vectors to the interrupt routine. Meanwhile, interrupt source B and its flag becomes active any time in the duration indicated by T:

In this case, flag B will be cleared as a standard procedure by the interrupt routine in the current service of the interrupt node. However, the pending

interrupt request for the node remains activated after RETI, as it is only cleared by hardware when CPU acknowledge the interrupt and vectors to the interrupt routine.

This leads to following servicing of the interrupt node again, but potentially no active flag is found, i.e. dummy interrupt service. The point to note is that the interrupt source B is not lost, as it was actually serviced in the current service of the interrupt node.

The recommendation is to ignore these dummy interrupt vectoring.

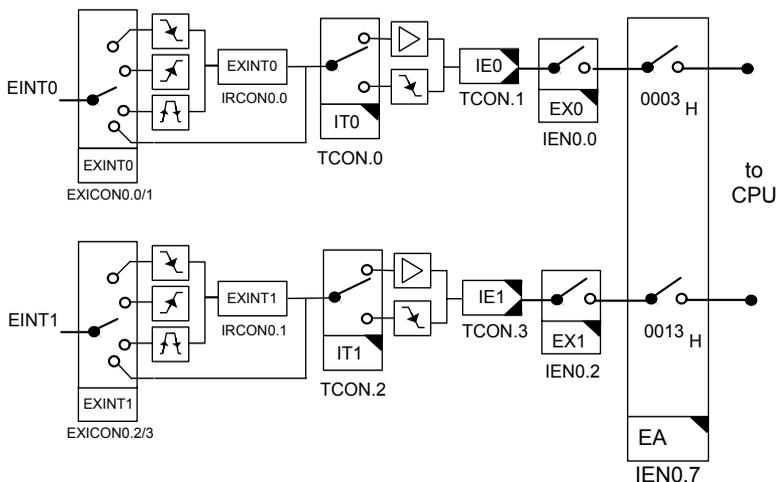
Figure 7

External interrupt 0 and 1 may individually be selected via respective bits (EXINT_x) in EXICON0 register, to request interrupt on falling edge, rising edge, both edges or to bypass the edge detection.

Edge detection is done in the system unit. If enabled, an active event will set the EXINT_x flag and correspondingly set the IE_x flag in TCON. It should be noted that after any external interrupt x event, flag EXINT_x must be cleared. In case of falling edge as active event, this allows any future active event to be able to set the flag IE_x as interrupt request. In case of low level as active event, this prevents unintended recurring triggering of interrupt request.
