**Device**            **XC866L-2FR**  
**Marking/Step**   **BE**  
**Package**           **PG-TSSOP-38**

This Errata Sheet describes the deviations from the current user documentation. The module oriented classification and numbering system uses an ascending sequence over several derivatives, including already solved deviations. So gaps inside this enumeration can occur.

## Table 1      **Current Documentation**

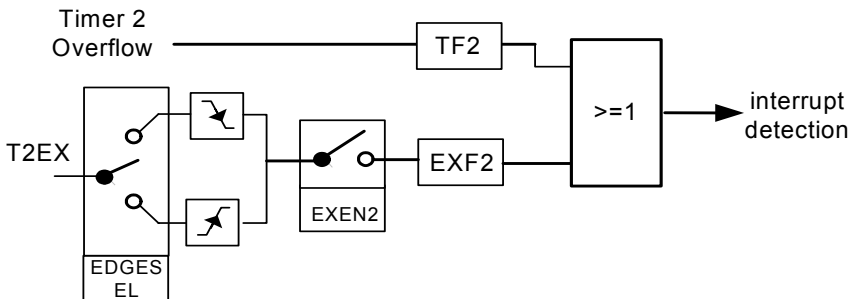
**Figure 1**

**INT\_XC8.004 Unable to Detect New Interrupt Request if Any One of Timer 2 Interrupt Flags Is Not Cleared (Unexpectedly)**

As illustrated in the simplified figure, the Timer 2 interrupt flags TF2 and EXF2 are combined as one interrupt request output. These flags are located within the Timer 2 kernel, with a single interrupt request line as output from the kernel.

Being of interrupt structure 2, the interrupt request of Timer 2 is detected on the rising edge of a positive pulse.

There is no problem if EXF2 is not enabled by setting bit EXEN2 = 0 i.e. external events are disabled, or if bit DCEN = 1 in auto-reload mode.

Otherwise if EXF2 is enabled, while TF2 is always enabled when Timer 2 is running, there are two suggested workaround:

1. If other events of Timer 2 interrupt node (ET2) need not be enabled for interrupt, disable this interrupt node and use software polling of the flags instead.
2. Before return from interrupt, check again if TF2 or EXF2 is (still) set (due to new request since the last check). If so, jump and execute the ISR routine from start. Exit only when all flags are checked to be cleared. However, dummy interrupt of the node may occur after return from interrupt, and should be ignored. Another drawback is if Timer 2 events are occurring at high rate, the CPU may be 'stuck' in the service routine of the Timer 2 interrupt for a long time.

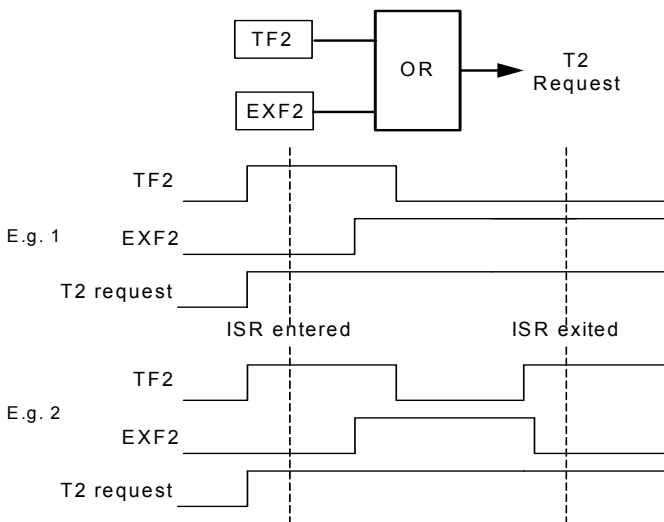
**Figure 2**

1. Timer 2 events are serviced by interrupt (i.e. flags are checked and cleared only in the interrupt routine ISR),
2. Either TF2 or EXF2 is set at any one time throughout the ISR (even while the other is cleared) such that at least one of the flags is still set after reti, causing the Timer 2 request line, which is an OR-function of the two flags TF2 and EXF2, to remain set throughout the ISR and after reti.

Two example scenarios are illustrated in the following figure:

This means, any future Timer 2 TF2 or EXF2 event is not able to cause a rising edge and therefore not able to trigger an interrupt request to the core – as if the Timer 2 interrupts had been disabled, until both EXF2 and TF2 flags are cleared at some time. The clearing of flags would have to be done by user's code additionally outside of the Timer 2 interrupt routine, which is however normally not feasible with an interrupt service scheme.

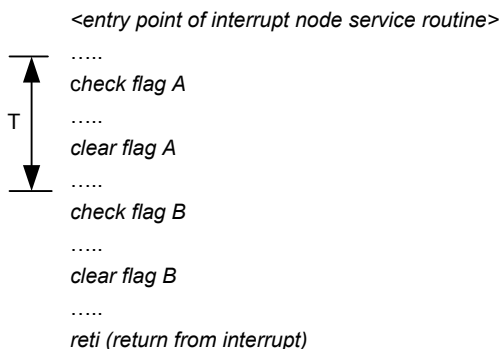
**Figure 4**

It might occur in the application, that sometimes interrupt requests are serviced, but no active interrupt flags are found. This would happen for those interrupt nodes which is shared by several interrupt sources.

Consider the following interrupt service routine pseudo-code, and scenerio where a interrupt source A event leads to interrupt request of the node and CPU vectors to the interrupt routine. Meanwhile, interrupt source B and its flag becomes active any time in the duration indicated by T:

In this case, flag B will be cleared as a standard procedure by the interrupt routine in the current service of the interrupt node. However, the pending interrupt request for the node remains activated after RETI, as it is only cleared

This leads to following servicing of the interrupt node again, but potentially no active flag is found, i.e. dummy interrupt service. The point to note is that the interrupt source B is not lost, as it was actually serviced in the current service of the interrupt node.

The recommendation is to ignore these dummy interrupt vectoring.

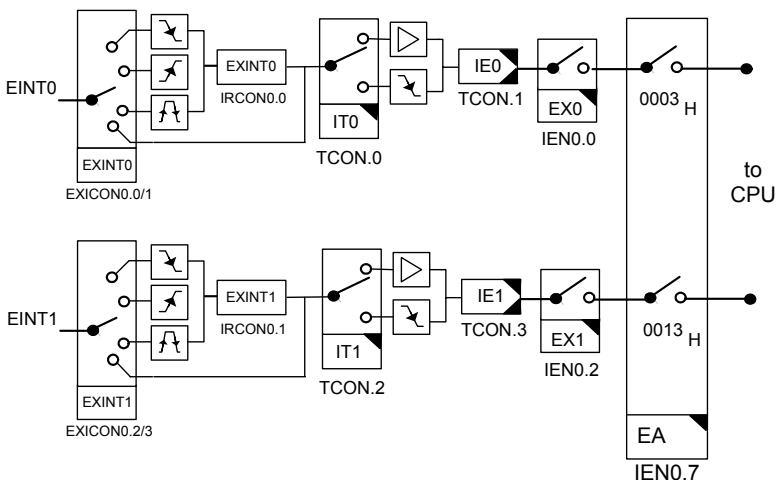
**Figure 5**

External interrupt 0 and 1 may individually be selected via respective bits (EXINT<sub>x</sub>) in EXICON0 register, to request interrupt on falling edge, rising edge, both edges or to bypass the edge detection.

Edge detection is done in the system unit. If enabled, an active event will set the EXINT<sub>x</sub> flag and correspondingly set the IE<sub>x</sub> flag in TCON. It should be noted that after any external interrupt x event, flag EXINT<sub>x</sub> must be cleared. In case of falling edge as active event, this allows any future active event to be able to set the flag IE<sub>x</sub> as interrupt request. In case of low level as active event, this prevents unintended recurring triggering of interrupt request.

In case of bypass edge detection, the input is connected directly to the core (bypass the system unit). The flag IE<sub>x</sub> in TCON will be set on the selected falling edge or low level (at least 2 clock cycles) event. In case of falling edge selected as active event by TCON.IT<sub>x</sub>, the flag EXINT<sub>x</sub> is set in addition to the flag IE<sub>x</sub>. However to use this mode properly, user must not clear the flag EXINT<sub>x</sub> and if necessary, to only access the flag TCON.IE<sub>x</sub> (refer to INT\_XC8.003).
