Device **XC866L-4FR**
Marking/Step **BC**
Package **PG-TSSOP-38**

This Errata Sheet describes the deviations from the current user documentation. The module oriented classification and numbering system uses an ascending sequence over several derivatives, including already solved deviations. So gaps inside this enumeration can occur.

XC866 User's Manual	V1.2	June 2006
XC866 Data Sheet	V1.0	Feb 2006

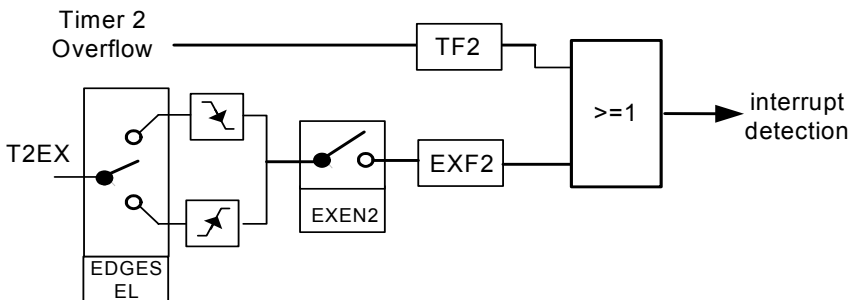
Figure 3

As illustrated in the simplified figure, the Timer 2 interrupt flags TF2 and EXF2 are combined as one interrupt request output. These flags are located within the Timer 2 kernel, with a single interrupt request line as output from the kernel.

Being of interrupt structure 2, the interrupt request of Timer 2 is detected on the rising edge of a positive pulse.

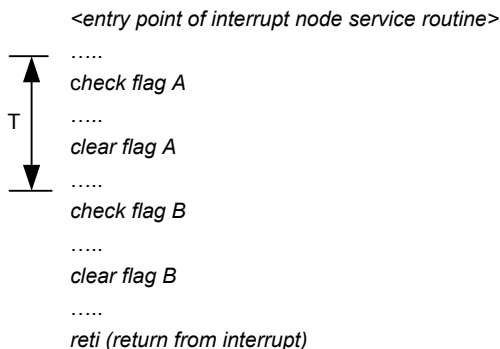
Figure 6

Consider the following interrupt service routine pseudo-code, and scenario where a interrupt source A event leads to interrupt request of the node and CPU vectors to the interrupt routine. Meanwhile, interrupt source B and its flag becomes active any time in the duration indicated by T:

In this case, flag B will be cleared as a standard procedure by the interrupt routine in the current service of the interrupt node. However, the pending

interrupt request for the node remains activated after RETI, as it is only cleared by hardware when CPU acknowledge the interrupt and vectors to the interrupt routine.

This leads to following servicing of the interrupt node again, but potentially no active flag is found, i.e. dummy interrupt service. The point to note is that the interrupt source B is not lost, as it was actually serviced in the current service of the interrupt node.

The recommendation is to ignore these dummy interrupt vectoring.

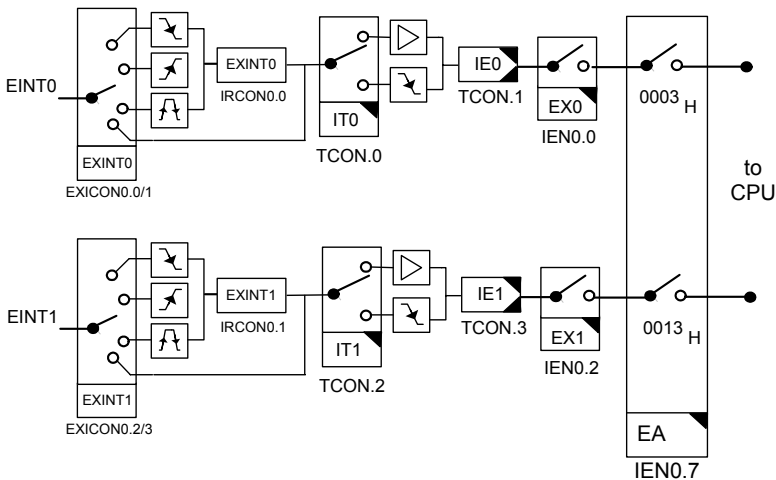
Figure 7

External interrupt 0 and 1 may individually be selected via respective bits (EXINTx) in EXICON0 register, to request interrupt on falling edge, rising edge, both edges or to bypass the edge detection.

Edge detection is done in the system unit. If enabled, an active event will set the EXINTx flag and correspondingly set the IEx flag in TCON. It should be noted that after any external interrupt x event, flag EXINTx must be cleared. In case of falling edge as active event, this allows any future active event to be able to set the flag IEx as interrupt request. In case of low level as active event, this prevents unintended recurring triggering of interrupt request.
