Device **XC866L-4FR**
Marking/Step **BE**
Package **PG-TSSOP-38**

This Errata Sheet describes the deviations from the current user documentation. The module oriented classification and numbering system uses an ascending sequence over several derivatives, including already solved deviations. So gaps inside this enumeration can occur.

XC866 User's Manual	V1.2	June 2006
XC866 Data Sheet	V1.0	Feb 2006

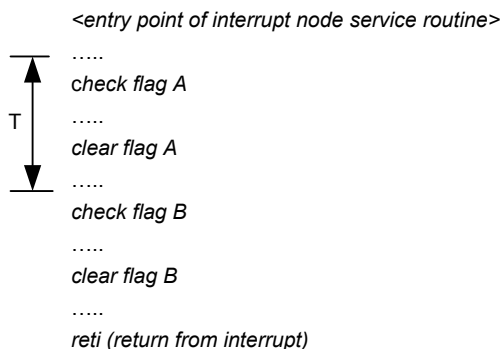
Figure 4

INT_XC8.H001 Interrupt Request With No Interrupt Flag Set

It might occur in the application, that sometimes interrupt requests are serviced, but no active interrupt flags are found. This would happen for those interrupt nodes which is shared by several interrupt sources.

Consider the following interrupt service routine pseudo-code, and scenario where a interrupt source A event leads to interrupt request of the node and CPU vectors to the interrupt routine. Meanwhile, interrupt source B and its flag becomes active any time in the duration indicated by T:

In this case, flag B will be cleared as a standard procedure by the interrupt routine in the current service of the interrupt node. However, the pending interrupt request for the node remains activated after RETI, as it is only cleared

This leads to following servicing of the interrupt node again, but potentially no active flag is found, i.e. dummy interrupt service. The point to note is that the interrupt source B is not lost, as it was actually serviced in the current service of the interrupt node.

The recommendation is to ignore these dummy interrupt vectoring.

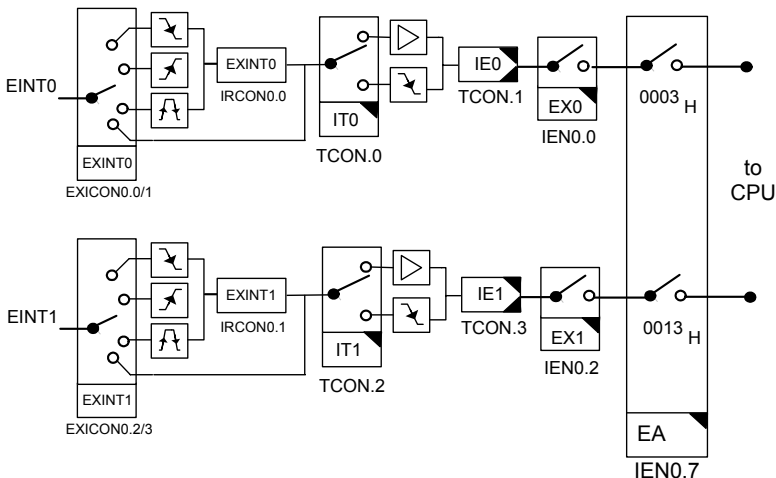
Figure 5

INT_XC8.H003 Interrupt Flags of External Interrupt 0 and 1

External interrupt 0 and 1 may individually be selected via respective bits ($EXINTx$) in $EXICON0$ register, to request interrupt on falling edge, rising edge, both edges or to bypass the edge detection.

Edge detection is done in the system unit. If enabled, an active event will set the $EXINTx$ flag and correspondingly set the IEx flag in $TCON$. It should be noted that after any external interrupt x event, flag $EXINTx$ must be cleared. In case of falling edge as active event, this allows any future active event to be able to set the flag IEx as interrupt request. In case of low level as active event, this prevents unintended recurring triggering of interrupt request.

In case of bypass edge detection, the input is connected directly to the core (bypass the system unit). The flag IEx in $TCON$ will be set on the selected falling edge or low level (at least 2 clock cycles) event. In case of falling edge selected as active event by $TCON.ITx$, the flag $EXINTx$ is set in addition to the flag IEx . However to use this mode properly, user must not clear the flag $EXINTx$ and if necessary, to only access the flag $TCON.IEx$ (refer to INT_XC8.003).
