Device	XC866L-1FR Series
Marking/Step	AB
Package	PG-TSSOP-38

This Errata Sheet describes the deviations from the current user documentation. The module oriented classification and numbering system uses an ascending sequence over several derivatives, including already solved deviations. So gaps inside this enumeration can occur.

This Errata Sheet covers the following devices:

- XC866-1FR
- XC866L-1FR

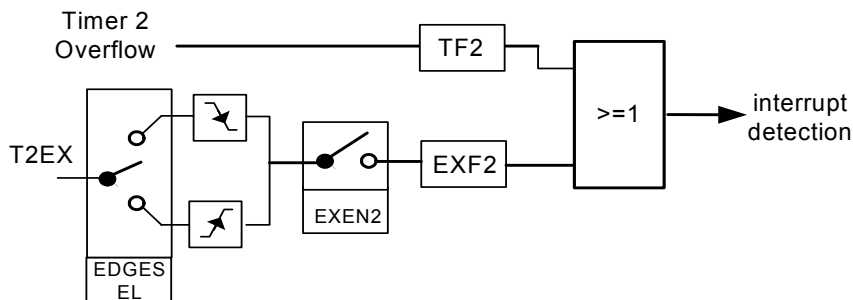
Figure 1

As illustrated in the simplified figure, the Timer 2 interrupt flags `TF2` and `EXF2` are combined as one interrupt request output. These flags are located within the Timer 2 kernel, with a single interrupt request line as output from the kernel.

Being of interrupt structure 2, the interrupt request of Timer 2 is detected on the rising edge of a positive pulse.
