Device	XC874CM Series
Marking/Step	AC
Package	PG-VQFN-48

This Errata Sheet describes the deviations from the current user documentation. The module oriented classification and numbering system uses an ascending sequence over several derivatives, including already solved deviations. So gaps inside this enumeration can occur.

This Errata Sheet covers the following devices:

- XC874-13/16FV
- XC874CM-13/16FV
- XC874LM-13/16FV

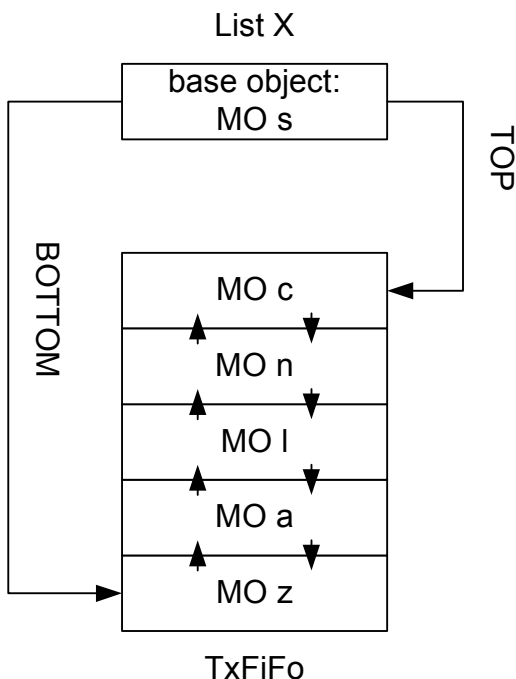
Figure 1 FIFO structure

MultiCAN TC.029 Tx FIFO overflow interrupt not generated**Specified behaviour**

After the successful transmission of a Tx FIFO element, a Tx overflow interrupt is generated if the FIFO base object fulfils these conditions:

- Bit MOFCR.OVIE=1, AND
- MOFGPR.CUR becomes equal to MOFGPR.SEL

Real behaviour

A Tx FIFO overflow interrupt will not be generated after the transmission of the Tx FIFO base object.

If Tx FIFO overflow interrupt needed, take the FIFO base object out of the circular list of the Tx message objects. That is to say, just use the FIFO base object for FIFO control, but not to store a Tx message.

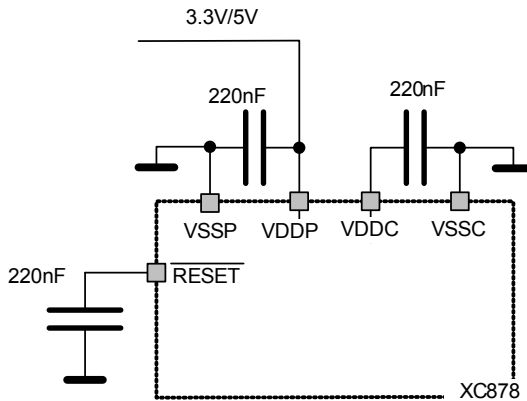
Figure 4 Noise Immunity Enhancement Circuitry

During power up, the EVR functionality may be affected due to injected noise from any functional pin. In order to enhance the noise immunity, the external reset pin RESET must be asserted until VDDC reaches $0.9 * VDDC$. The delay of external reset can be realized by an external capacitor at RESET pin. This capacitor value must be selected so that VRESET reaches 0.4 V, but not before VDDC reaches $0.9 * VDDC$.

A typical application example is shown in **Figure 4**. A 220 nF capacitor is connected to VDDP pin, VDDC pin and RESET pin. In addition, it is also essential to put it as close as possible to the chip.

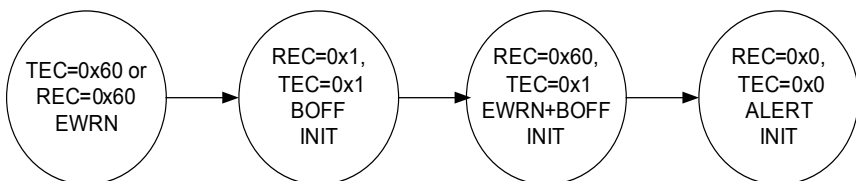
Figure 5 Alert Interrupt Behavior in case of Bus-Off

MultiCAN_AI.H007 Alert Interrupt Behavior in case of Bus-Off

The MultiCAN module shows the following behavior in case of a bus-off status:

When the threshold for error warning (EWRN) is reached (default value of Error Warning Level EWRN = 0x60), then the EWRN interrupt is issued. The bus-off (BOFF) status is reached if $TEC > 255$ according to CAN specification, changing the MultiCAN module with REC and TEC to the same value 0x1, setting the INIT bit to 1_B, and issuing the BOFF interrupt. The bus-off recovery phase starts automatically. Every time an idle time is seen, REC is incremented. If REC = 0x60, a combined status EWRN+BOFF is reached. The corresponding interrupt can also be seen as a pre-warning interrupt, that the bus-off recovery phase will be finished soon. When the bus-off recovery phase has finished (128 times idle time have been seen on the bus), EWRN and BOFF are cleared, the ALERT interrupt bit is set and the INIT bit is still set.

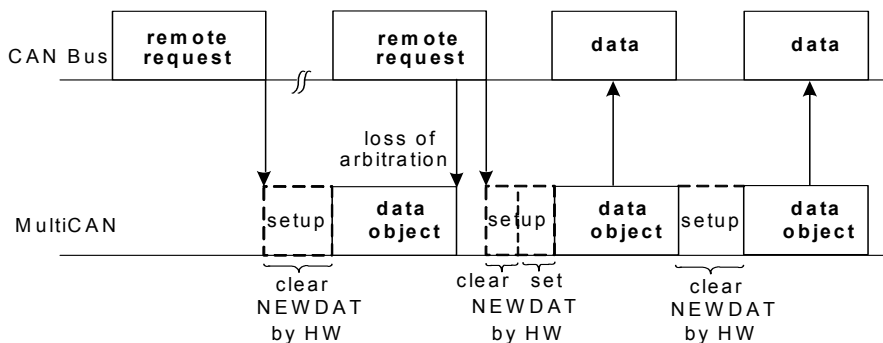
Figure 6 Loss of Arbitration

When the appropriate message object (data frame) triggered by the first remote frame wins the arbitration, it will be sent out and NEWDAT is not reset. This leads to an additional data frame, that will be sent by this message object (clearing NEWDAT).

There will, however, not be more data frames than there are corresponding remote requests.
