Device **XC878CLM Series**
Marking/Step **AC**
Package **PG-LQFP-64**

This Errata Sheet describes the deviations from the current user documentation. The module oriented classification and numbering system uses an ascending sequence over several derivatives, including already solved deviations. So gaps inside this enumeration can occur.

- XC878CM-13/16FF
- XC878CLM-13/16FF

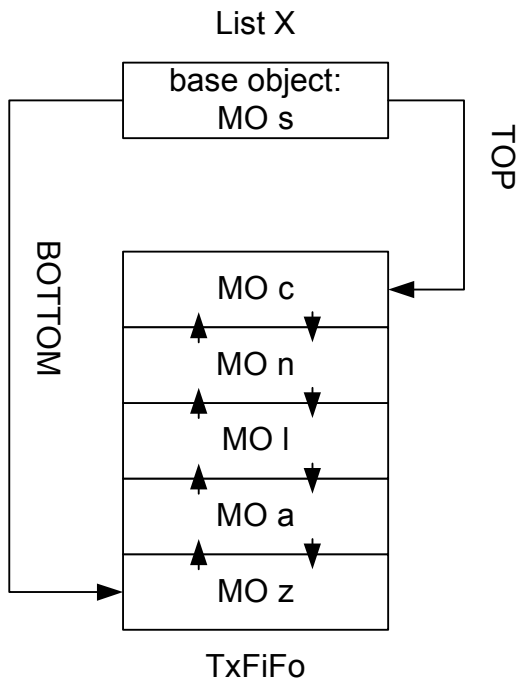
Figure 1 FIFO structure

A Tx FIFO overflow interrupt will not be generated after the transmission of the Tx FIFO base object.

If Tx FIFO overflow interrupt needed, take the FIFO base object out of the circular list of the Tx message objects. That is to say, just use the FIFO base object for FIFO control, but not to store a Tx message.

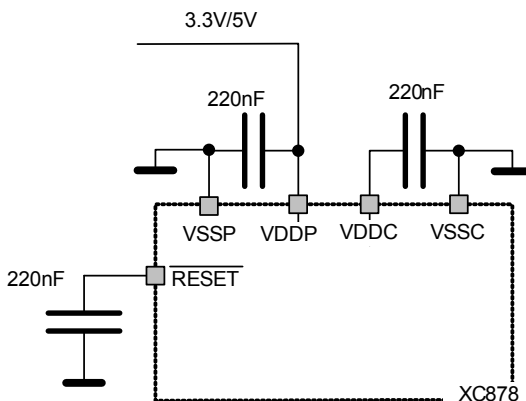
Figure 4 Noise Immunity Enhancement Circuitry

During power up, the EVR functionality may be affected due to injected noise from any functional pin. In order to enhance the noise immunity, the external reset pin RESET must be asserted until VDDC reaches $0.9 * VDDC$. The delay of external reset can be realized by an external capacitor at RESET pin. This capacitor value must be selected so that VRESET reaches 0.4 V, but not before VDDC reaches $0.9 * VDDC$.

A typical application example is shown in **Figure 4**. A 220 nF capacitor is connected to VDDP pin, VDDC pin and RESET pin. In addition, it is also essential to put it as close as possible to the chip.

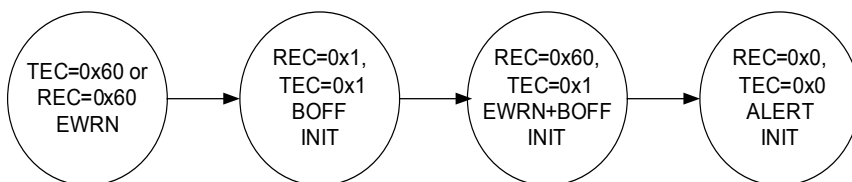
Figure 5 Alert Interrupt Behavior in case of Bus-Off

The MultiCAN module shows the following behavior in case of a bus-off status:

When the threshold for error warning (EWRN) is reached (default value of Error Warning Level EWRN = 0x60), then the EWRN interrupt is issued. The bus-off (BOFF) status is reached if $TEC > 255$ according to CAN specification, changing the MultiCAN module with REC and TEC to the same value 0x1, setting the INIT bit to 1_B, and issuing the BOFF interrupt. The bus-off recovery phase starts automatically. Every time an idle time is seen, REC is incremented. If REC = 0x60, a combined status EWRN+BOFF is reached. The corresponding interrupt can also be seen as a pre-warning interrupt, that the bus-off recovery phase will be finished soon. When the bus-off recovery phase has finished (128 times idle time have been seen on the bus), EWRN and BOFF are cleared, the ALERT interrupt bit is set and the INIT bit is still set.
