Device **XC878LM Series**
Marking/Step **AC**
Package **PG-LQFP-64**

This Errata Sheet describes the deviations from the current user documentation. The module oriented classification and numbering system uses an ascending sequence over several derivatives, including already solved deviations. So gaps inside this enumeration can occur.

This Errata Sheet covers the following devices:

- XC878-13/16FF
- XC878M-13/16FF
- XC878LM-13/16FF

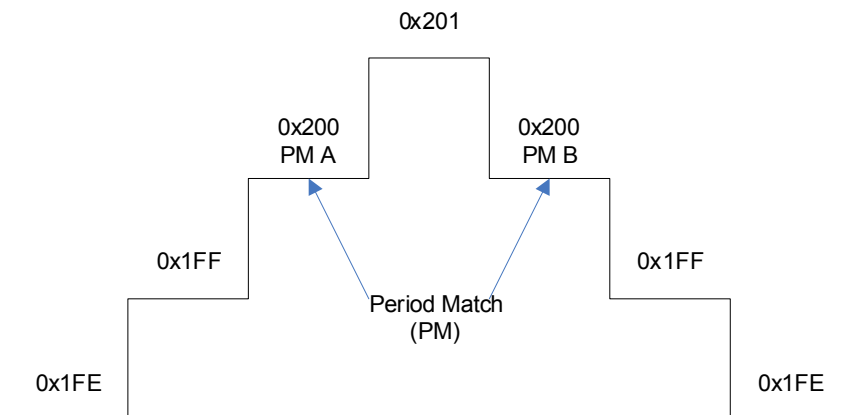
Figure 1 Counting sequence of T12 in center-aligned mode

After detecting a period match (PM A) in centre-aligned mode, T12 counts down from PM + 1 as shown below:

This means a second PM event (PM B) will occur during the counting down. If ADC is triggered externally via ETRx2 (T12PM), it will be triggered twice in succession. Depending on how real-time the application code is running as well

as the T12 count rate and ADC conversion rate, the application could observe two ADC interrupts - once at PM A and once at PM B.

To avoid triggering twice the ADC interrupts, it is suggested to use ETRx6 from multi-channel mode instead of ETRx2 as the trigger source for ADC. Additional initialization are as follows:

- Configure MCMCTR.SWSEL = 101_B (Transfer on T12 period match)
- Configure MCMCTR.SWSYN = 00_B (Direct transfer)
- Write to MCMOUTSTL = CF_H (To enable multi-Channel PWM pattern on CC6x and COUT6x)

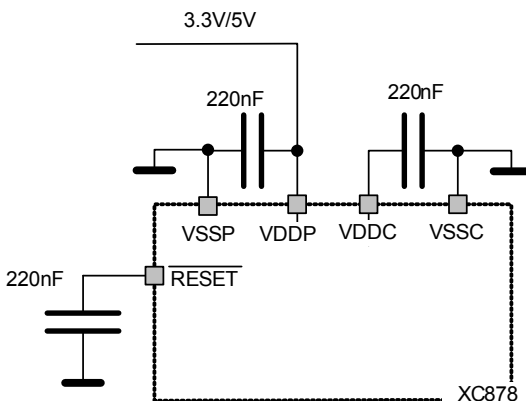
Figure 2 Noise Immunity Enhancement Circuitry

During power up, the EVR functionality may be affected due to injected noise from any functional pin. In order to enhance the noise immunity, the external reset pin RESET must be asserted until VDDC reaches $0.9 * VDDC$. The delay of external reset can be realized by an external capacitor at RESET pin. This capacitor value must be selected so that VRESET reaches 0.4 V, but not before VDDC reaches $0.9 * VDDC$.

A typical application example is shown in **Figure 2**. A 220 nF capacitor is connected to VDDP pin, VDDC pin and RESET pin. In addition, it is also essential to put it as close as possible to the chip.
