**Device**            **XC886CM-8FF**  
**Marking/Step**   **EES AA**  
**Package**         **PG-TQFP-48**

This Errata Sheet describes the deviations from the current user documentation. The module oriented classification and numbering system uses an ascending sequence over several derivatives, including already solved deviations. So gaps inside this enumeration can occur.

# 1 History List/Change Summary

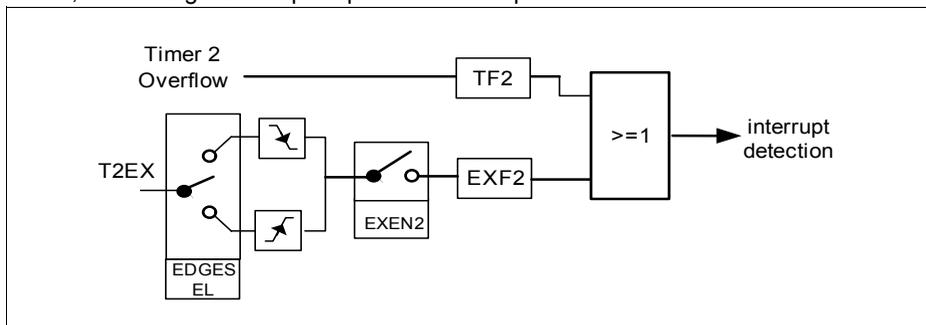
**INT\_XC8.004 Unable to Detect New Interrupt Request if Any One of Timer 2/Timer 21/UART1 Interrupt Flags Is Not Cleared (Unexpectedly)**

As illustrated in the simplified figure, the Timer 2 interrupt flags TF2 and EXF2 are combined as one interrupt request output. These flags are located within the Timer 2 kernel, with a single interrupt request line as output from the kernel.

Being of interrupt structure 2, the interrupt request of Timer 2 is detected on the rising edge of a positive pulse.

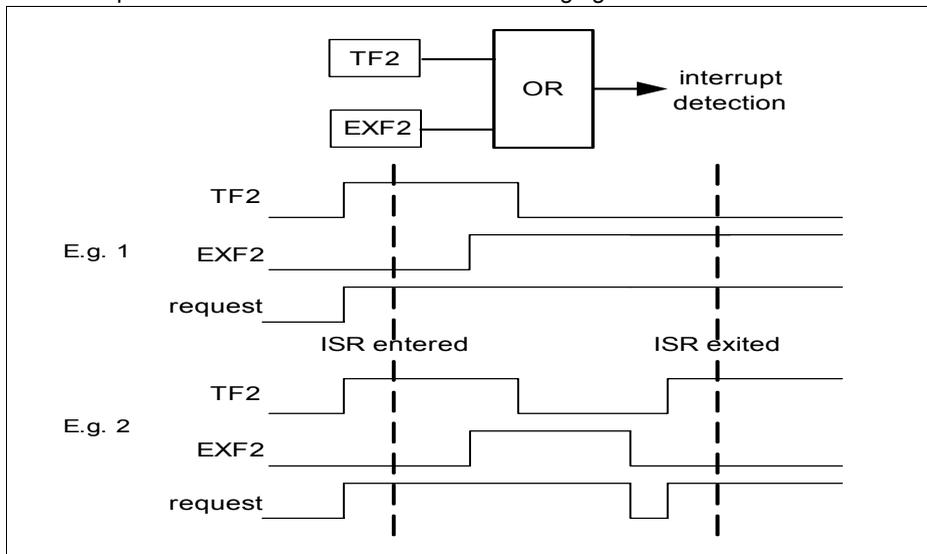
The problem is that it may occur at some point in the application, that any new Timer 2 interrupt request can no longer be detected after a return-from-interrupt (reti) due to service of earlier event(s). This happens when the following conditions are true:

1. Timer 2 events are serviced by interrupt (i.e. flags are checked and cleared only in the interrupt routine ISR),
2. Either TF2 or EXF2 is set at any one time throughout the ISR (even while the other is cleared) such that at least one of the flags is still set after reti, causing the Timer 2 request line, which is an OR-function of the two flags TF2 and EXF2, to remain set throughout the ISR and after reti.

Two example scenerios are illustrated in the following figure:

This means, any future Timer 2 TF2 or EXF2 event is not able to cause a rising edge and therefore not able to trigger an interrupt request to the core – as if the Timer 2 interrupts had been disabled, until both EXF2 and TF2 flags are cleared at some time. The clearing of flags would have to be done by user’s code additionally outside of the Timer 2 interrupt routine, which is however normally not feasible with an interrupt service scheme.

There is no problem if EXF2 is not enabled by setting bit EXEN2 = 0 i.e. external events are disabled, or if bit DCEN = 1 in auto-reload mode.

Otherwise if EXF2 is enabled, while TF2 is always enabled when Timer 2 is running, there are two suggested workaround:

1. If other events of Timer 2 interrupt node (ET2) need not be enabled for interrupt, disable this interrupt node and use software polling of the flags instead.
2. Before return from interrupt, check again if TF2 or EXF2 is (still) set (due to new request since the last check). If so, jump and execute the ISR routine from start. Exit only when all flags are checked to be cleared. However, dummy interrupt of the node may occur after return from interrupt, and should be ignored. Another drawback is if Timer 2 events are occurring at high rate, the CPU may be 'stuck' in the service routine of the Timer 2 interrupt for a long time.

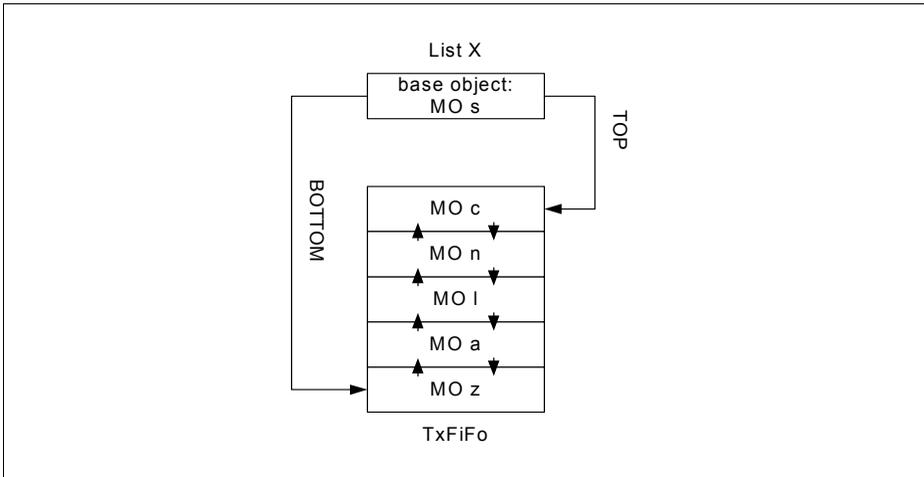
### **MultiCAN\_XC8.005 Tx FIFO overflow interrupt not generated**

A Tx FIFO overflow interrupt will not be generated after the transmission of the Tx FIFO base object.

If Tx FIFO overflow interrupt needed, take the FIFO base object out of the circular list of the Tx message objects. That is to say, just use the FIFO base object for FIFO control, but not to store a Tx message.

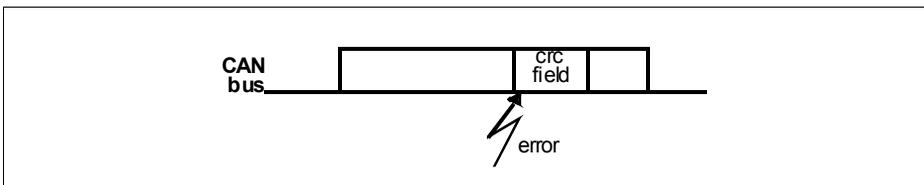
**MultiCAN\_XC8.006 Wrong transmit order when CAN error at start of CRC transmission**

The priority order defined by acceptance filtering, specified in the message objects, define the sequential order in which these messages are sent on the CAN bus. If an error occurs on the CAN bus, the transmissions are delayed due to the destruction of the message on the bus, but the transmission order is kept. However, if a CAN error occurs when starting to transmit the CRC field, the arbitration order for the corresponding CAN node is disturbed, because the faulty message is not retransmitted directly, but after the next transmission of the CAN node.

None.

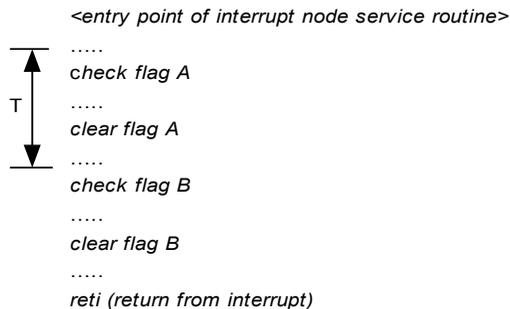
It might occur in the application, that sometimes NMI interrupt requests are serviced, but no active NMI interrupt flags are found.

Consider the following NMI interrupt service routine pseudo-code, and scenerio where a NMI interrupt source A event leads to interrupt request of the NMI node and CPU vectors to the NMI interrupt routine. Meanwhile, NMI interrupt source B and its flag becomes active any time in the duration indicated by T:

In this case, NMI flag B will be cleared as a standard procedure by the NMI interrupt routine in the current service. However, the pending interrupt request for the NMI node remains activated after RETI, as it is only cleared by hardware when CPU acknowledge the NMI interrupt and vectors to the NMI service routine.

This leads to following servicing of the NMI interrupt node again, but potentially no active NMI flag is found, i.e. dummy NMI interrupt service. The point to note is that the NMI interrupt source B is not lost, as it was actually serviced in the current service of the NMI interrupt node.

The recommendation is to ignore these dummy NMI interrupt vectoring.

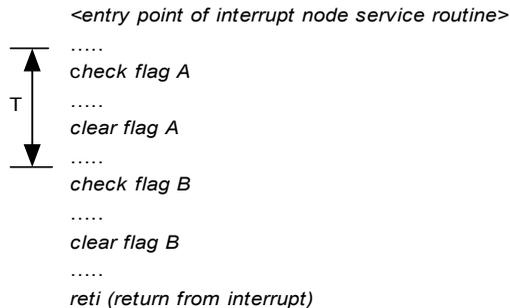
Consider the case where an enabled interrupt node is shared by more than 2 events, and where at least two of the events (A and B) are enabled for interrupt while at least one event (C) is not enabled for interrupt. In this case, flag C is one of the flags listed in above table.

While the interrupt routine is already running due to event A having occurred, event B and C occurs any time in the duration indicated by T:

This sets the pending interrupt request while flag B is set.

Although event B is serviced and flag B is cleared in the following service routine, on return from interrupt, the pending interrupt request remains activated. This is because event C is not enabled for interrupt (and therefore flag C is neither checked nor cleared in the interrupt routine) while flag C is not qualified.

This leads to following servicing of the interrupt node again, but potentially no active flag is found, i.e. dummy interrupt service.
