**Device** XC886CM-8FF  
**Marking/Step** ES AB  
**Package** PG-TQFP-48

This Errata Sheet describes the deviations from the current user documentation. The module oriented classification and numbering system uses an ascending sequence over several derivatives, including already solved deviations. So gaps inside this enumeration can occur.

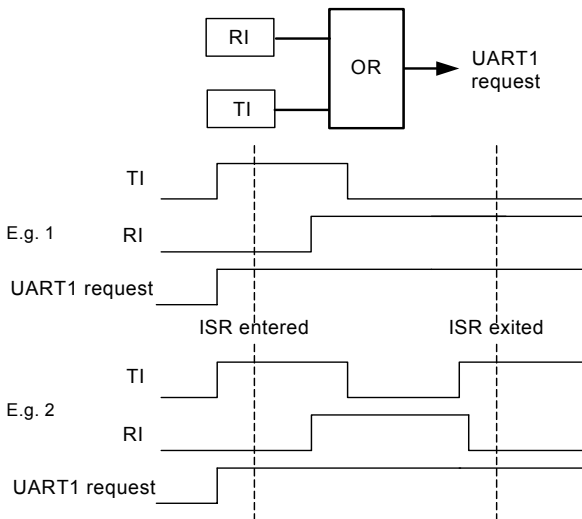
**Figure 4**

The problem is that it may occur at some point in the application, that any new UART1 interrupt request can no longer be detected after a return-from-interrupt (reti) due to service of earlier event(s). This happens when the following conditions are true:

1. UART1 events are serviced by interrupt (i.e. flags are checked and cleared only in the interrupt routine ISR),
2. Either RI or TI is set at any one time throughout the ISR (even while the other is cleared) such that at least one of the flags is still set after reti, causing the UART1 request line, which is an OR-function of the two flags RI and TI, to remain set throughout the ISR and after reti.

This means, any future UART1 RI or TI event is not able to cause a rising edge and therefore not able to trigger an interrupt request to the core – as if the UART1 interrupts had been disabled, until both RI and TI flags are cleared at some time. The clearing of flags would have to be done by user's code additionally outside of the UART1 interrupt routine, which is however normally not feasible with an interrupt service scheme.

1. If other events of interrupt node XINTR8 (EX2) need not be enabled for interrupt, disable this interrupt node and use software polling of the flags instead.
2. Before return from interrupt, check again if RI or TI is (still) set (due to new request since the last check). If so, jump and execute the ISR routine from start. Exit only when all flags are checked to be cleared. However, dummy

interrupt of the node may occur after return from interrupt, and should be ignored. Another drawback is if UART1 events are occurring at high rate, the CPU may be 'stuck' in the service routine of the UART1 interrupt for a long time.

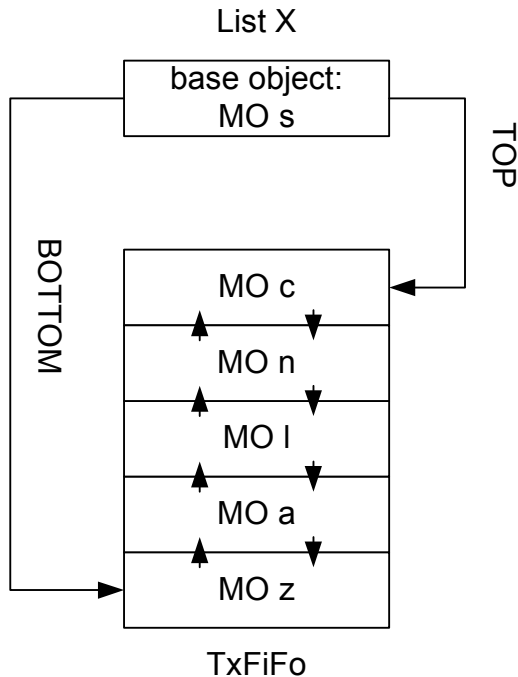
**Figure 6** FIFO structure

After the successful transmission of a Tx FIFO element, a Tx overflow interrupt is generated if the FIFO base object fulfils these conditions:

If Tx FIFO overflow interrupt needed, take the FIFO base object out of the circular list of the Tx message objects. That is to say, just use the FIFO base object for FIFO control, but not to store a Tx message.
