**Device**                **XC886C-8FF**  
**Marking/Step**      **ES AB**  
**Package**            **PG-TQFP-48**

This Errata Sheet describes the deviations from the current user documentation. The module oriented classification and numbering system uses an ascending sequence over several derivatives, including already solved deviations. So gaps inside this enumeration can occur.

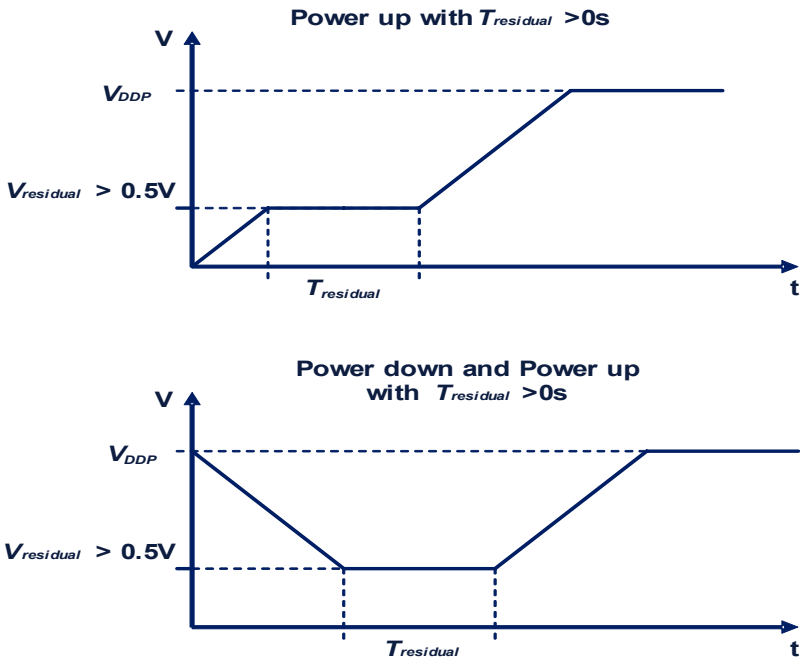
**Figure 1** Critical Cases for Power up/ Power down when  $V_{residual} > 500mV$

In case of  $V_{DDP}$  residual voltage is more than 500mV, the holding time of residual voltage affects the reset toggling issue. **Figure 1** shows the critical cases for power up/power down when the residual voltages is held for some time. **Figure 2** shows the uncritical case for power up and power down when the power up is triggered immediately after power down. In case of a residual voltage due to immediate power up after power down, the users have to contact IFX to ensure no power up failure.

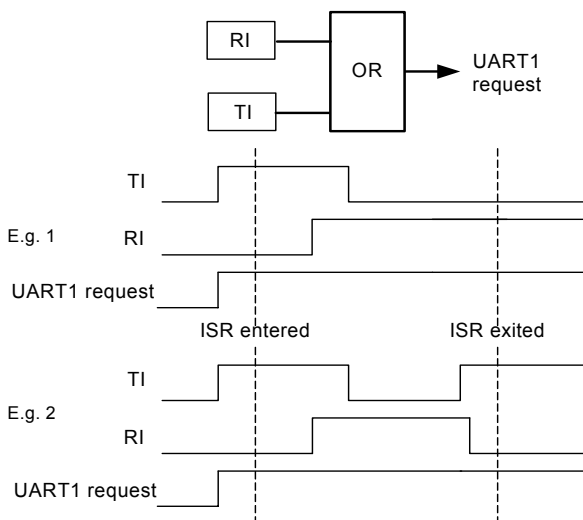
**Figure 4**

The problem is that it may occur at some point in the application, that any new UART1 interrupt request can no longer be detected after a return-from-interrupt (reti) due to service of earlier event(s). This happens when the following conditions are true:

1. UART1 events are serviced by interrupt (i.e. flags are checked and cleared only in the interrupt routine ISR),
2. Either RI or TI is set at any one time throughout the ISR (even while the other is cleared) such that at least one of the flags is still set after reti, causing the UART1 request line, which is an OR-function of the two flags RI and TI, to remain set throughout the ISR and after reti.

This means, any future UART1 RI or TI event is not able to cause a rising edge and therefore not able to trigger an interrupt request to the core – as if the UART1 interrupts had been disabled, until both RI and TI flags are cleared at some time. The clearing of flags would have to be done by user's code additionally outside of the UART1 interrupt routine, which is however normally not feasible with an interrupt service scheme.

1. If other events of interrupt node XINTR8 (EX2) need not be enabled for interrupt, disable this interrupt node and use software polling of the flags instead.
2. Before return from interrupt, check again if RI or TI is (still) set (due to new request since the last check). If so, jump and execute the ISR routine from start. Exit only when all flags are checked to be cleared. However, dummy

interrupt of the node may occur after return from interrupt, and should be ignored. Another drawback is if UART1 events are occurring at high rate, the CPU may be 'stuck' in the service routine of the UART1 interrupt for a long time.

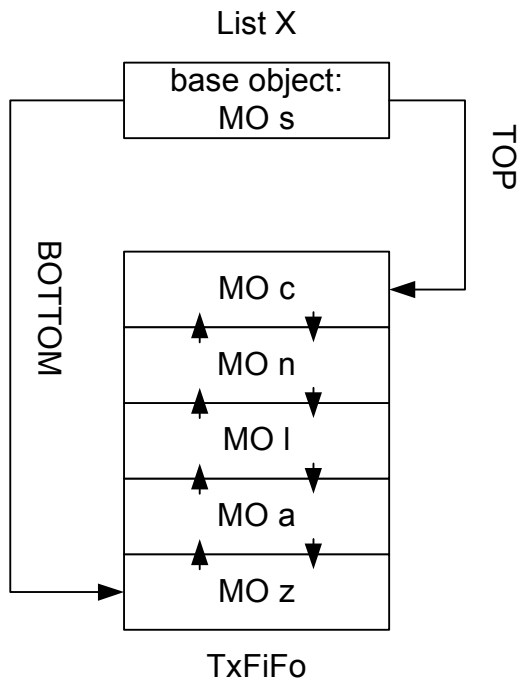
**Figure 6**    **FIFO structure**

After the successful transmission of a Tx FIFO element, a Tx overflow interrupt is generated if the FIFO base object fulfils these conditions:

If Tx FIFO overflow interrupt needed, take the FIFO base object out of the circular list of the Tx message objects. That is to say, just use the FIFO base object for FIFO control, but not to store a Tx message.
