Device **XC886LM-6FF**
Marking/Step **ES AB**
Package **PG-TQFP-48**

This Errata Sheet describes the deviations from the current user documentation. The module oriented classification and numbering system uses an ascending sequence over several derivatives, including already solved deviations. So gaps inside this enumeration can occur.

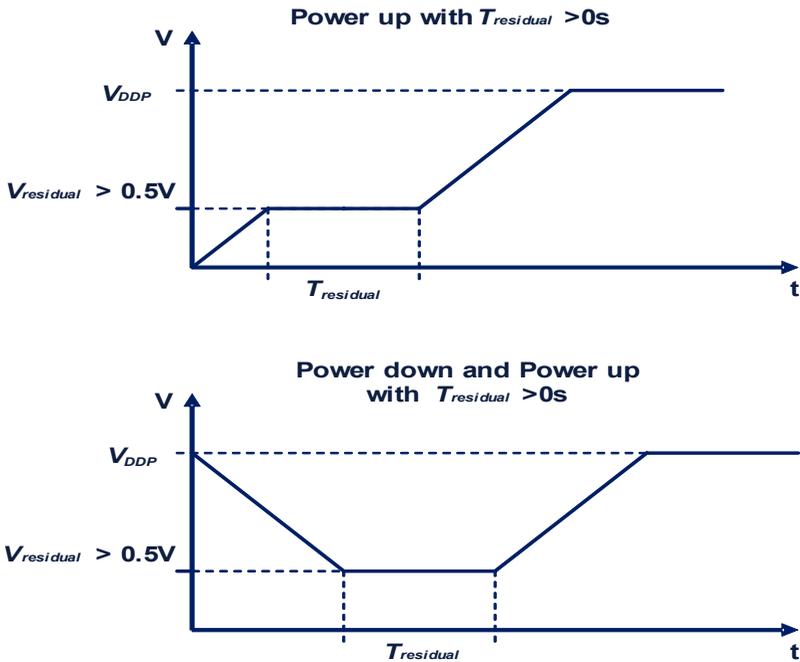
Figure 1 Critical Cases for Power up/ Power down when $V_{residual} > 500mV$

Due to the limitation of the EVR, the reset toggling may occur during the power up. To prevent the reset toggling issue for power up, the following conditions must be met :

1. For power up, the rising time must be less than $2ms/V$.
2. The power down time must be more than $0.2ms/V$.
3. A permanent V_{DDP} residual voltage is less than 500mV.

In case of V_{DDP} residual voltage is more than 500mV, the holding time of residual voltage affects the reset toggling issue. **Figure 1** shows the critical cases for power up/power down when the residual voltages is held for some time. **Figure 2** shows the uncritical case for power up and power down when the power up is triggered immediately after power down. In case of a residual voltage due to immediate power up after power down, the users have to contact IFX to ensure no power up failure.

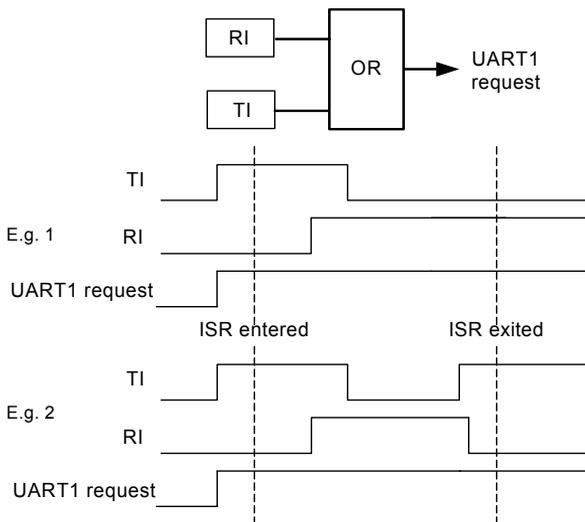
Figure 4

The problem is that it may occur at some point in the application, that any new UART1 interrupt request can no longer be detected after a return-from-interrupt (reti) due to service of earlier event(s). This happens when the following conditions are true:

1. UART1 events are serviced by interrupt (i.e. flags are checked and cleared only in the interrupt routine ISR),
2. Either RI or TI is set at any one time throughout the ISR (even while the other is cleared) such that at least one of the flags is still set after reti, causing the UART1 request line, which is an OR-function of the two flags RI and TI, to remain set throughout the ISR and after reti.

Two example scenerios are illustrated in the following figure:

This means, any future UART1 RI or TI event is not able to cause a rising edge and therefore not able to trigger an interrupt request to the core – as if the UART1 interrupts had been disabled, until both RI and TI flags are cleared at some time. The clearing of flags would have to be done by user's code additionally outside of the UART1 interrupt routine, which is however normally not feasible with an interrupt service scheme.

There are two suggested workaround:

1. If other events of interrupt node XINTR8 (EX2) need not be enabled for interrupt, disable this interrupt node and use software polling of the flags instead.
2. Before return from interrupt, check again if RI or TI is (still) set (due to new request since the last check). If so, jump and execute the ISR routine from start. Exit only when all flags are checked to be cleared. However, dummy

interrupt of the node may occur after return from interrupt, and should be ignored. Another drawback is if UART1 events are occurring at high rate, the CPU may be 'stuck' in the service routine of the UART1 interrupt for a long time.

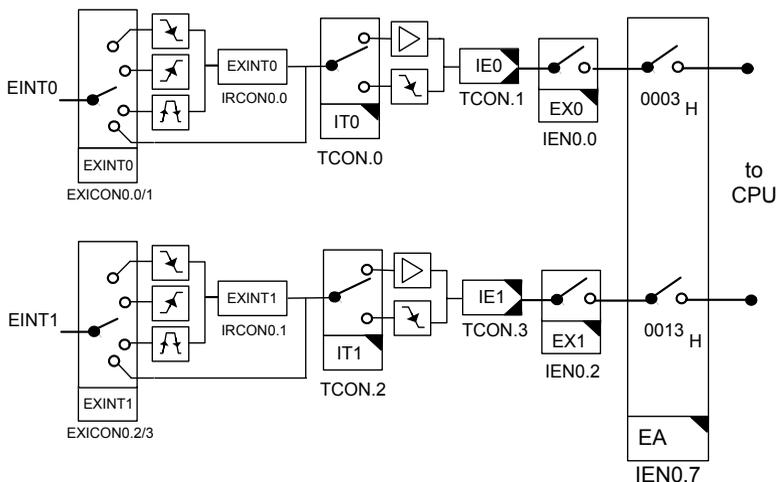
Figure 6

External interrupt 0 and 1 may individually be selected via respective bits (EXINT_x) in EXICON0 register, to request interrupt on falling edge, rising edge, both edges or to bypass the edge detection.

Edge detection is done in the system unit. If enabled, an active event will set the `EXINTx` flag and correspondingly set the `IEx` flag in `TCON`. It should be noted that after any external interrupt `x` event, flag `EXINTx` must be cleared. In case of falling edge as active event, this allows any future active event to be able to set the flag `IEx` as interrupt request. In case of low level as active event, this prevents unintended recurring triggering of interrupt request.

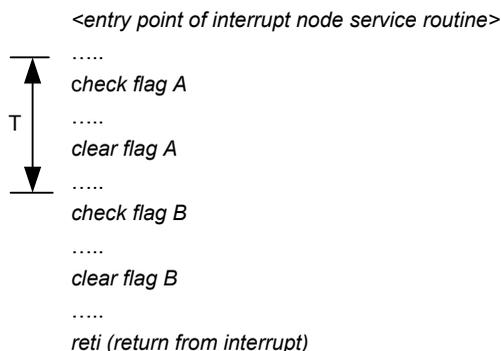
Figure 7

Consider the following NMI interrupt service routine pseudo-code, and scenario where a NMI interrupt source A event leads to interrupt request of the NMI node and CPU vectors to the NMI interrupt routine. Meanwhile, NMI interrupt source B and its flag becomes active any time in the duration indicated by T:

In this case, NMI flag B will be cleared as a standard procedure by the NMI interrupt routine in the current service. However, the pending interrupt request for the NMI node remains activated after RETI, as it is only cleared by hardware when CPU acknowledge the NMI interrupt and vectors to the NMI service routine.

This leads to following servicing of the NMI interrupt node again, but potentially no active NMI flag is found, i.e. dummy NMI interrupt service. The point to note is that the NMI interrupt source B is not lost, as it was actually serviced in the current service of the NMI interrupt node.

The recommendation is to ignore these dummy NMI interrupt vectoring.

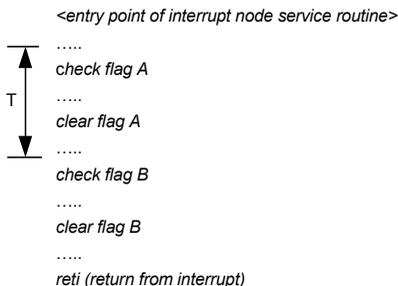
Figure 8

While the interrupt routine is already running due to event A having occurred, event B and C occurs any time in the duration indicated by T:

This sets the pending interrupt request while flag B is set. Although event B is serviced and flag B is cleared in the following service routine, on return from interrupt, the pending interrupt request remains activated. This is because event C is not enabled for interrupt (and therefore flag C is neither checked nor cleared in the interrupt routine) while flag C is not qualified. This leads to following servicing of the interrupt node again, but potentially no active flag is found, i.e. dummy interrupt service. To prevent such dummy interrupt vectoring on the above listed interrupt nodes, do not use mixed interrupt servicing and polling scheme, i.e. enable all events of the node for interrupt if interrupt node is enabled. Otherwise if mixed interrupt servicing and polling scheme is to be used, ignore these dummy interrupt vectoring.
