Device XC886LM-6FF
Marking/Step ES AB
Package PG-TQFP-48

This Errata Sheet describes the deviations from the current user documentation. The module oriented classification and numbering system uses an ascending sequence over several derivatives, including already solved deviations. So gaps inside this enumeration can occur.

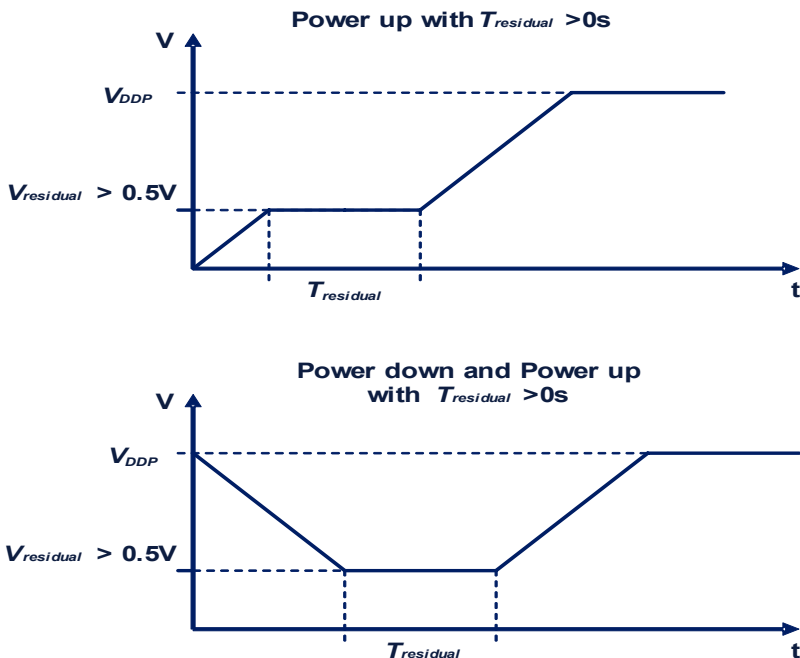
Figure 1 Critical Cases for Power up/ Power down when $V_{residual} > 500mV$

Due to the limitation of the EVR, the reset toggling may occur during the power up. To prevent the reset toggling issue for power up, the following conditions must be met :

1. For power up, the rising time must be less than $2\text{ms}/V$.
2. The power down time must be more than $0.2\text{ms}/V$.
3. A permanent V_{DDP} residual voltage is less than 500mV.

In case of V_{DDP} residual voltage is more than 500mV, the holding time of residual voltage affects the reset toggling issue. **Figure 1** shows the critical cases for power up/power down when the residual voltages is held for some time. **Figure 2** shows the uncritical case for power up and power down when the power up is triggered immediately after power down. In case of a residual voltage due to immediate power up after power down, the users have to contact IFX to ensure no power up failure.

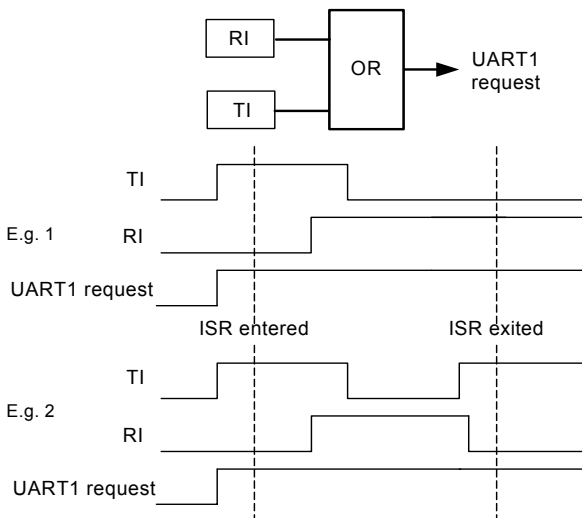
Figure 4

The problem is that it may occur at some point in the application, that any new UART1 interrupt request can no longer be detected after a return-from-interrupt (reti) due to service of earlier event(s). This happens when the following conditions are true:

1. UART1 events are serviced by interrupt (i.e. flags are checked and cleared only in the interrupt routine ISR),
2. Either RI or TI is set at any one time throughout the ISR (even while the other is cleared) such that at least one of the flags is still set after reti, causing the UART1 request line, which is an OR-function of the two flags RI and TI, to remain set throughout the ISR and after reti.

This means, any future UART1 RI or TI event is not able to cause a rising edge and therefore not able to trigger an interrupt request to the core – as if the UART1 interrupts had been disabled, until both RI and TI flags are cleared at some time. The clearing of flags would have to be done by user's code additionally outside of the UART1 interrupt routine, which is however normally not feasible with an interrupt service scheme.

There are two suggested workaround:

1. If other events of interrupt node XINTR8 (EX2) need not be enabled for interrupt, disable this interrupt node and use software polling of the flags instead.
2. Before return from interrupt, check again if RI or TI is (still) set (due to new request since the last check). If so, jump and execute the ISR routine from start. Exit only when all flags are checked to be cleared. However, dummy

interrupt of the node may occur after return from interrupt, and should be ignored. Another drawback is if UART1 events are occurring at high rate, the CPU may be 'stuck' in the service routine of the UART1 interrupt for a long time.

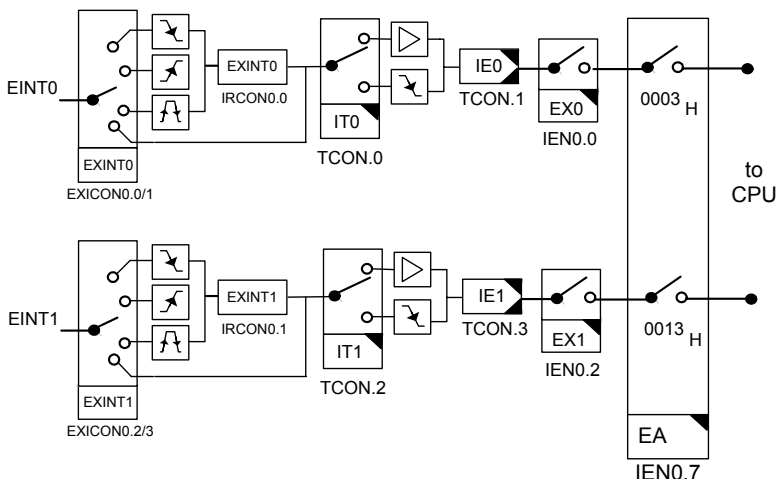
Figure 6

Edge detection is done in the system unit. If enabled, an active event will set the `EXINTx` flag and correspondingly set the `IEx` flag in `TCON`. It should be noted that after any external interrupt `x` event, flag `EXINTx` must be cleared. In case of falling edge as active event, this allows any future active event to be able to set the flag `IEx` as interrupt request. In case of low level as active event, this prevents unintended recurring triggering of interrupt request.

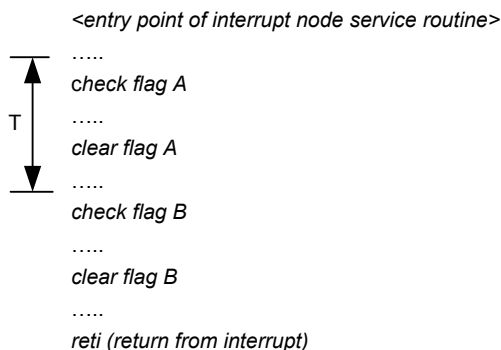
Figure 7

Consider the following NMI interrupt service routine pseudo-code, and scenario where a NMI interrupt source A event leads to interrupt request of the NMI node and CPU vectors to the NMI interrupt routine. Meanwhile, NMI interrupt source B and its flag becomes active any time in the duration indicated by T:

In this case, NMI flag B will be cleared as a standard procedure by the NMI interrupt routine in the current service. However, the pending interrupt request for the NMI node remains activated after RETI, as it is only cleared by hardware when CPU acknowledge the NMI interrupt and vectors to the NMI service routine.

This leads to following servicing of the NMI interrupt node again, but potentially no active NMI flag is found, i.e. dummy NMI interrupt service. The point to note is that the NMI interrupt source B is not lost, as it was actually serviced in the current service of the NMI interrupt node.

The recommendation is to ignore these dummy NMI interrupt vectoring.
