**Device**                **XC888CM-8FF**  
**Marking/Step**      **ES AB**  
**Package**            **PG-TQFP-64**

This Errata Sheet describes the deviations from the current user documentation. The module oriented classification and numbering system uses an ascending sequence over several derivatives, including already solved deviations. So gaps inside this enumeration can occur.

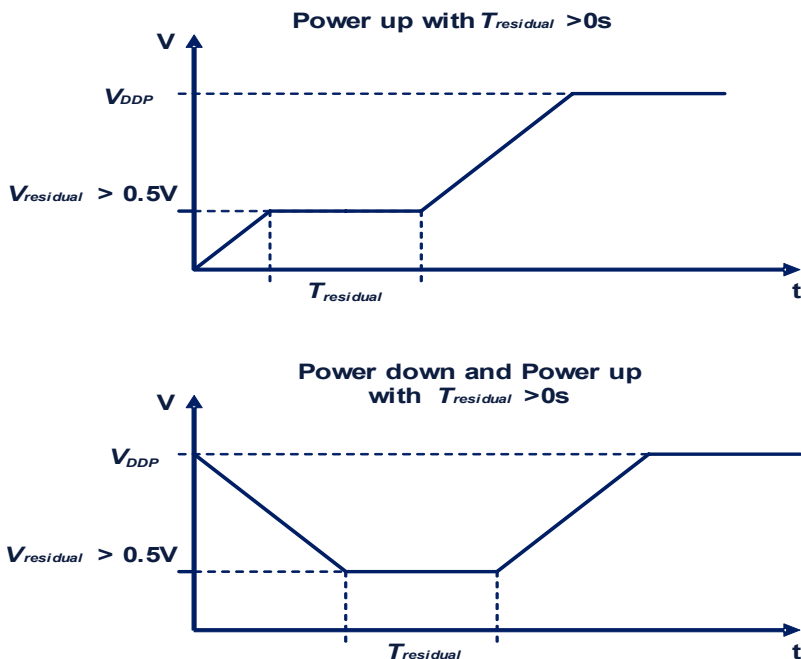
**Figure 1** Critical Cases for Power up/ Power down when  $V_{residual} > 500mV$

### **EVR\_XC8.005 Reset toggling issue for repeated power up**

Due to the limitation of the EVR, the reset toggling may occur during the power up. To prevent the reset toggling issue for power up, the following conditions must be met :

1. For power up, the rising time must be less than  $2\text{ms}/V$ .
2. The power down time must be more than  $0.2\text{ms}/V$ .
3. A permanent  $V_{\text{DDP}}$  residual voltage is less than 500mV.

In case of  $V_{\text{DDP}}$  residual voltage is more than 500mV, the holding time of residual voltage affects the reset toggling issue. **Figure 1** shows the critical cases for power up/power down when the residual voltages is held for some time. **Figure 2** shows the uncritical case for power up and power down when the power up is triggered immediately after power down. In case of a residual voltage due to immediate power up after power down, the users have to contact IFX to ensure no power up failure.

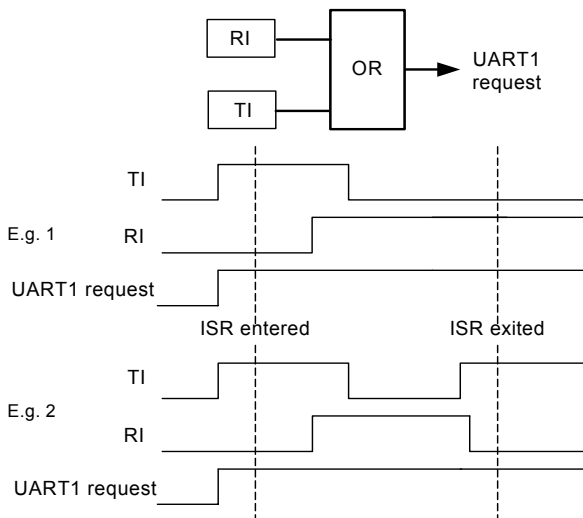
**Figure 4**

### **INT\_XC8.004 Unable to Detect New Interrupt Request if Any One of Timer 2/UART1 Interrupt Flags Is Not Cleared (Unexpectedly)**

The problem is that it may occur at some point in the application, that any new UART1 interrupt request can no longer be detected after a return-from-interrupt (reti) due to service of earlier event(s). This happens when the following conditions are true:

1. UART1 events are serviced by interrupt (i.e. flags are checked and cleared only in the interrupt routine ISR),
2. Either RI or TI is set at any one time throughout the ISR (even while the other is cleared) such that at least one of the flags is still set after reti, causing the UART1 request line, which is an OR-function of the two flags RI and TI, to remain set throughout the ISR and after reti.

This means, any future UART1 RI or TI event is not able to cause a rising edge and therefore not able to trigger an interrupt request to the core – as if the UART1 interrupts had been disabled, until both RI and TI flags are cleared at some time. The clearing of flags would have to be done by user's code additionally outside of the UART1 interrupt routine, which is however normally not feasible with an interrupt service scheme.

1. If other events of interrupt node XINTR8 (EX2) need not be enabled for interrupt, disable this interrupt node and use software polling of the flags instead.
2. Before return from interrupt, check again if RI or TI is (still) set (due to new request since the last check). If so, jump and execute the ISR routine from start. Exit only when all flags are checked to be cleared. However, dummy

interrupt of the node may occur after return from interrupt, and should be ignored. Another drawback is if UART1 events are occurring at high rate, the CPU may be 'stuck' in the service routine of the UART1 interrupt for a long time.
