Device	XC886/888CLM Series
Marking/Step	ES AB
Package	PG-TQFP-48/64

This Errata Sheet describes the deviations from the current user documentation. The module oriented classification and numbering system uses an ascending sequence over several derivatives, including already solved deviations. So gaps inside this enumeration can occur.

- XC886/888C-6/8FF
- XC886/888CM-6/8FF
- XC886/888CLM-6/8FF

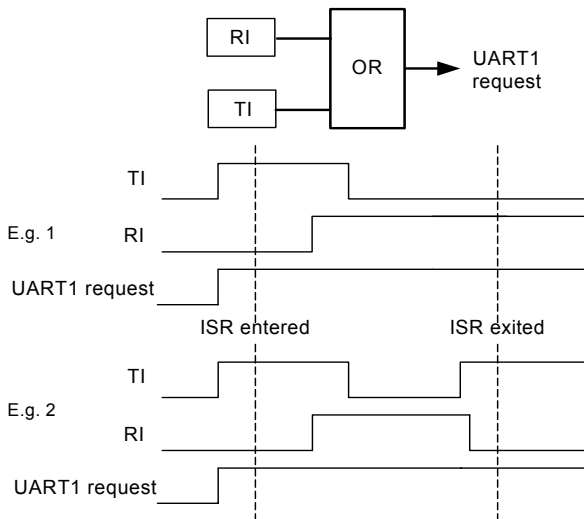
Figure 4

The problem is that it may occur at some point in the application, that any new UART1 interrupt request can no longer be detected after a return-from-interrupt (reti) due to service of earlier event(s). This happens when the following conditions are true:

1. UART1 events are serviced by interrupt (i.e. flags are checked and cleared only in the interrupt routine ISR),
2. Either RI or TI is set at any one time throughout the ISR (even while the other is cleared) such that at least one of the flags is still set after reti, causing the UART1 request line, which is an OR-function of the two flags RI and TI, to remain set throughout the ISR and after reti.

This means, any future UART1 RI or TI event is not able to cause a rising edge and therefore not able to trigger an interrupt request to the core – as if the UART1 interrupts had been disabled, until both RI and TI flags are cleared at some time. The clearing of flags would have to be done by user's code additionally outside of the UART1 interrupt routine, which is however normally not feasible with an interrupt service scheme.

There are two suggested workaround:

1. If other events of interrupt node XINTR8 (EX2) need not be enabled for interrupt, disable this interrupt node and use software polling of the flags instead.
2. Before return from interrupt, check again if RI or TI is (still) set (due to new request since the last check). If so, jump and execute the ISR routine from start. Exit only when all flags are checked to be cleared. However, dummy

interrupt of the node may occur after return from interrupt, and should be ignored. Another drawback is if UART1 events are occurring at high rate, the CPU may be 'stuck' in the service routine of the UART1 interrupt for a long time.
