| Device | XC886/888CLM Series |
| Marking/Step | AC |
| Package | PG-TQFP-48/64 |

This Errata Sheet describes the deviations from the current user documentation. The module oriented classification and numbering system uses an ascending sequence over several derivatives, including already solved deviations. So gaps inside this enumeration can occur.

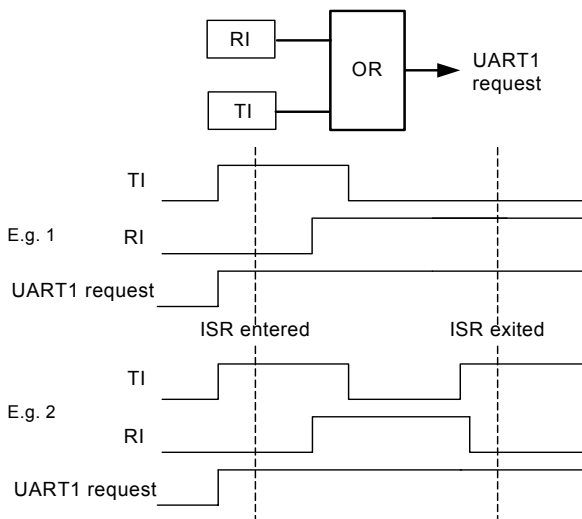
Figure 2

The problem is that it may occur at some point in the application, that any new UART1 interrupt request can no longer be detected after a return-from-interrupt (reti) due to service of earlier event(s). This happens when the following conditions are true:

1. UART1 events are serviced by interrupt (i.e. flags are checked and cleared only in the interrupt routine ISR),
2. Either RI or TI is set at any one time throughout the ISR (even while the other is cleared) such that at least one of the flags is still set after reti, causing the UART1 request line, which is an OR-function of the two flags RI and TI, to remain set throughout the ISR and after reti.

This means, any future UART1 RI or TI event is not able to cause a rising edge and therefore not able to trigger an interrupt request to the core – as if the UART1 interrupts had been disabled, until both RI and TI flags are cleared at some time. The clearing of flags would have to be done by user's code

additionally outside of the UART1 interrupt routine, which is however normally not feasible with an interrupt service scheme.

1. If other events of interrupt node XINTR8 (EX2) need not be enabled for interrupt, disable this interrupt node and use software polling of the flags instead.
2. Before return from interrupt, check again if RI or TI is (still) set (due to new request since the last check). If so, jump and execute the ISR routine from start. Exit only when all flags are checked to be cleared. However, dummy interrupt of the node may occur after return from interrupt, and should be ignored. Another drawback is if UART1 events are occurring at high rate, the CPU may be 'stuck' in the service routine of the UART1 interrupt for a long time.

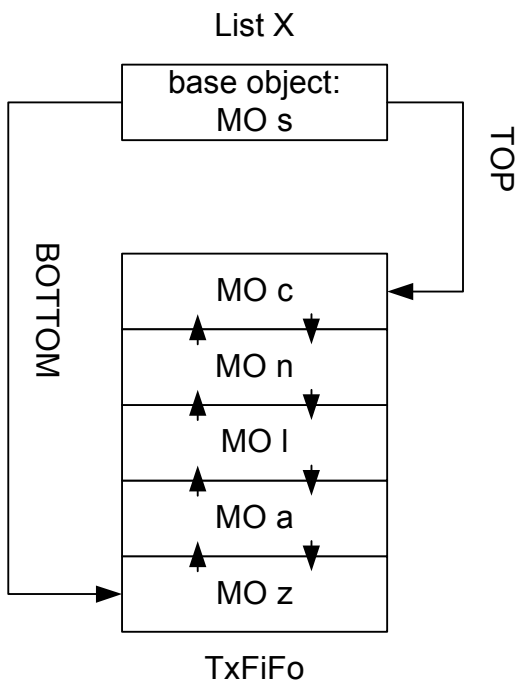
Figure 4 FIFO structure

After the successful transmission of a Tx FIFO element, a Tx overflow interrupt is generated if the FIFO base object fulfils these conditions:

If Tx FIFO overflow interrupt needed, take the FIFO base object out of the circular list of the Tx message objects. That is to say, just use the FIFO base object for FIFO control, but not to store a Tx message.

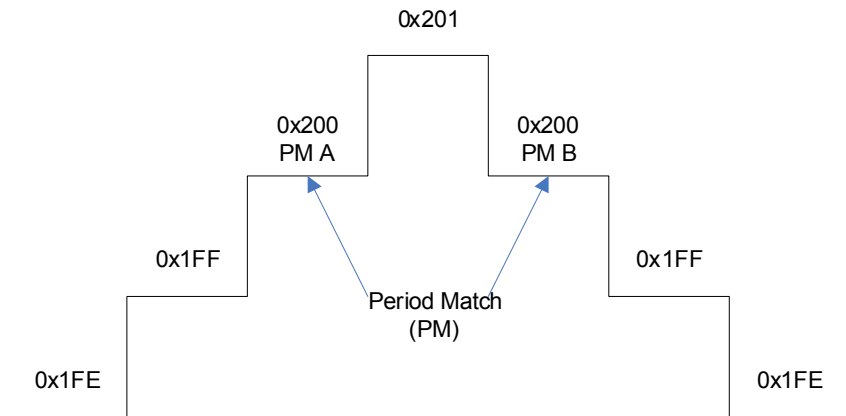
Figure 6 Counting sequence of T12 in center-aligned mode

After detecting a period match (PM A) in centre-aligned mode, T12 counts down from PM + 1 as shown below:

This means a second PM event (PM B) will occur during the counting down. If ADC is triggered externally via ETRx2 (T12PM), it will be triggered twice in succession. Depending on how real-time the application code is running as well as the T12 count rate and ADC conversion rate, the application could observe two ADC interrupts - once at PM A and once at PM B.

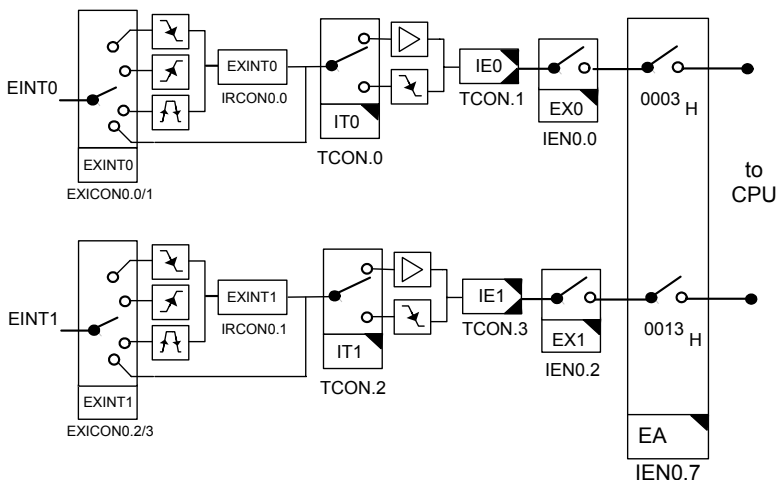
Figure 7

External interrupt 0 and 1 may individually be selected via respective bits (`EXINTx`) in `EXICON0` register, to request interrupt on falling edge, rising edge, both edges or to bypass the edge detection.

Edge detection is done in the system unit. If enabled, an active event will set the `EXINTx` flag and correspondingly set the `IEx` flag in `TCON`. It should be noted that after any external interrupt `x` event, flag `EXINTx` must be cleared. In case of falling edge as active event, this allows any future active event to be able to set the flag `IEx` as interrupt request. In case of low level as active event, this prevents unintended recurring triggering of interrupt request.

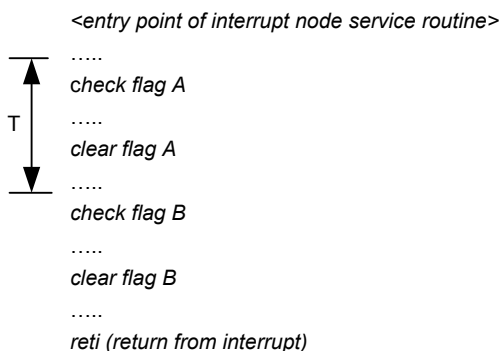
Figure 8

Consider the following NMI interrupt service routine pseudo-code, and scenario where a NMI interrupt source A event leads to interrupt request of the NMI node and CPU vectors to the NMI interrupt routine. Meanwhile, NMI interrupt source B and its flag becomes active any time in the duration indicated by T:

In this case, NMI flag B will be cleared as a standard procedure by the NMI interrupt routine in the current service. However, the pending interrupt request for the NMI node remains activated after RETI, as it is only cleared by hardware when CPU acknowledge the NMI interrupt and vectors to the NMI service routine.

This leads to following servicing of the NMI interrupt node again, but potentially no active NMI flag is found, i.e. dummy NMI interrupt service. The point to note is that the NMI interrupt source B is not lost, as it was actually serviced in the current service of the NMI interrupt node.

The recommendation is to ignore these dummy NMI interrupt vectoring.

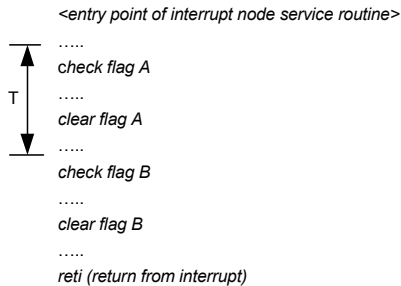
Figure 9

While the interrupt routine is already running due to event A having occurred, event B and C occurs any time in the duration indicated by T:

This sets the pending interrupt request while flag B is set. Although event B is serviced and flag B is cleared in the following service routine, on return from interrupt, the pending interrupt request remains activated. This is because event C is not enabled for interrupt (and therefore flag C is neither checked nor cleared in the interrupt routine) while flag C is not qualified. This leads to following servicing of the interrupt node again, but potentially no active flag is found, i.e. dummy interrupt service. To prevent such dummy interrupt vectoring on the above listed interrupt nodes, do not use mixed interrupt servicing and polling scheme, i.e. enable all events of the node for interrupt if interrupt node is enabled. Otherwise if mixed interrupt servicing and polling scheme is to be used, ignore these dummy interrupt vectoring.

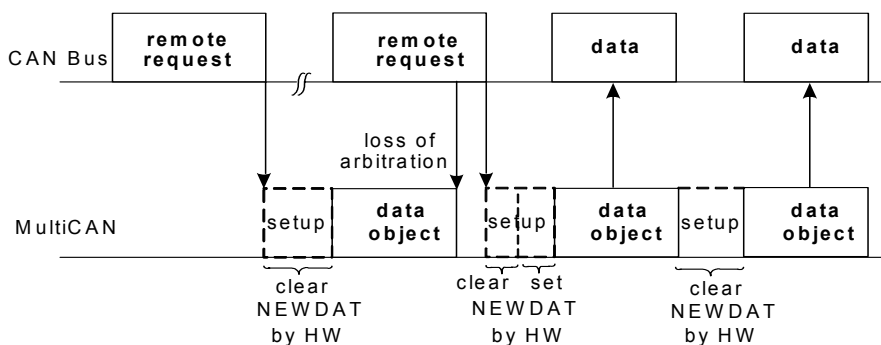
Figure 10 Loss of Arbitration

When the appropriate message object (data frame) triggered by the first remote frame wins the arbitration, it will be sent out and NEWDAT is not reset. This leads to an additional data frame, that will be sent by this message object (clearing NEWDAT).

There will, however, not be more data frames than there are corresponding remote requests.
