Device	XC886/888CLM Series
Marking/Step	AA
Package	PG-TQFP-48/64

This Errata Sheet describes the deviations from the current user documentation. The module oriented classification and numbering system uses an ascending sequence over several derivatives, including already solved deviations. So gaps inside this enumeration can occur.

- XC886/888C-6/8RF
- XC886/888CM-6/8RF
- XC886/888CLM-6/8RF

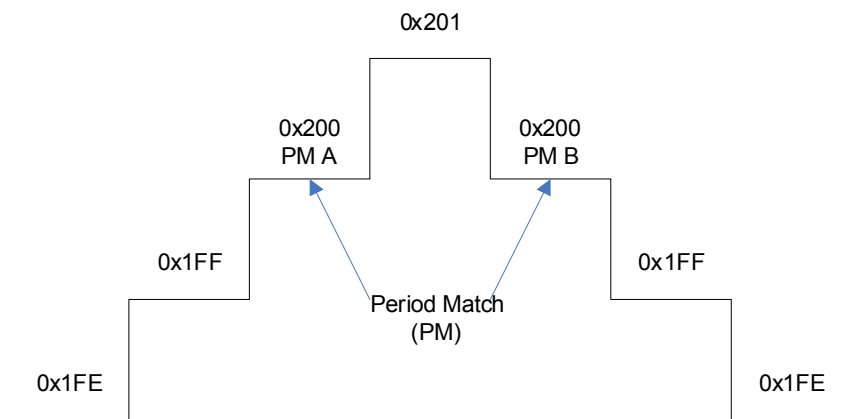
Figure 6 Counting sequence of T12 in center-aligned mode

After detecting a period match (PM A) in centre-aligned mode, T12 counts down from PM + 1 as shown below:

This means a second PM event (PM B) will occur during the counting down. If ADC is triggered externally via ETRx2 (T12PM), it will be triggered twice in succession. Depending on how real-time the application code is running as well as the T12 count rate and ADC conversion rate, the application could observe two ADC interrupts - once at PM A and once at PM B.

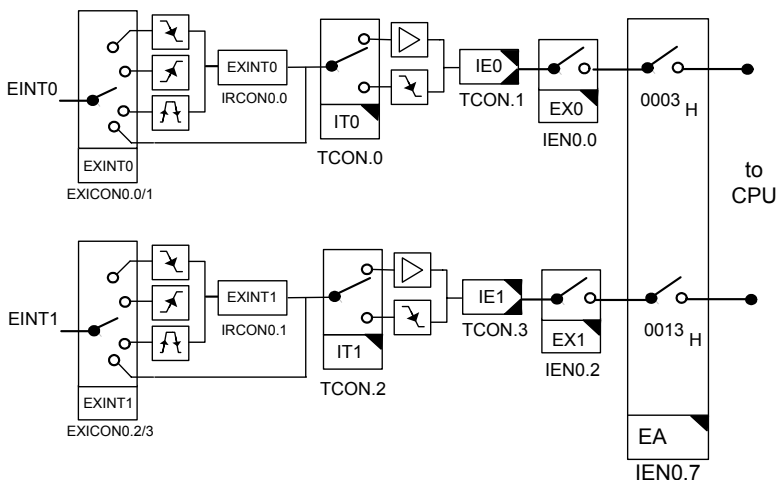
Figure 7

External interrupt 0 and 1 may individually be selected via respective bits (`EXINTx`) in `EXICON0` register, to request interrupt on falling edge, rising edge, both edges or to bypass the edge detection.

Edge detection is done in the system unit. If enabled, an active event will set the `EXINTx` flag and correspondingly set the `IEx` flag in `TCON`. It should be noted that after any external interrupt `x` event, flag `EXINTx` must be cleared. In case of falling edge as active event, this allows any future active event to be able to set the flag `IEx` as interrupt request. In case of low level as active event, this prevents unintended recurring triggering of interrupt request.

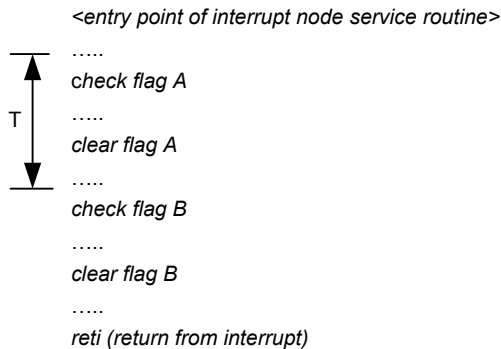
Figure 8

Consider the following NMI interrupt service routine pseudo-code, and scenario where a NMI interrupt source A event leads to interrupt request of the NMI node and CPU vectors to the NMI interrupt routine. Meanwhile, NMI interrupt source B and its flag becomes active any time in the duration indicated by T:

In this case, NMI flag B will be cleared as a standard procedure by the NMI interrupt routine in the current service. However, the pending interrupt request for the NMI node remains activated after RETI, as it is only cleared by hardware when CPU acknowledge the NMI interrupt and vectors to the NMI service routine.

This leads to following servicing of the NMI interrupt node again, but potentially no active NMI flag is found, i.e. dummy NMI interrupt service. The point to note is that the NMI interrupt source B is not lost, as it was actually serviced in the current service of the NMI interrupt node.

The recommendation is to ignore these dummy NMI interrupt vectoring.

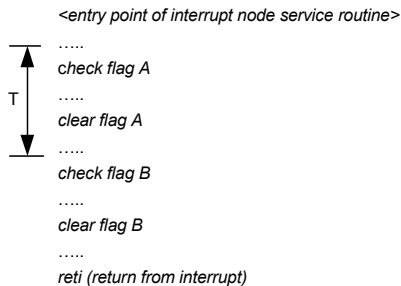
Figure 9

While the interrupt routine is already running due to event A having occurred, event B and C occurs any time in the duration indicated by T:

This sets the pending interrupt request while flag B is set. Although event B is serviced and flag B is cleared in the following service routine, on return from interrupt, the pending interrupt request remains activated. This is because event C is not enabled for interrupt (and therefore flag C is neither checked nor cleared in the interrupt routine) while flag C is not qualified. This leads to following servicing of the interrupt node again, but potentially no active flag is found, i.e. dummy interrupt service. To prevent such dummy interrupt vectoring on the above listed interrupt nodes, do not use mixed interrupt servicing and polling scheme, i.e. enable all events of the node for interrupt if interrupt node is enabled. Otherwise if mixed interrupt servicing and polling scheme is to be used, ignore these dummy interrupt vectoring.

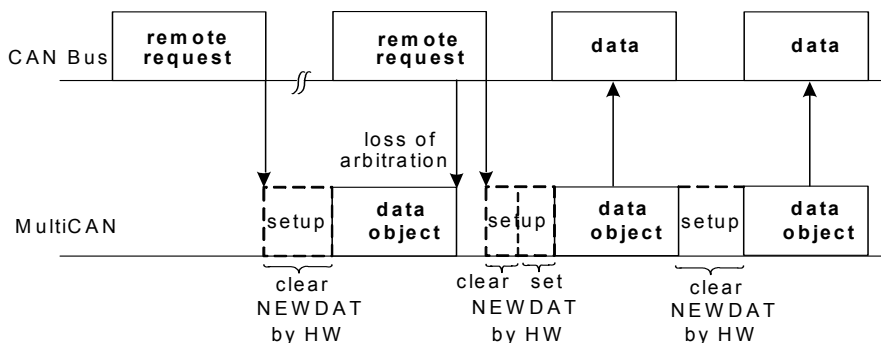
Figure 10 Loss of Arbitration

When the appropriate message object (data frame) triggered by the first remote frame wins the arbitration, it will be sent out and `NEWDAT` is not reset. This leads to an additional data frame, that will be sent by this message object (clearing `NEWDAT`).

There will, however, not be more data frames than there are corresponding remote requests.
