Device	XMC4400
Marking/Step	EES-AA, ES-AA
Package	PG-LQFP-64/100

Document ID is **02512AERRA**.

This “Errata Sheet” describes product deviations with respect to the user documentation listed below.

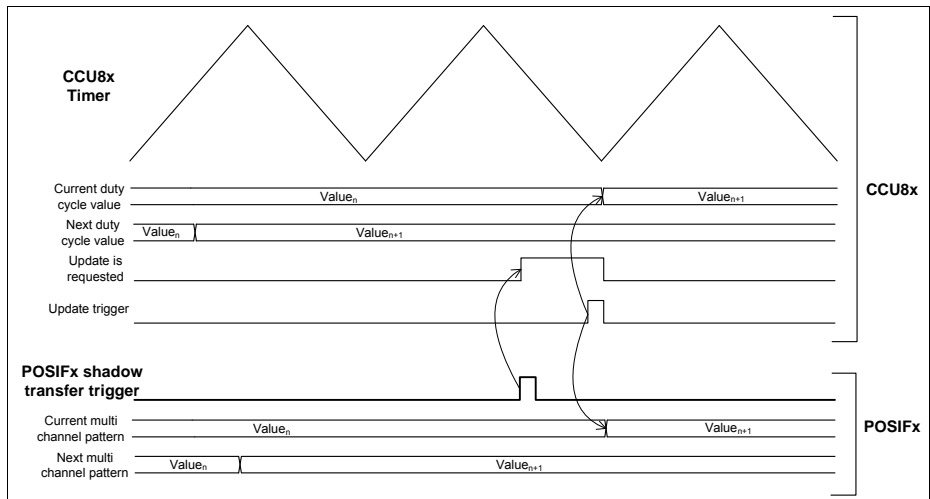
Figure 2 Value update handshake between CCU8x and POSIFx

This feature cannot be used with the Timer2 (defined as CC82 in the documentation) of the CCU8x module(s) (more than one CCU8 module can be contained on a specific device).

All the other 3 Timers (defined as CC80, CC81, CC83) inside the CCU8x modul are not affected by this issue.

None

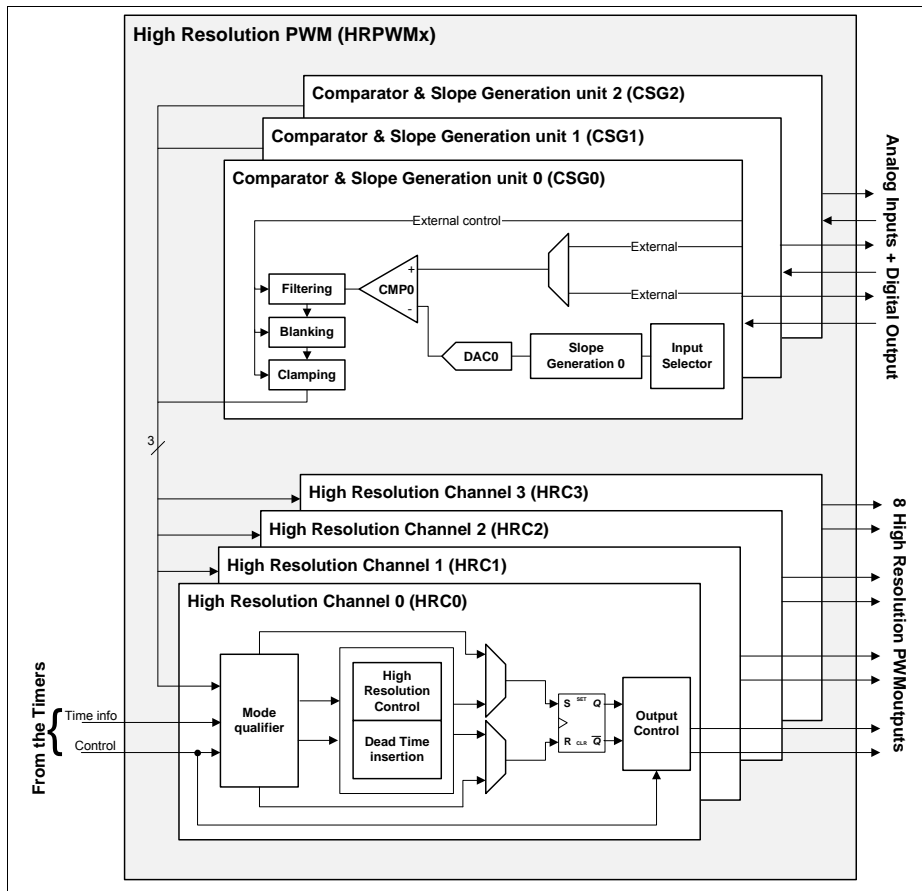
Figure 12 High Resolution Channel (HRC) simplified block diagram

Also due to power connection issues, the HRC sub modules can have the following problems:

- High Resolution Channel 3 may stop working due to internal voltage drop.
- Generation of the 150 ps resolution of all the HRCs may not ramp up properly during module initialization (temperature dependency). If this happens, then all the HRC channels are not able to generate a 150 ps resolution. The proper ramp can be checked by polling the HRGHRS.HRGR bitfield.
