Device	XMC4500
Marking/Step	EES-AA, ES-AA
Package	PG-LQFP-100/144, PG-LFBGA-144

Document ID is **02462AERRA**.

This “Errata Sheet” describes product deviations with respect to the user documentation listed below.

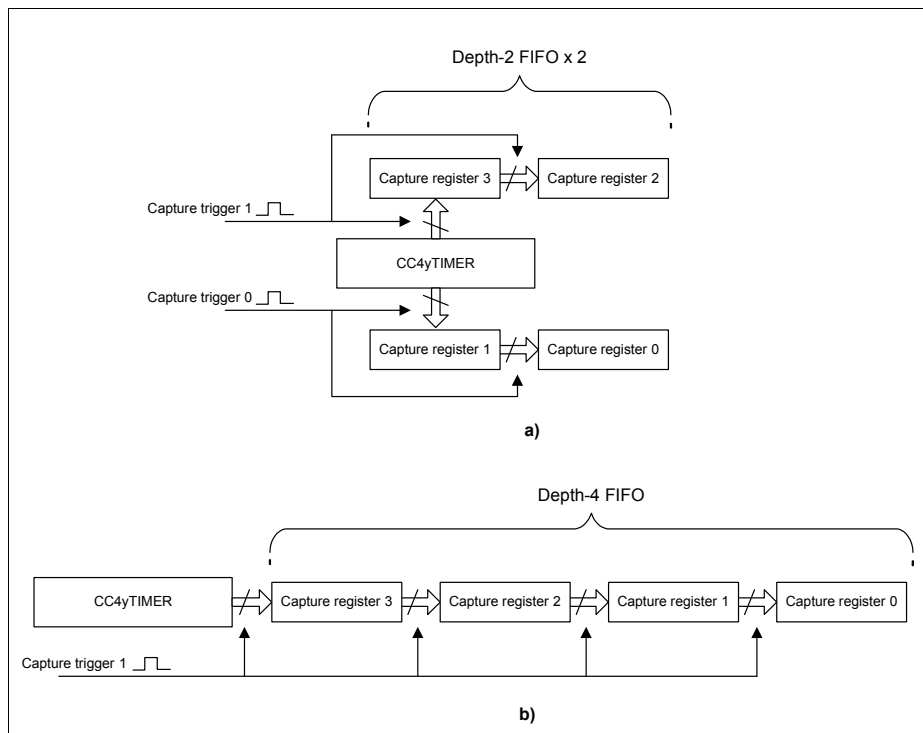
Figure 1 CCU4 capture modes - a) Depth-2 x2 Capture; b) Depth-4 Capture

The period interrupt is not generated when the timer slice is programmed in the depth-4 capture mode or when is programmed in depth-2 capture mode and the capture trigger 1 is used.

These situations occur whenever capture trigger 1 is being used (when the CC4yCMC.CAP1S field is programmed with a value different from 00_B).

A straightforward workaround is to use only 2 capture registers (instead of a maximum of 4). This is done by setting the CC4yCMC.CAP1S to 00_B and program the CC4yCMC.CAP0S with a value different from 00_B .

By using the floating prescaler function present in each timer slice, the capture routine can ignore the missing period interrupt, for a capture trigger frequency as low as 0.25 Hz (for f_{CCU} equal to 120 MHz).

The floating prescaler function can be enabled by setting the CC4yTC.FPE = 1_B .

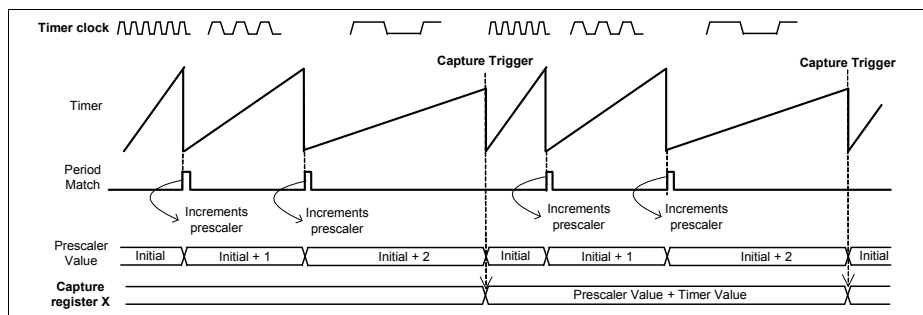
Figure 2 Floating Prescaler for Capturing

The usage of Capture Register 2 and Capture Register 3 is not possible when the Floating Prescaler function is enabled, $CC8yTC.FPE = 1_B$. This only happens when the Capture Trigger 1 is being used, $CC8yCMD.CAP1S \neq 00_B$. Therefore is not possible to use the Floating Prescaler feature with the capture trigger 1. The usage of the capture trigger 0 is not affected, which means that capture register 0 and capture register 1 can be used with the floating prescaler feature.

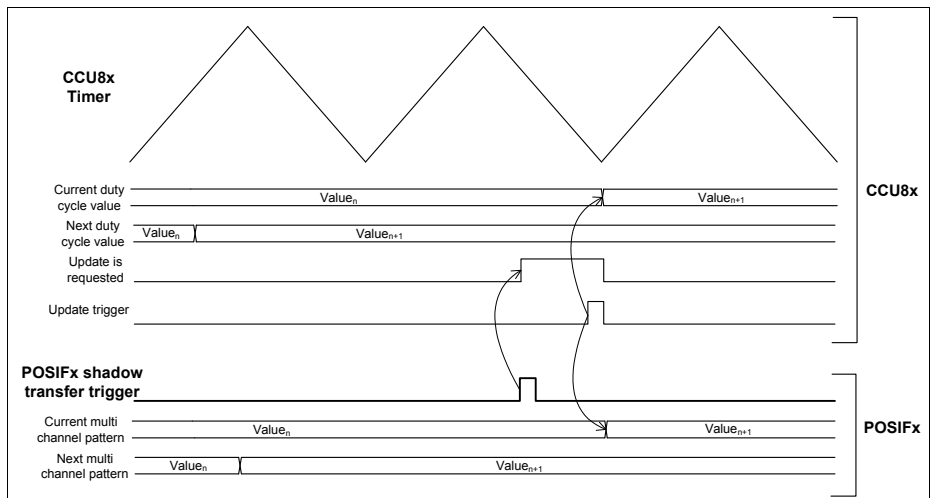
Figure 4 Value update handshake between CCU8x and POSIFx

This feature cannot be used with the Timer2 (defined as CC82 in the documentation) of the CCU8x module(s) (more than one CCU8 module can be contained on a specific device).

All the other 3 Timers (defined as CC80, CC81, CC83) inside the CCU8x moduel are not affected by this issue.

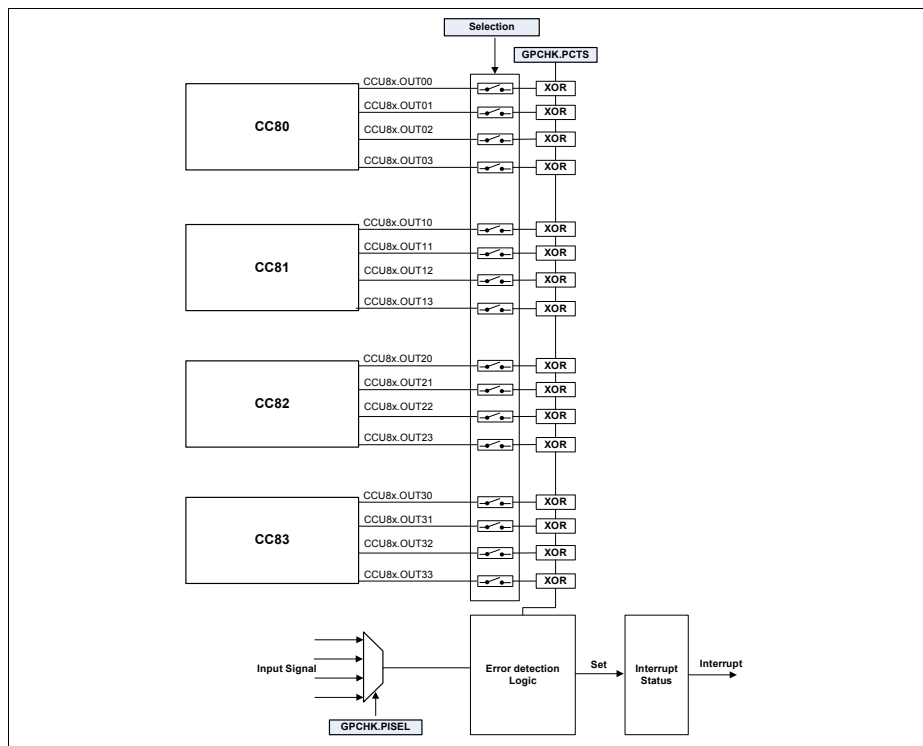
Figure 5 Parity Checker diagram

When using the parity checker function, the associated status bitfield, is cleared automatically by hardware in the next PWM cycle whenever an error is not present.

This means that if in the previous PWM cycle an error was detected and one interrupt was triggered, the software needs to read back the status register before the end of the immediately next PWM cycle.

Not ORing the Parity Checker error interrupt with any other interrupt source. With this approach, the software does not need to read back the status information to understand what was the origin of the interrupt - because there is only one source.

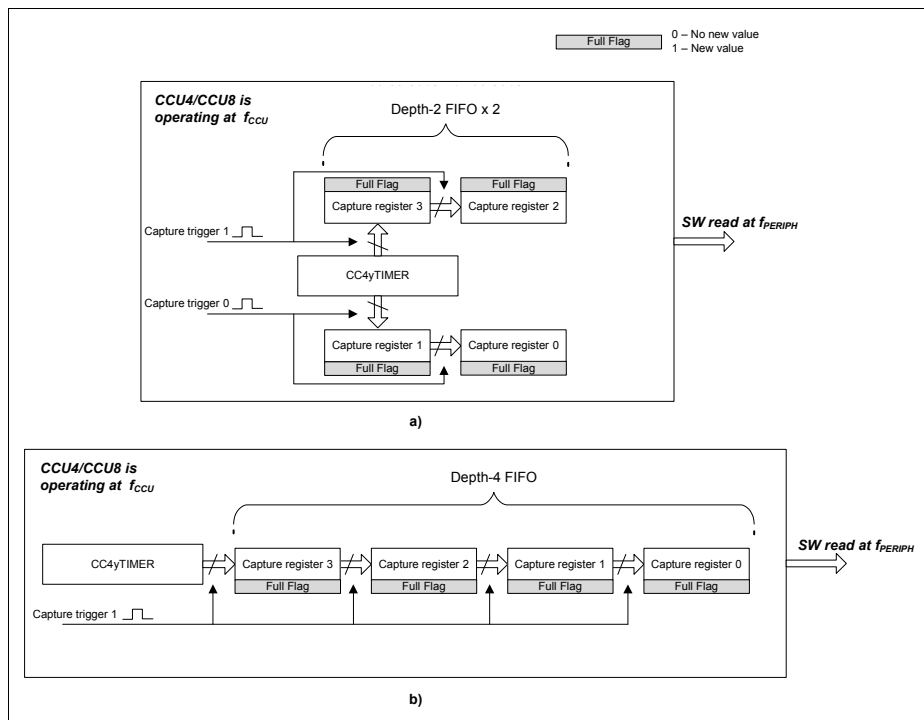
Figure 6 Capture Modes Structure - a) Depth-2 x2 Capture; b) Depth-4 Capture

When the peripheral bus clock frequency is smaller than the CCU4/CCU8 module clock frequency, $f_{\text{periph}} < f_{\text{CCU}}$, the read back of the full flag is inconsistent. Sometimes it returns the information that a new value has been captured and sometimes it does not.

When the usage of the FFL field is needed, the module clock of the CCU4/CCU8 module should be equal to the peripheral bus clock frequency:

To do this, the following SCU (System Control Unit) registers should be set with values that force this condition: CCUCLKCR.CCUDIV, CPUCLKCR.CPUDIV and PBCLKCR.PBDIV.

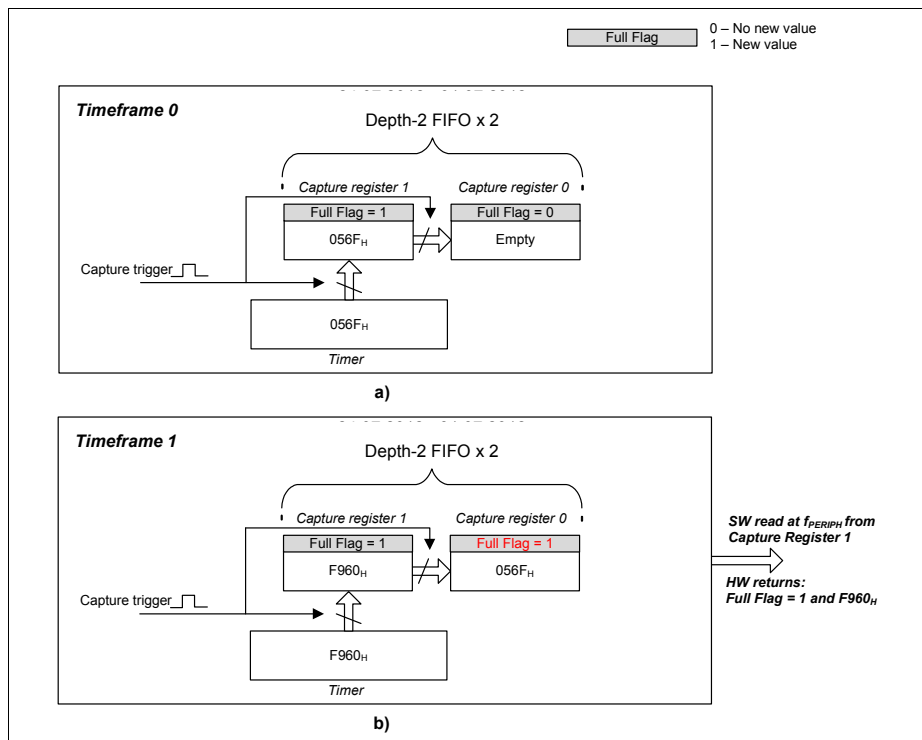
Figure 8 Capture shift during read back phase - a) Capture trigger without collision with read back; b) Capture trigger collision with read back

Referring to [Figure 8](#), it can be understood that the proper data is sent to the software when it reads back the capture register 1, nevertheless this same data is shifted to the next capture register (capture register 0) and the full flag of this register is set.

After this if the software reads back capture register 0, a value is going to be returned with a full flag set (indicating that this is a new value - that has not yet been read, which is not true).

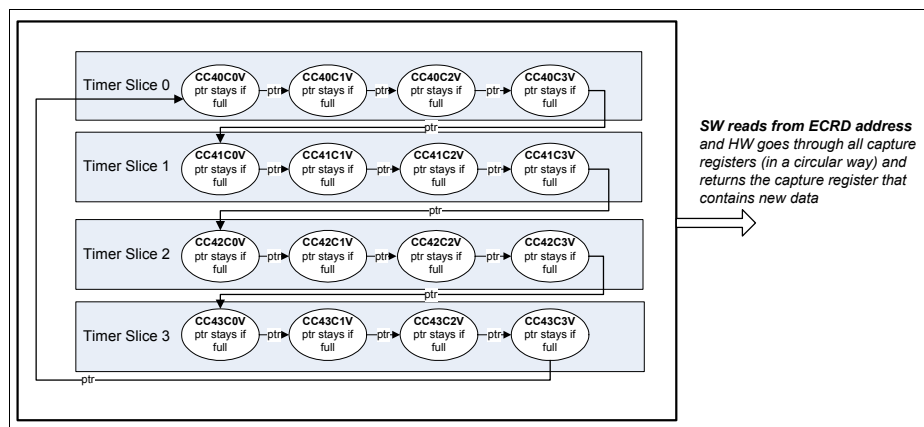
Figure 9 Extended Read Back access - example for CCU4 (CCU8 structure is the same)

- Timer X has 4 capture registers and is the only Timer set with $ECM = 1_B$. At the moment that the software starts reading the capture registers via the ECRD address, we have already captured two values. The ECRD read back will output CC4xC2V -> CC4xC2V (CC4xC3V value is lost)

- Timer X and Timer Y have 4 capture registers each and they are both configured with $ECM = 1_B$. At the moment that the software starts reading the capture registers via the ECRD address, we have already captured two values on Timer X and 4 on Timer Y. The ECRD read back will output CC4xC0V -> CC4xC1V -> CC4xC2V -> CC4xC3V -> CC4yC2V -> CC4yC2V (CC4yC3V value is lost)

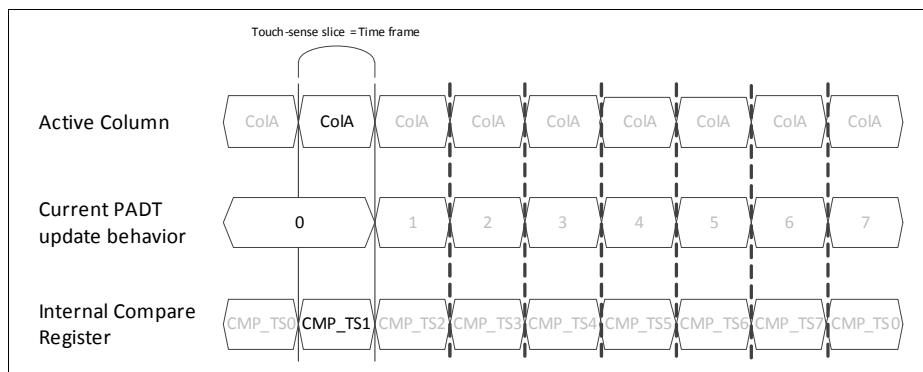
Figure 13 Pad turn 0 prevails for one time slice longer when no LEDs are enabled

If the number of LED columns enabled is smaller than 2, the delay will affect the activation period of the current active pad. At the beginning of every new Col A, the value of the current PADT's compare register is updated to the internal compare register. However, the delay causes the value of the previous PADT's compare register is updated to the internal compare register instead. This means that the current active pad would be activated with the duration of the previous pad's oscillation window ([Figure 12](#)). In addition to this, when no LEDs are enabled, pad turn 0 will prevail for one time slice longer before it gets updated ([Figure 13](#)).

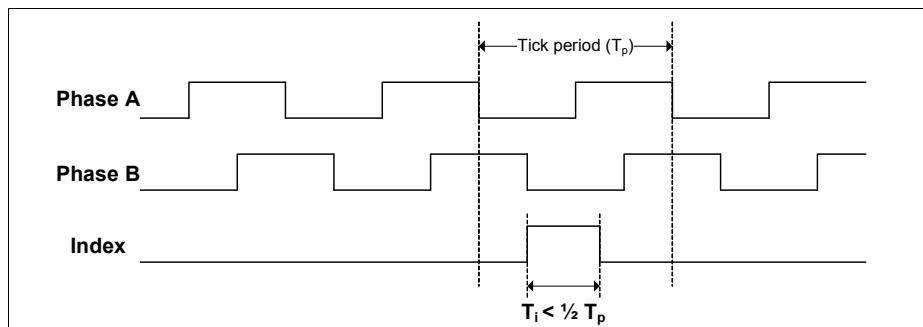
Figure 17 Different index signal types

When the index signal is smaller than 1/2 of the tick period, the POSIF module is not able to decode this signal properly, Figure 2 - notice that the reference edge of the index generation in this figure is the falling of Phase B, nevertheless this is an example and depending on the encoder type, this edge may be one of the other three.

Due to this fact it is not possible to use the POSIF to decode these type of signals (index with duration below 1/2 of the tick period).
