<b>Device</b>	<b>C504-2R, C504-L</b>
<b>Marking/Step</b>	<b>Step AC, AC-T*</b>
<b>Package</b>	<b>P-MQFP-44</b>

This Errata Sheet describes the deviations from the current user documentation.

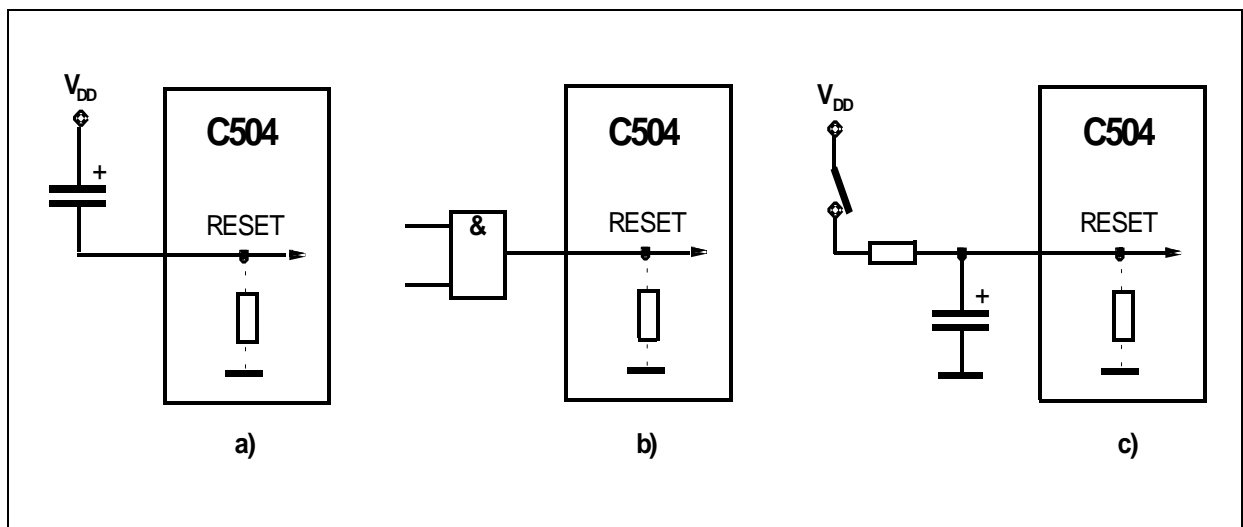
**Figure 1 Reset Circuitries**

**RST.1: Figure in User’s Manual and Data Sheet regarding the Reset Circuitries is incorrect**

Figure 5-1 in User’s Manual and Figure 6 in Data Sheet show incorrectly that the RESET pin has an internal pullup resistor connected to the  $V_{DD}$ . Instead, at the RESET pin, an internal pulldown resistor is connected to the  $V_{SS}$ . The correct implementation is illustrated in **Figure 1**.

This correction will be updated to the future versions of the User’s Manual and Data Sheet.
