<b>Device</b>	<b>C505A-4RM, C505CA-2RM/4RM/LM, C505CA-4RC</b>
<b>Marking/Step</b>	<b>Step ES-CA, CA</b>
<b>Package</b>	<b>P-MQFP-44, Bare Die</b>

This Errata Sheet describes the deviations from the current user documentation.

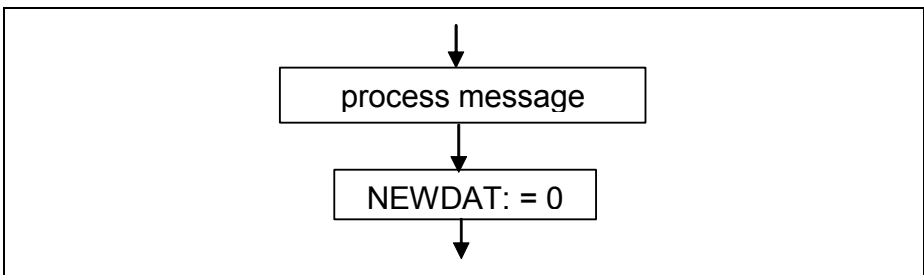
**CAN.4: Flowchart sequence in figure in User's Manual regarding Micro-controller handling of the Last Message Object is partly incorrect**

For the software flowchart figure 6-48 in User's Manual 11.97, the correct would be to first 'process message contents' and then to 'clear bit NEWDAT'.

This correction will be updated to the future versions of the User's Manuals.
